Appendix B

Photographs

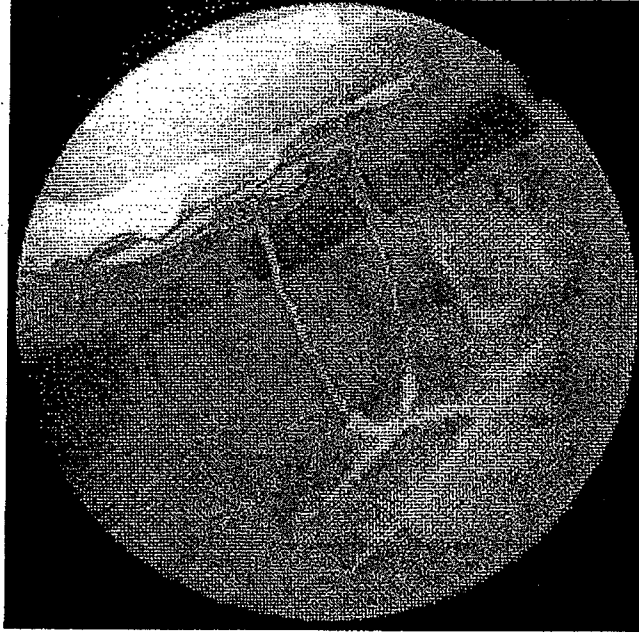
Figure B1-3: Brickwork - Disengaged and corroded brick tie.

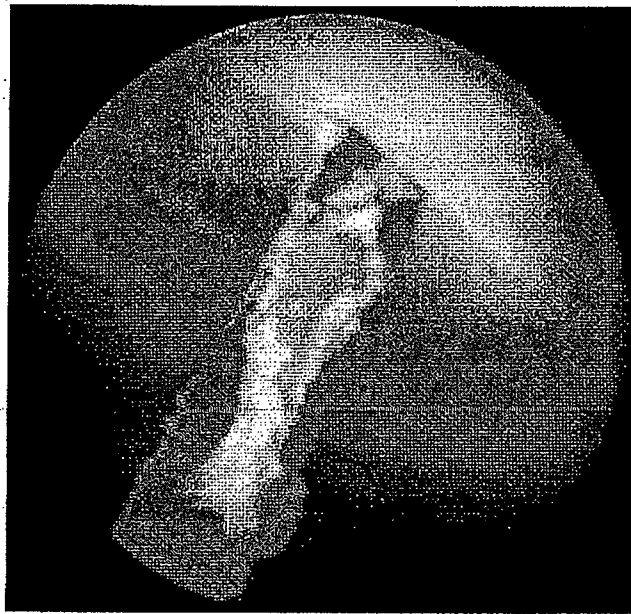
Figure B1-4: Brickwork – Corroded brick tie.

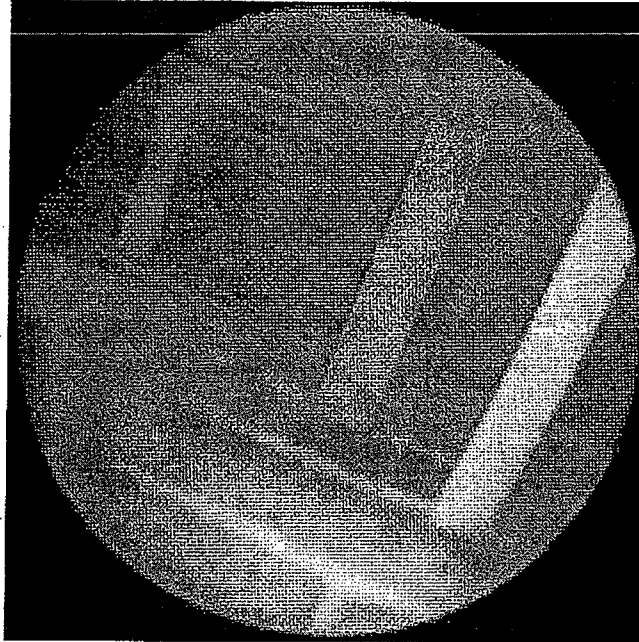
Figure B1-5: Brickwork – Engaged but corroded brick tie fixings.

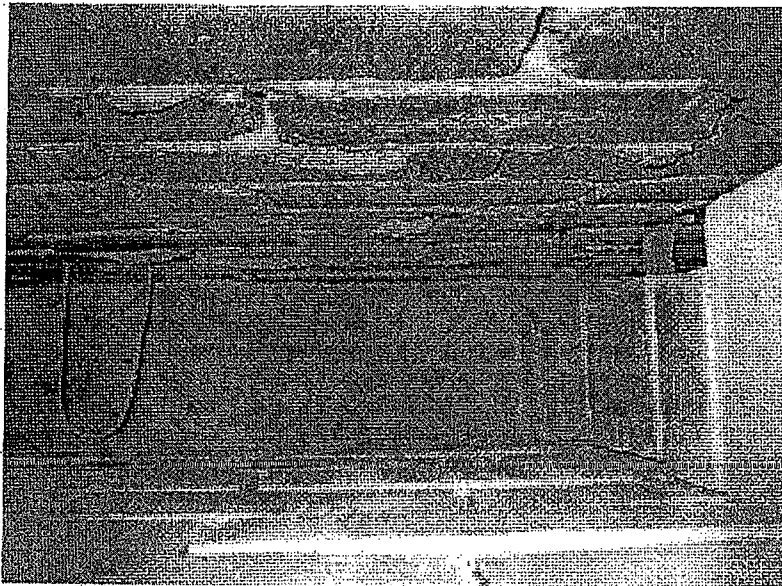
Figure B1-6: Brickwork – Disengaged brick tie. (Note piers are not engaged with external skin of brickwork)

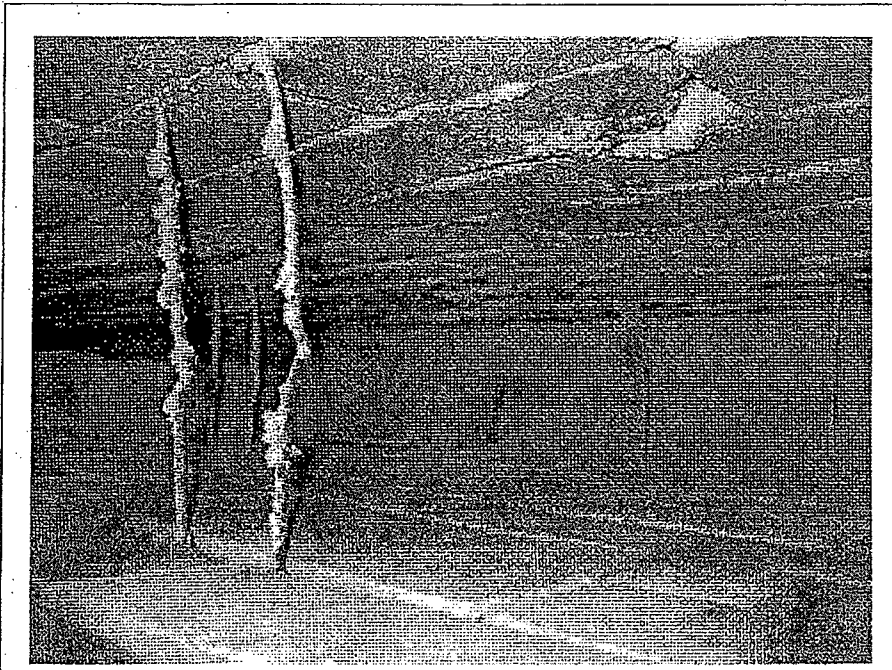
Figure B1-7: Brickwork – Corroded brick tie.

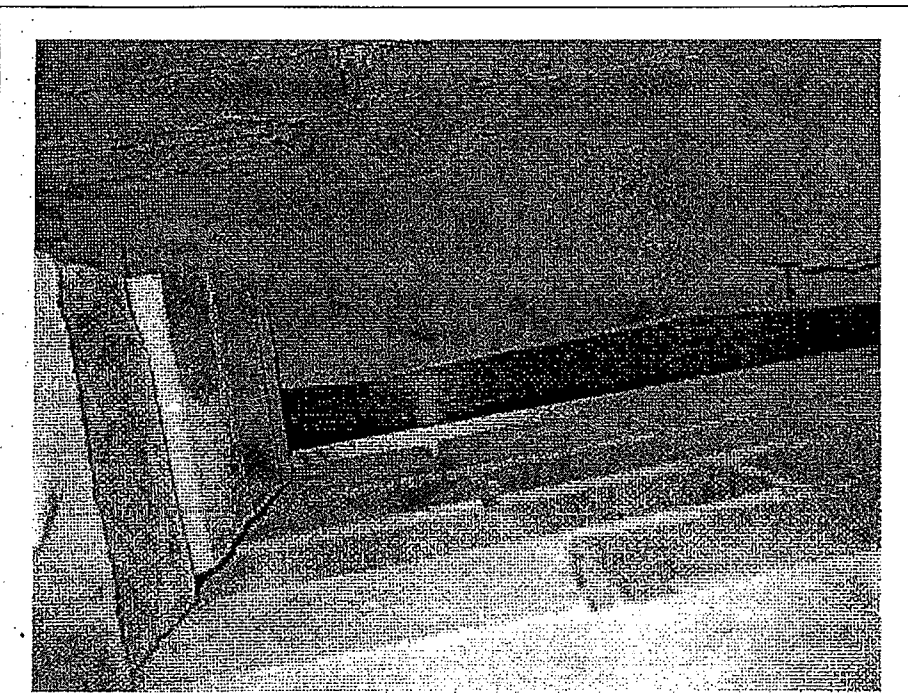
Figure B1-8: Brickwork – Disengaged brickwork pier.

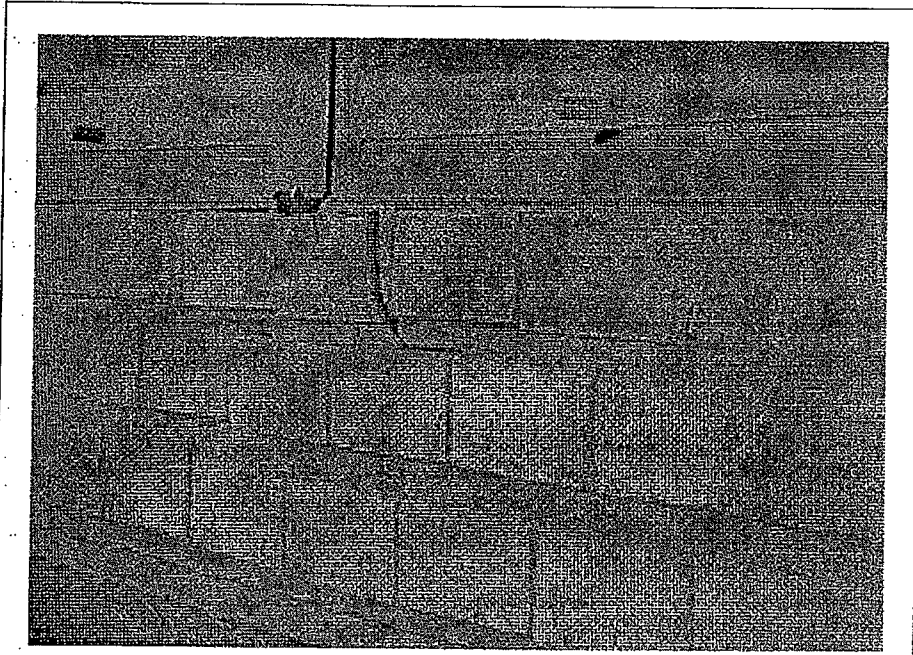
Figure B1-9: Brickwork – Fractured and displaced brick due to corrosion of embedded window fixings on the northern wing.

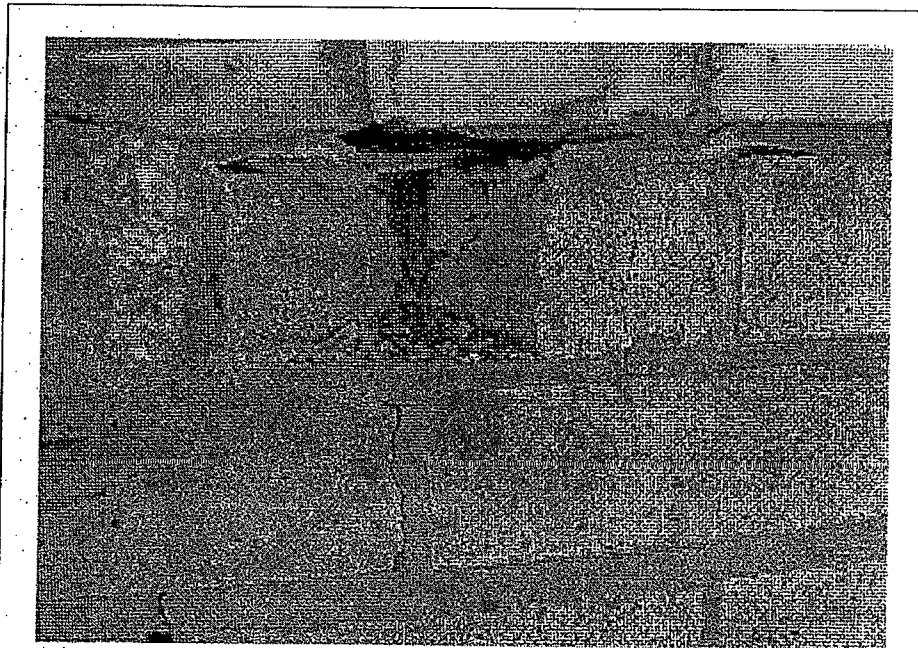
Figure B1-10: Brickwork – Fractured brick due to corrosion of window fixings on the northern wing.

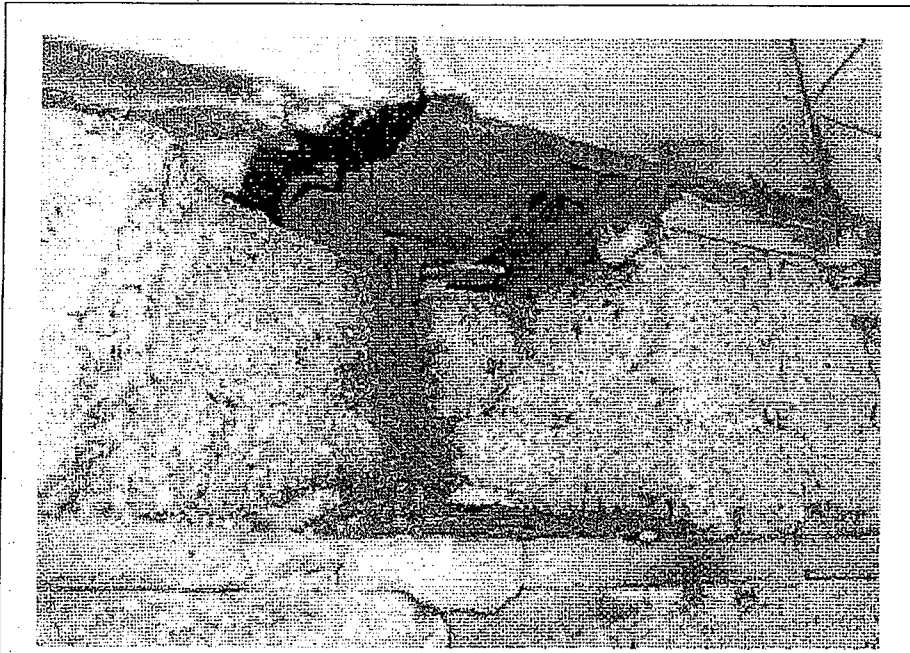
Figure B1-11: Brickwork – Fractured Brick due to corrosion of window fixings and bracket on the northern wing.

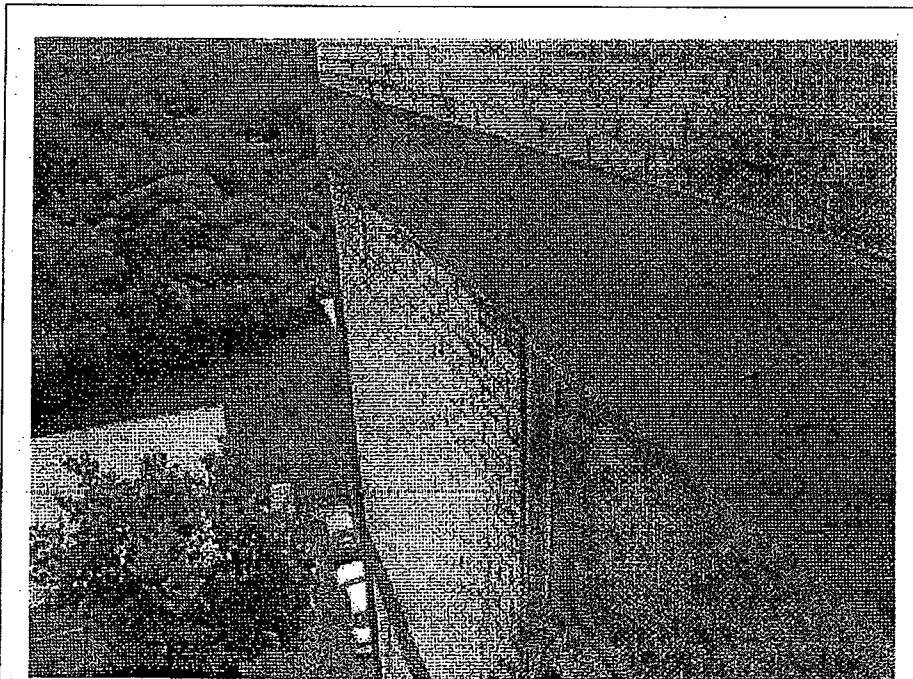
Figure B1-12: Brickwork – Brickwork panel exhibiting corner “peeling” on the western elevation of the northern wing.

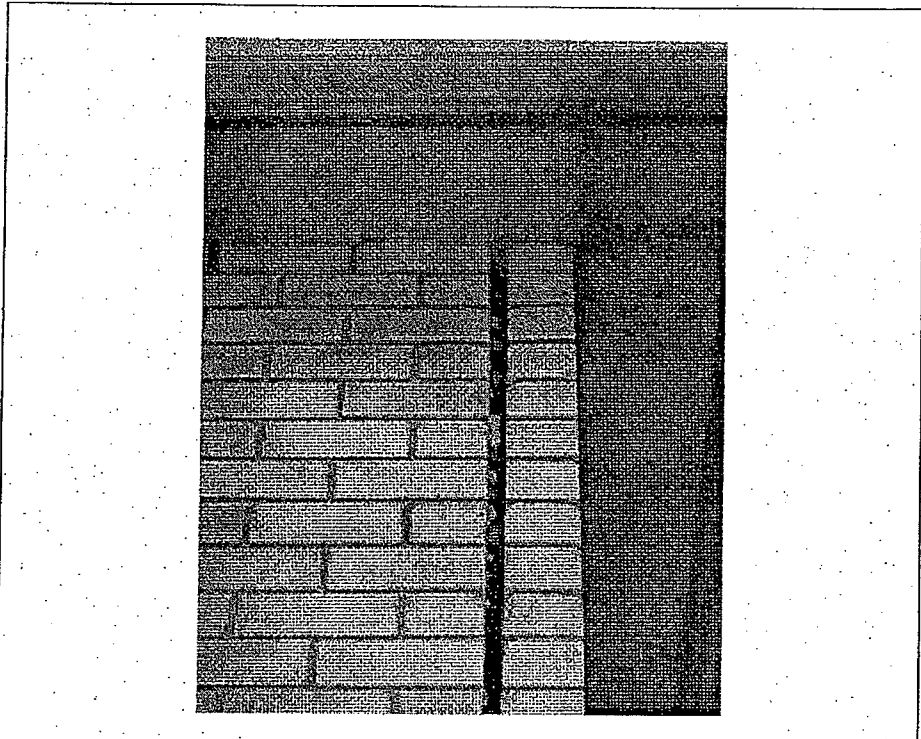
Figure B1-17: Brickwork – Gradual leaning and peeling of brickwork panel.

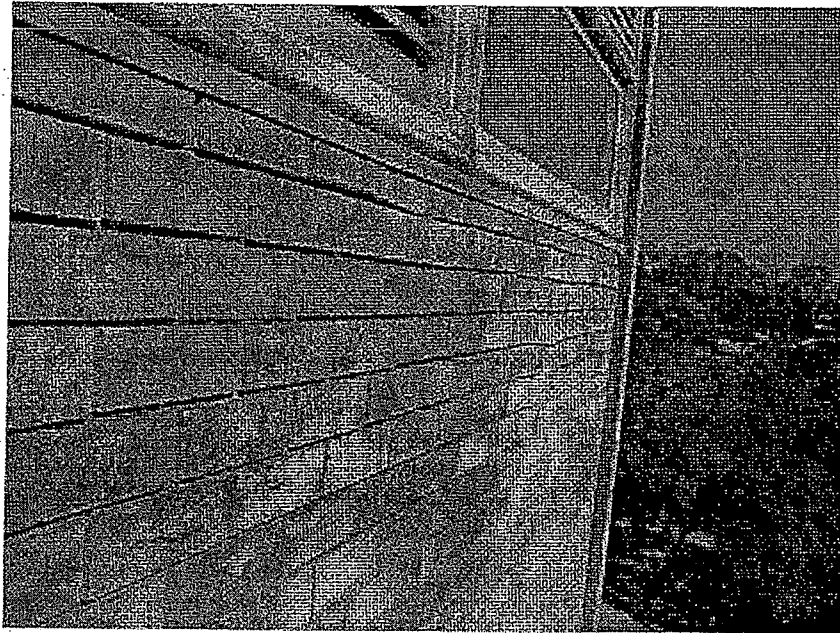
Figure B1-21: Brickworks – Stained and displaced brickwork.

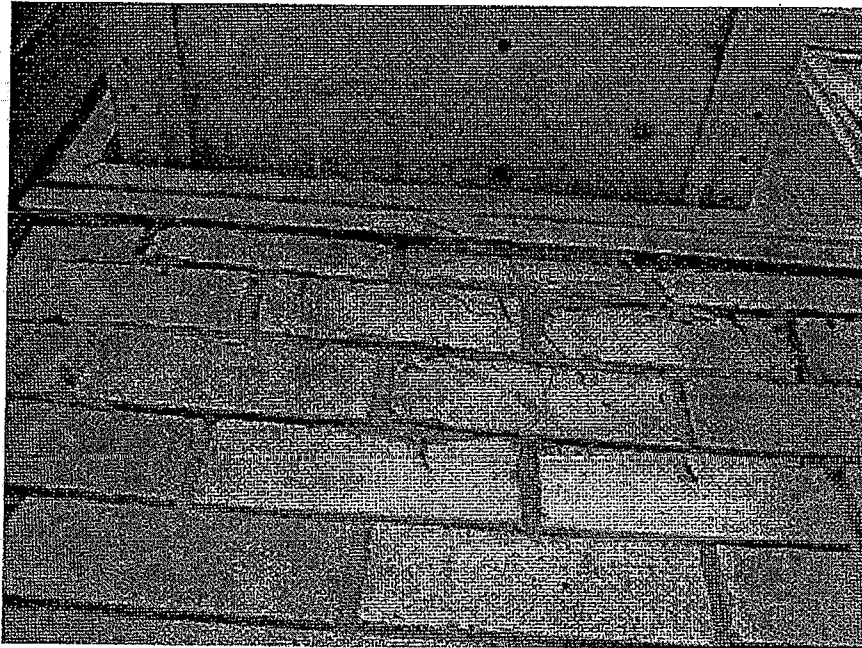
Figure B1-22: Brickwork – Inadequate silicone application to brickwork mortar joints.

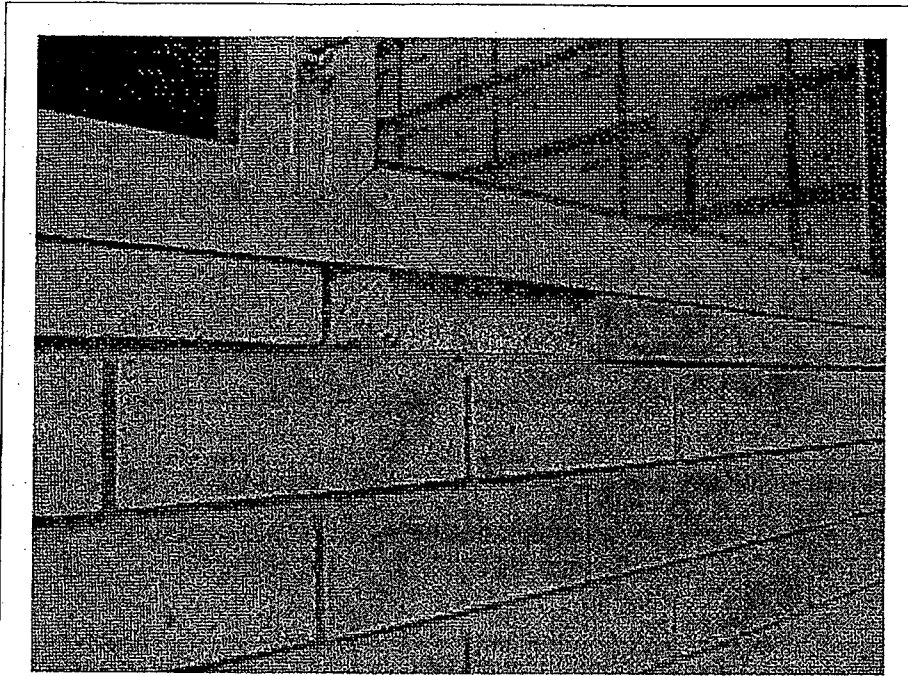
Figure B1-23: Brickworks – Surface erosion of brickwork (fretting).

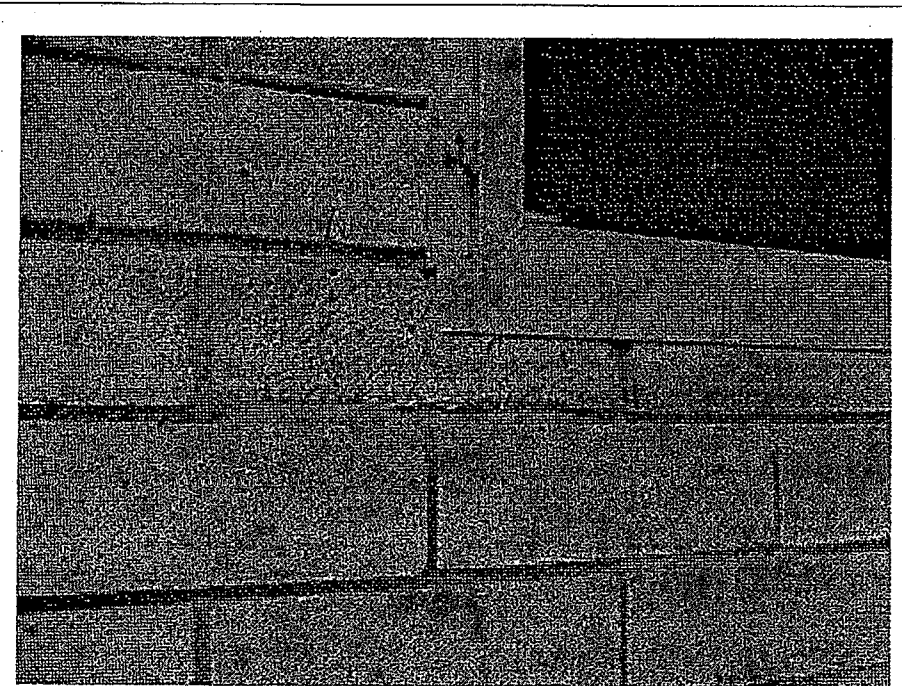
Figure B1-24: Brickworks – Surface erosion of brickwork (fretting).

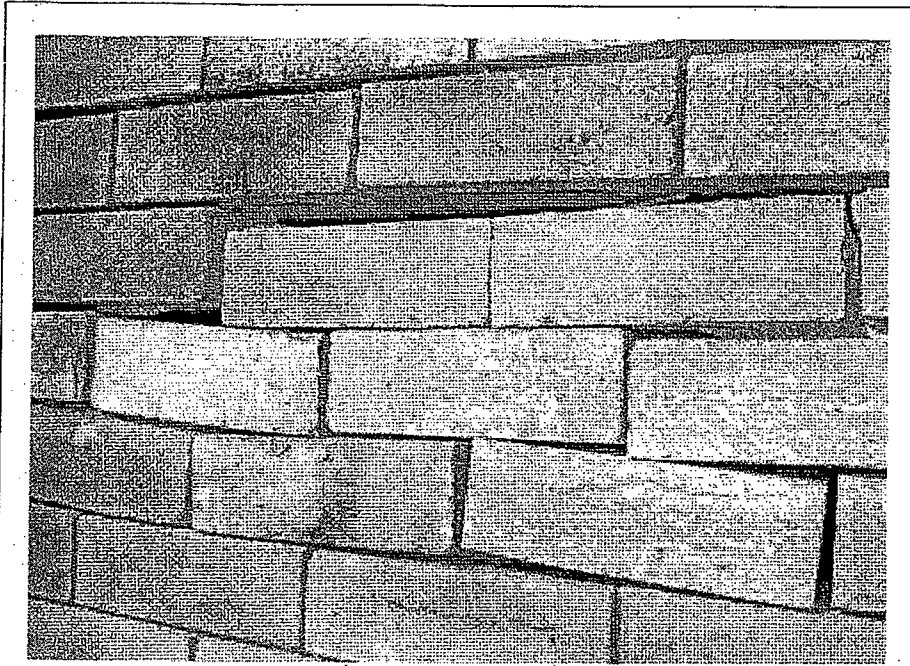
Figure B1-25: Brickworks – Erosion of mortar resulting in brickwork displacement and loss of structural integrity.

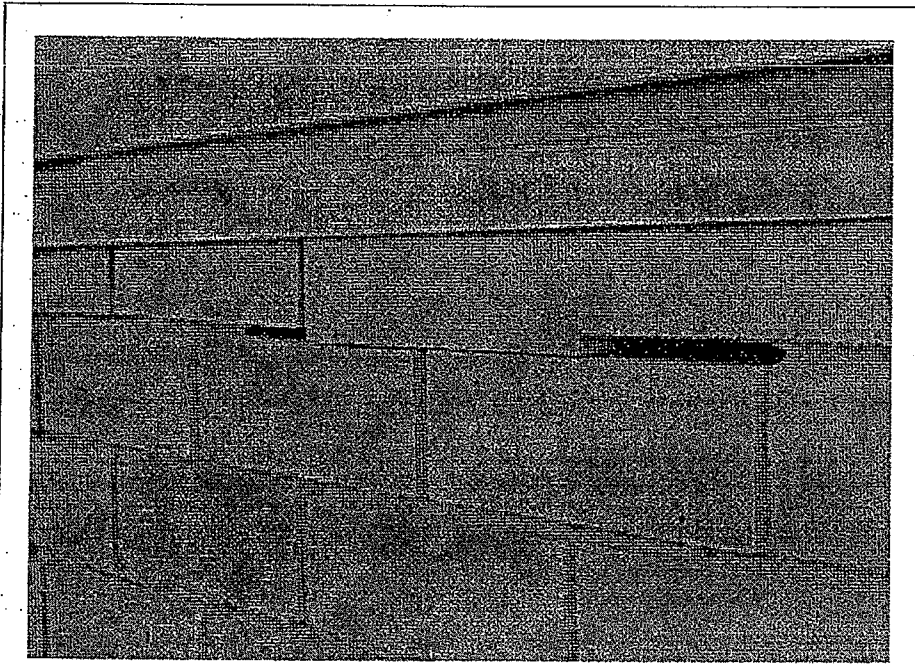
Figure B1-29: Brickworks – Erosion of mortar resulting in brickwork displacement.

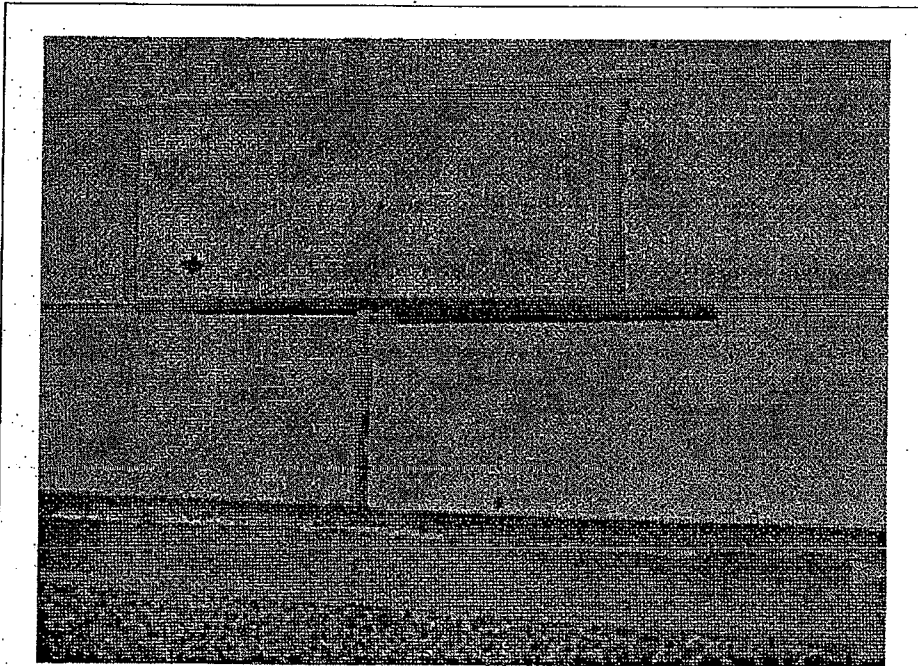
Figure B1-30: Brickworks – Erosion of mortar which could result in brickwork displacement.

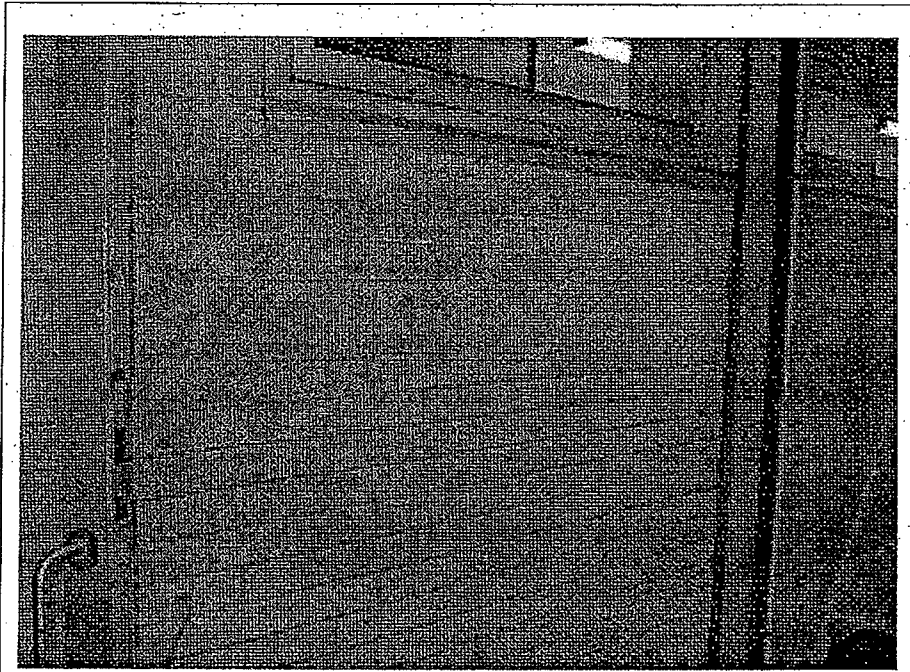
Figure B1-31: Brickwork – Repaired brickwork section.

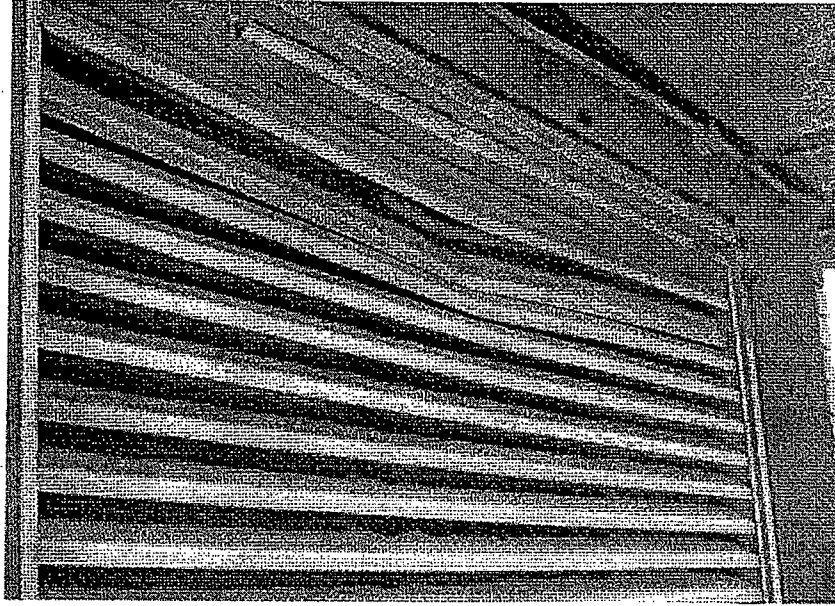
Figure B2-1: Windows and Louvres – Damaged louvre blades.

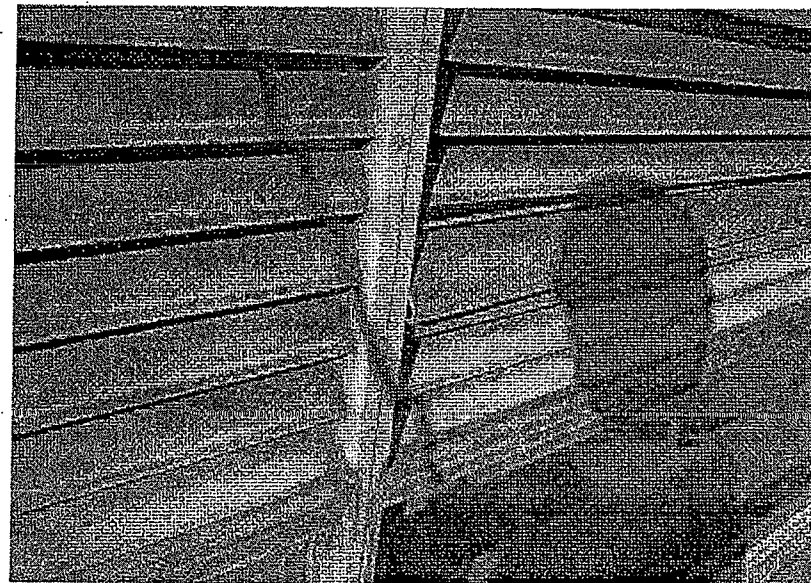
Figure B2-2: Windows and Louvres – Pitted edges and dislodged louvre fixings.

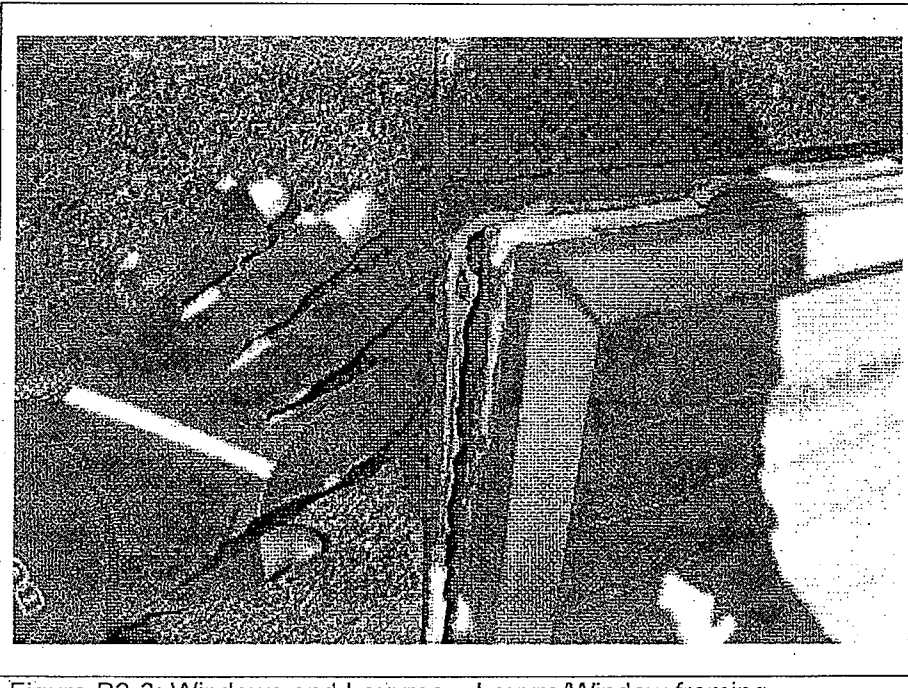
Figure B2-3: Windows and Louvres – Louvre/Window framing detachment from concrete structure and surface corrosion of louvres.

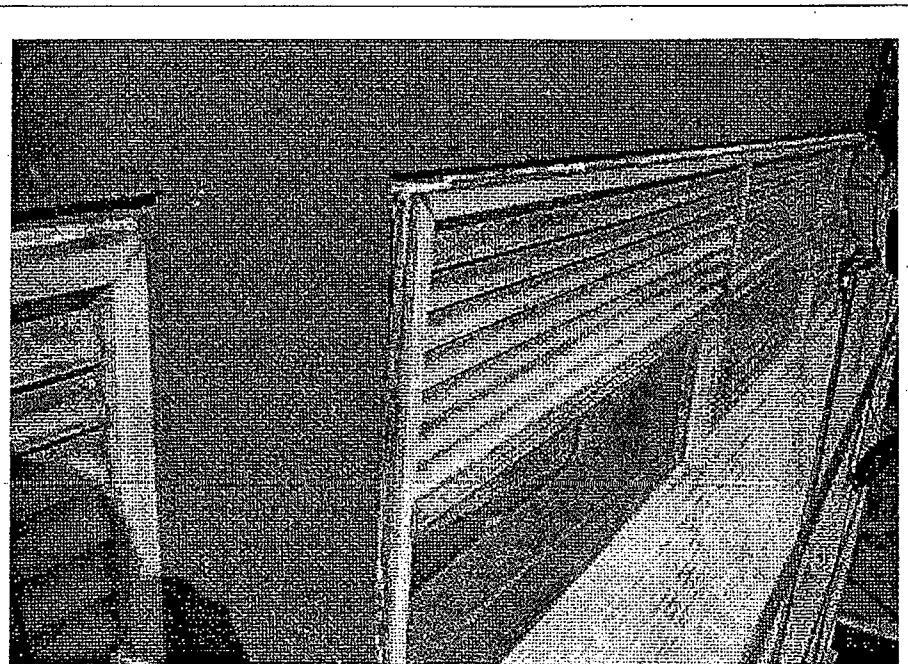
Figure B2-4: Windows and Louvres – Louvre/Window framing detachment from concrete structure and surface corrosion of louvres.

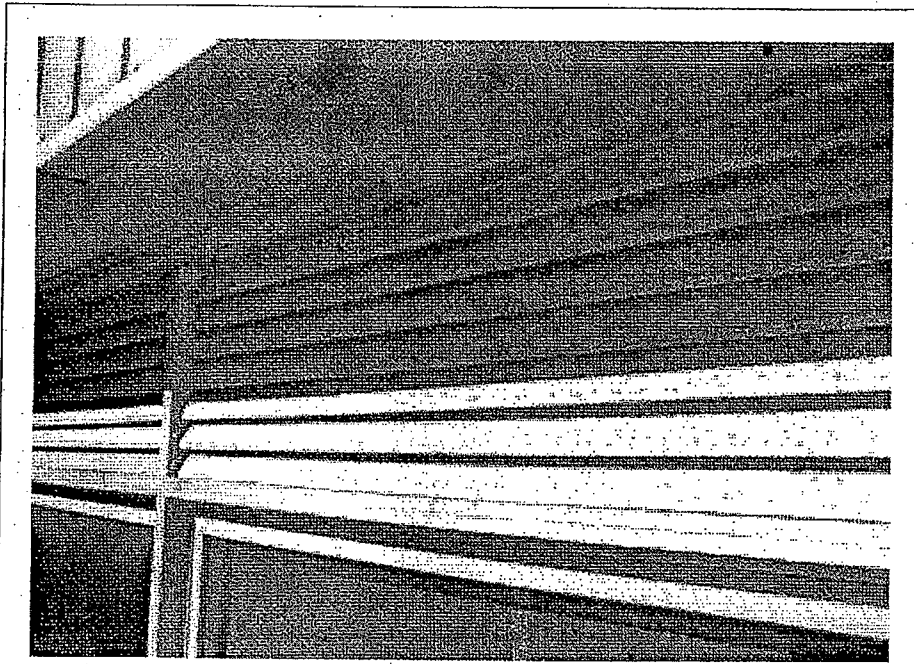
Figure B2-5: Windows and Louvres – Surface corrosion of the louvres and corrosion of mild steel louvre fixings.

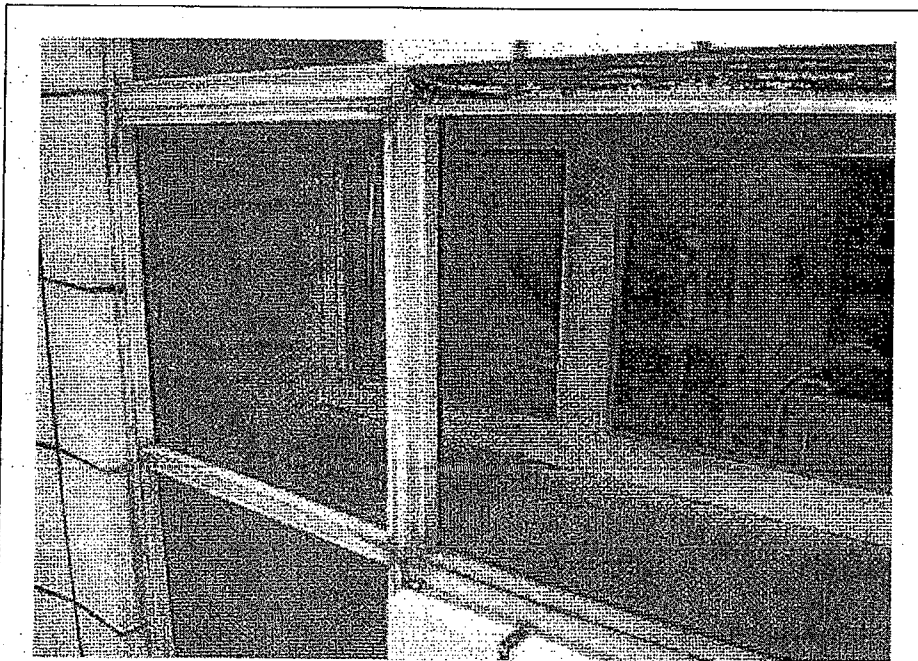
Figure B2-6: Windows and Louvres – Surface corrosion of window framing.

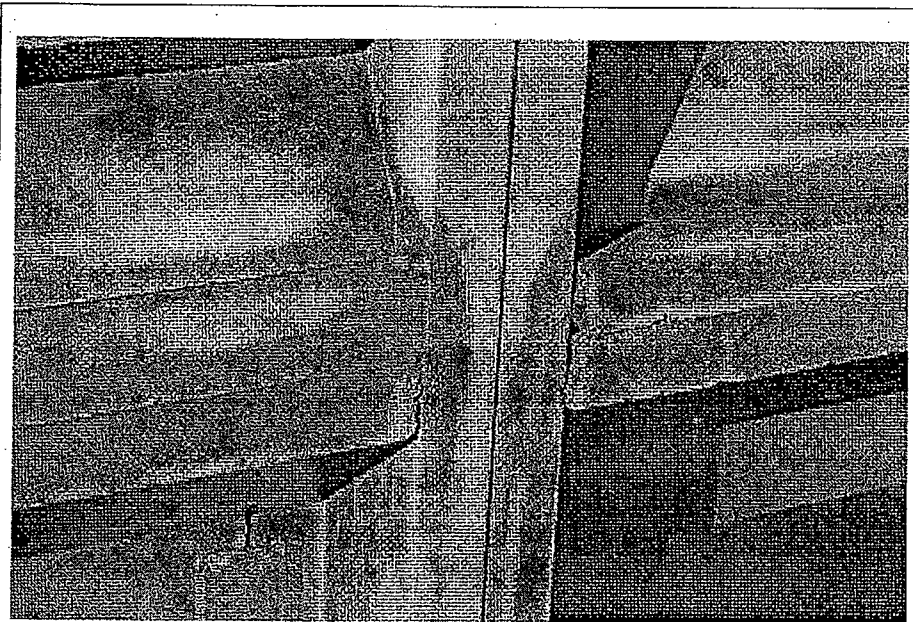
Figure B2-7: Windows and Louvres – Surface corrosion of window framing showing localised corrosion (pitting) at joints.

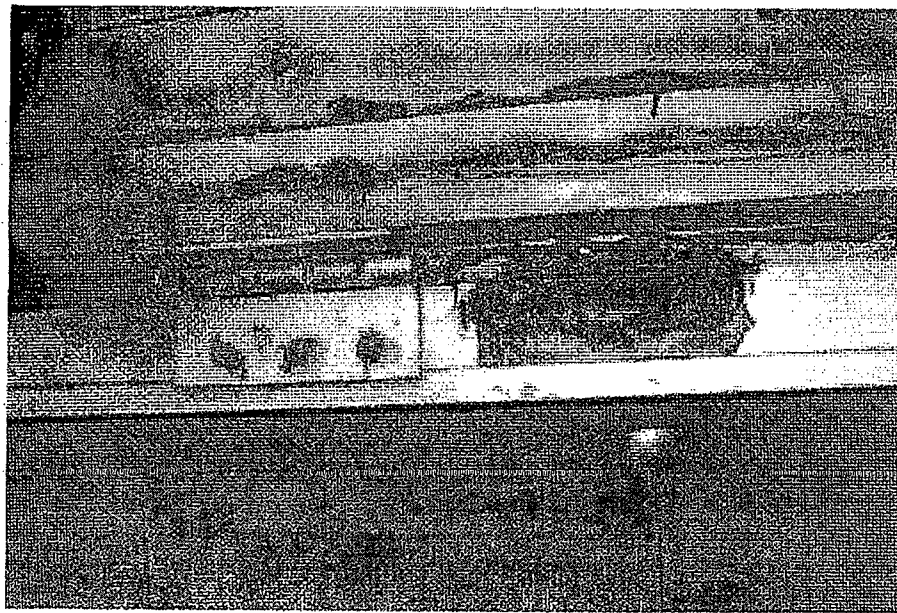
Figure B2-8: Windows and Louvres – Corrosion of window hinges fixings.

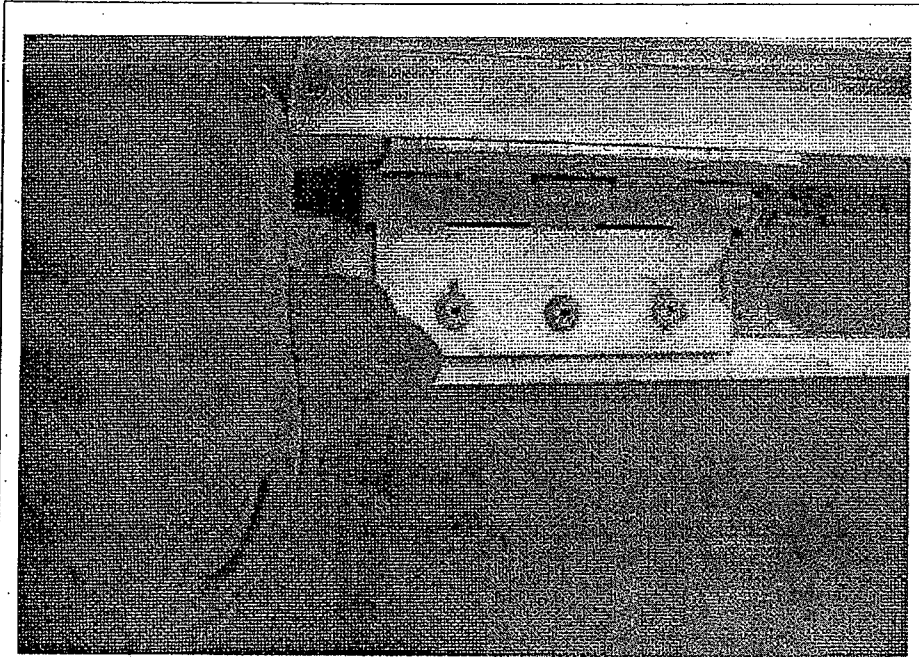
Figure B2-9: Windows and Louvres – Corroded window hinge fixings.

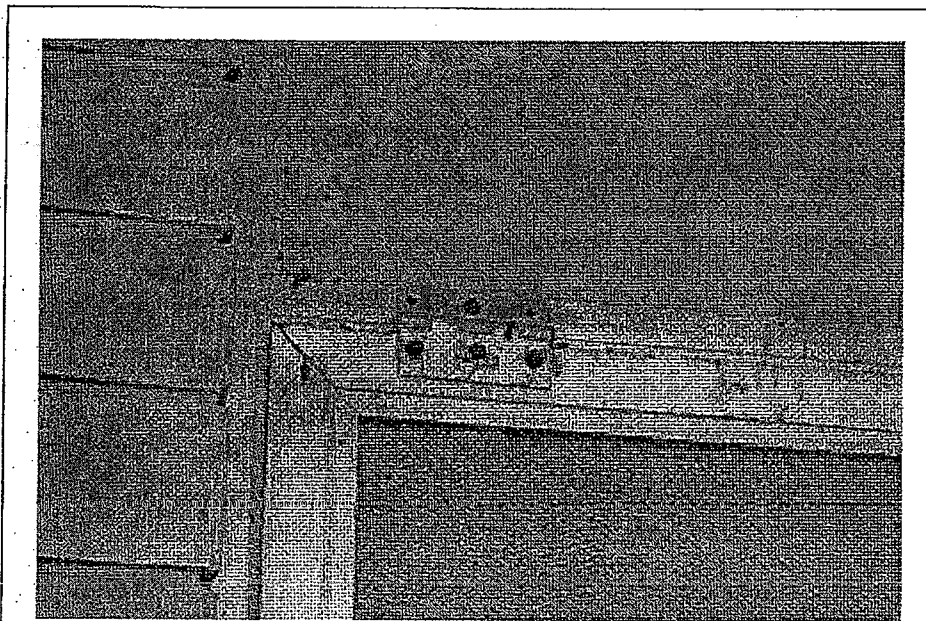
Figure B2-10: Windows and Louvres – Corrosion and missing window hinge screws.

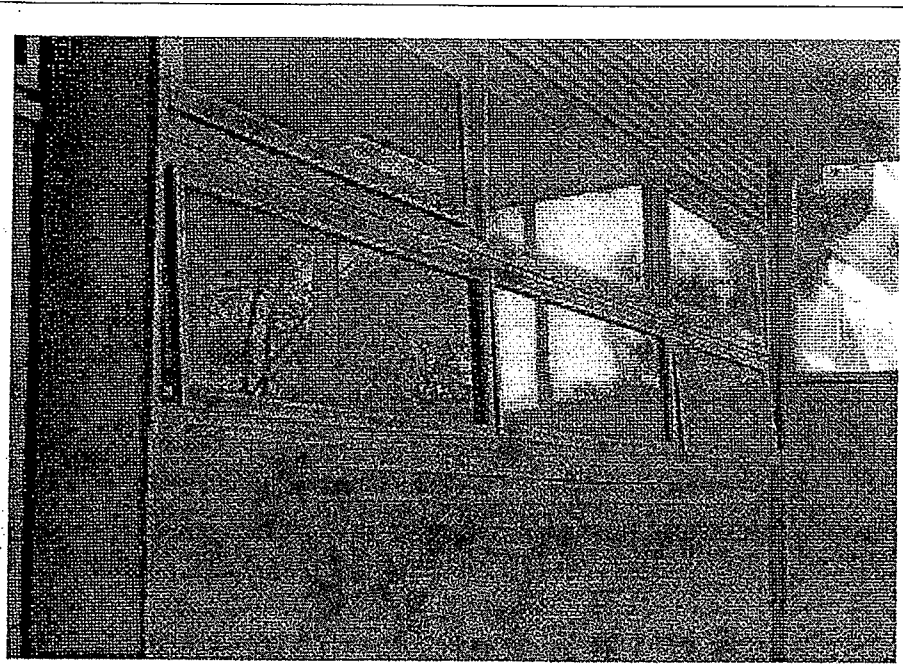
Figure B2-11: Windows and Louvres – Sagging of window framing on the northern wing.

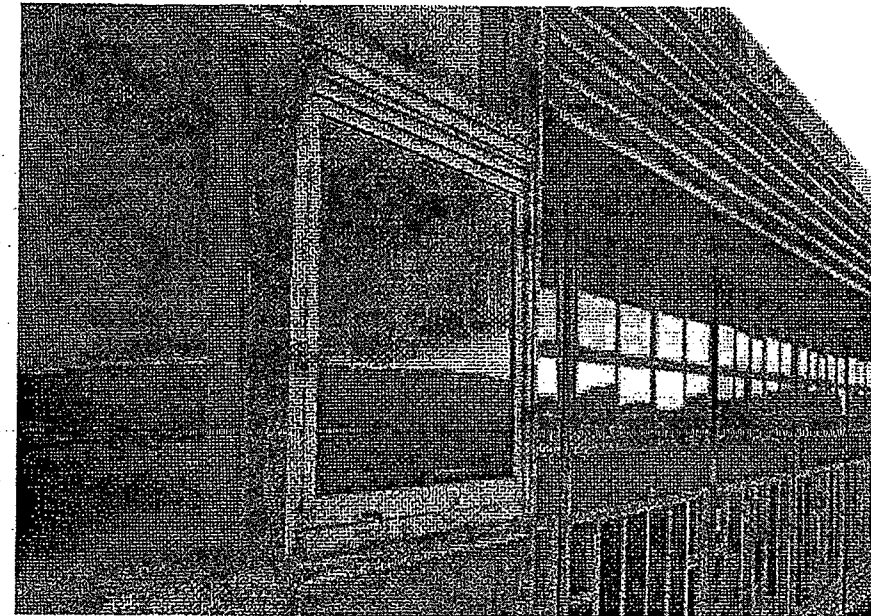
Figure B2-12: Windows and Louvres – Glazing film deterioration on new window panels on western wing.

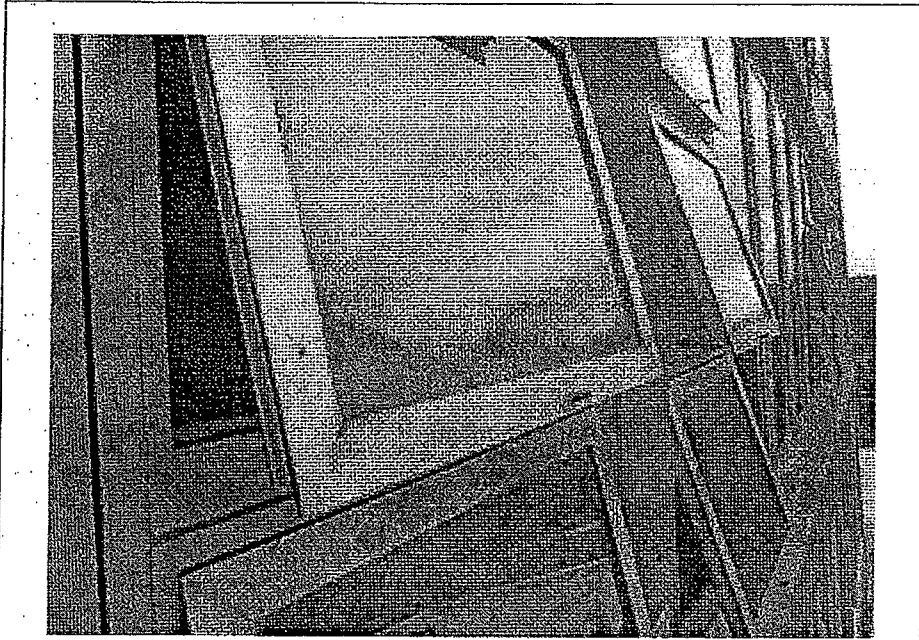
Figure B2-13: Windows and Louvres – Glazing film deterioration on new window panels on western wing.

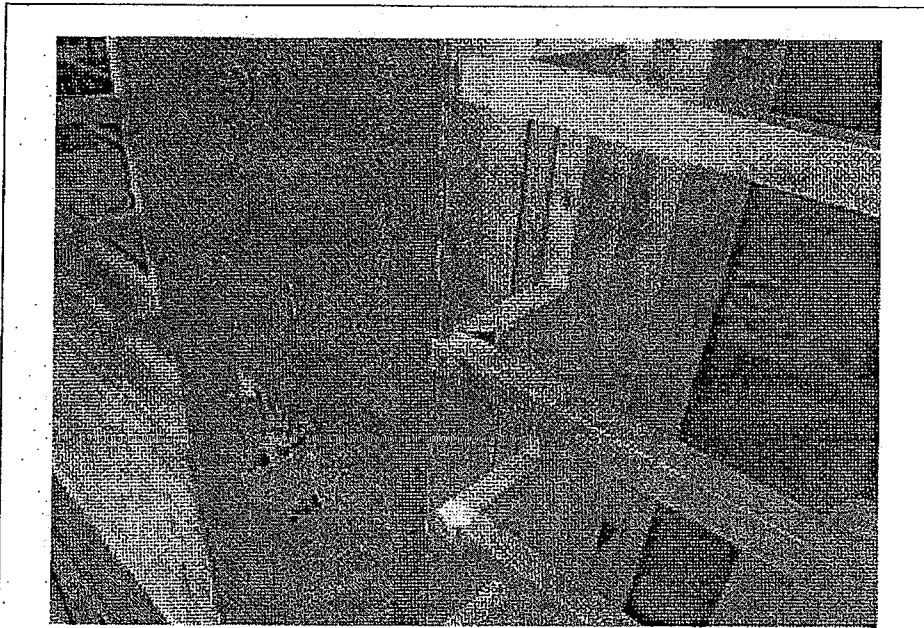
Figure B2-14: Windows and Louvres – Corrosion and failure of new window fall protection.

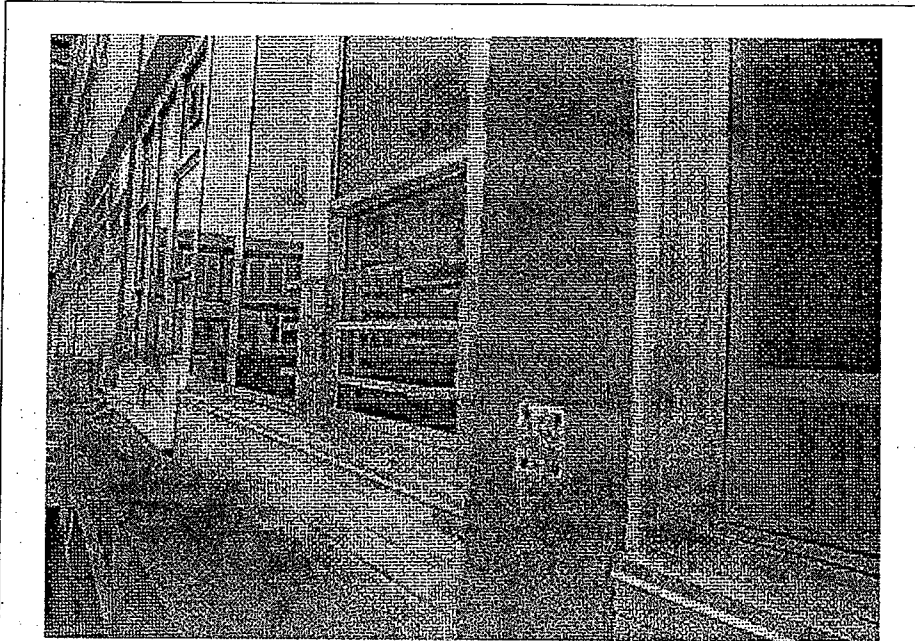
Figure B2-15: Windows and Louvres – Missing window fall protection.

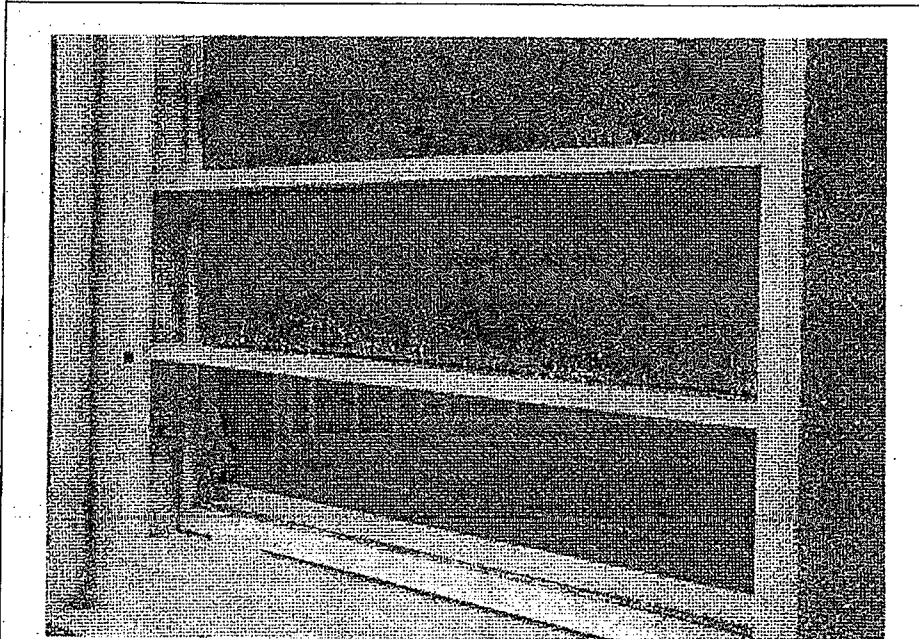
Figure B2-16: Windows and Louvres – Non-functional and damaged fly screen protection on new window systems.

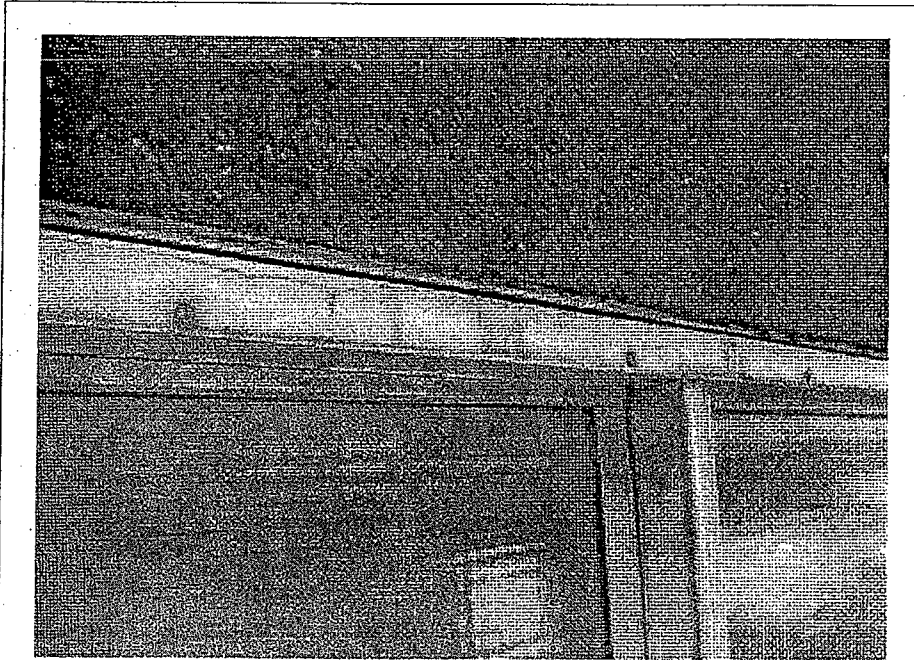
Figure B2-17: Windows and Louvres– Excessive movement on curtain wall stair windows when pushed by hand.

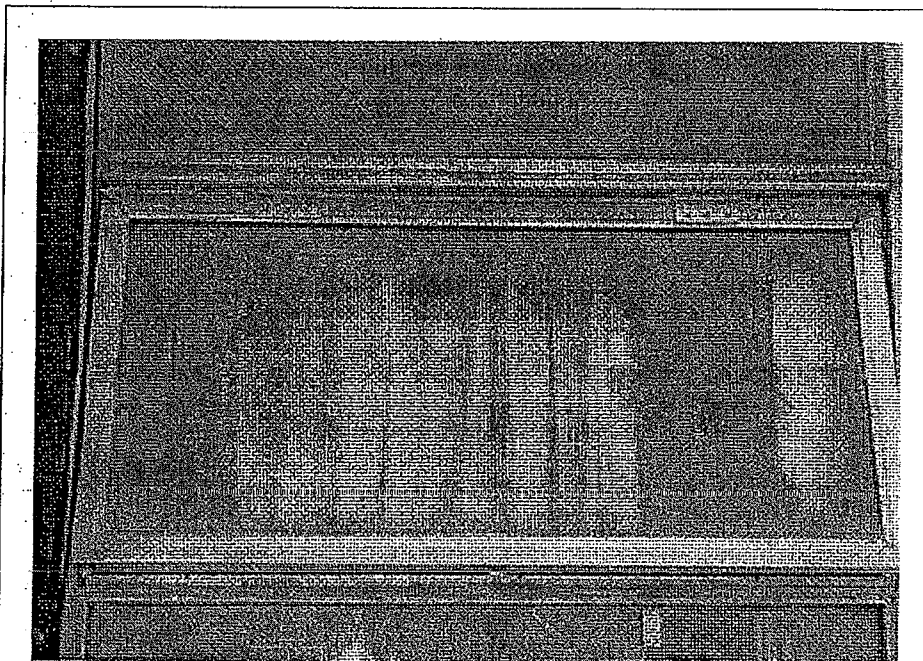
Figure B2-22: Windows and Louvres – Corroding hinge fittings on curtain wall tower windows.

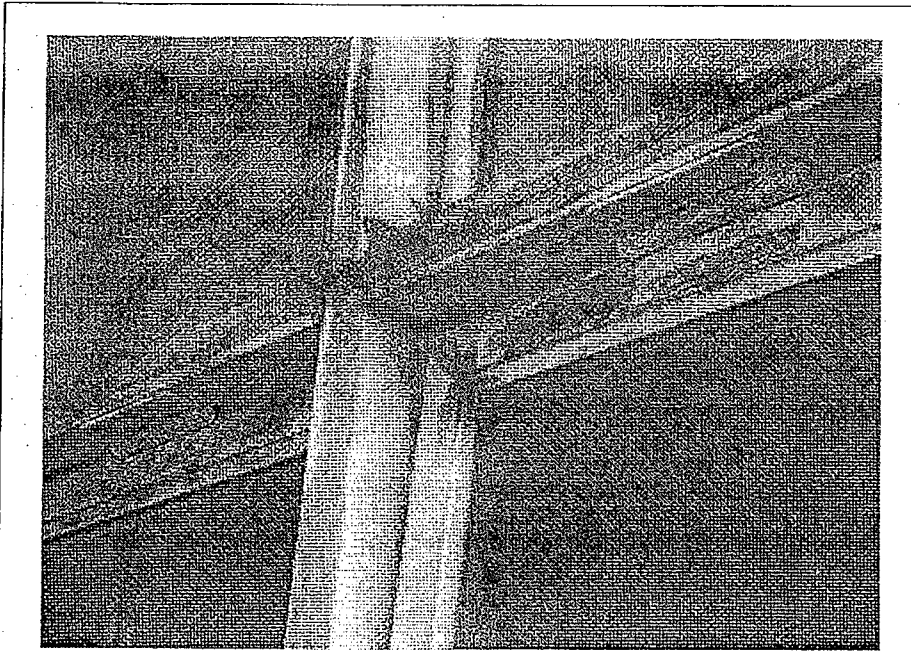
Figure B2-23: Windows and Louvres – Corroding hinge fittings on curtain wall tower windows. Note excessive use of silicone.

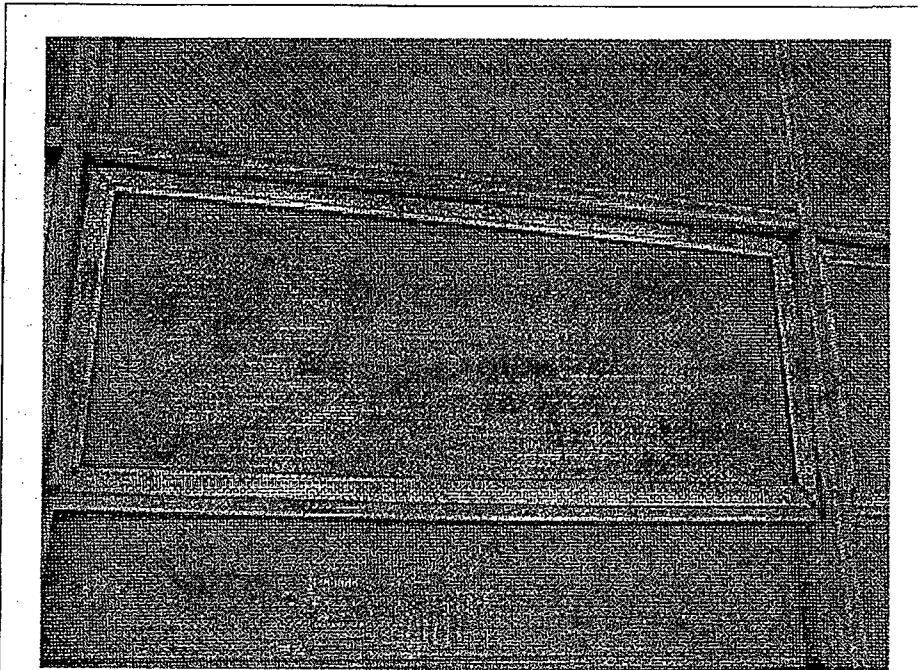
Figure B2-24: Windows and Louvres – Permanently fixed glazing on the curtain wall tower windows suffering fixing corrosion.
