Appendix B

Photographs

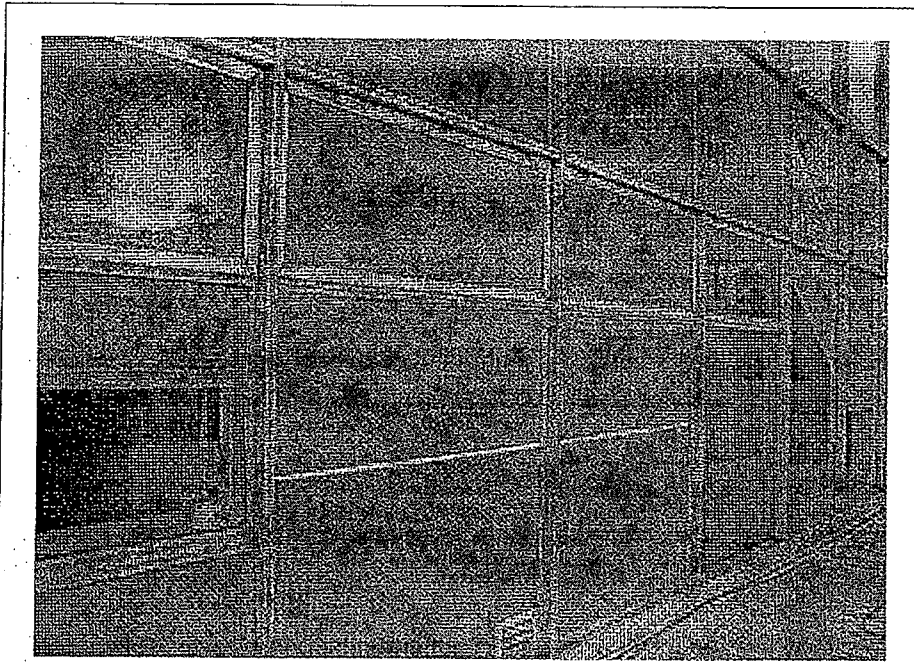
Figure B2-25: Windows and Louvres – Permanently fixed glazing on the curtain wall tower windows suffering fixing corrosion.

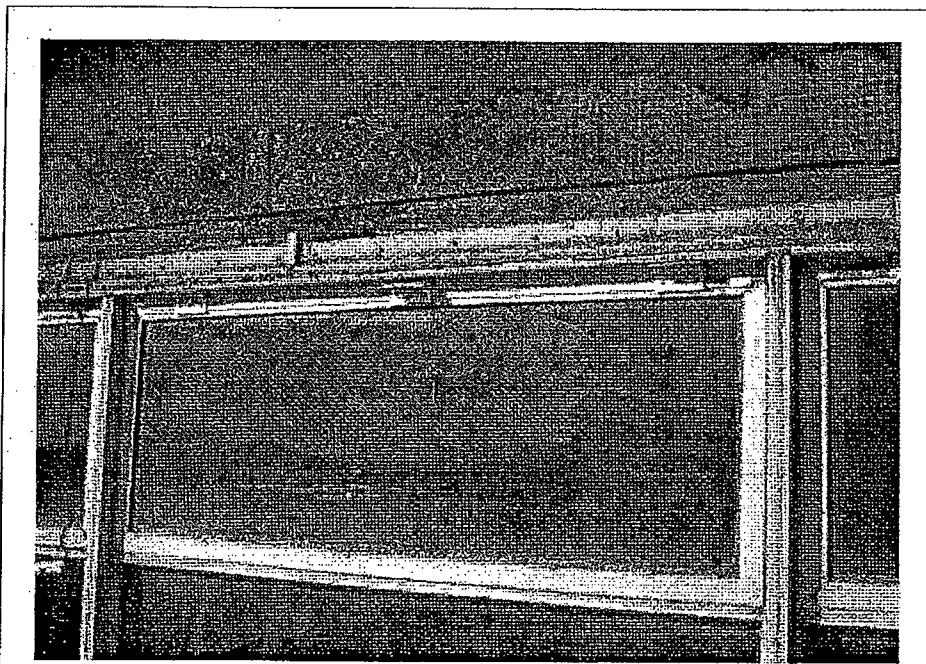
Figure B2-26: Windows and Louvres – Triple hinged sash held by only two hinges on the curtain wall tower. Note excessive use of silicone.

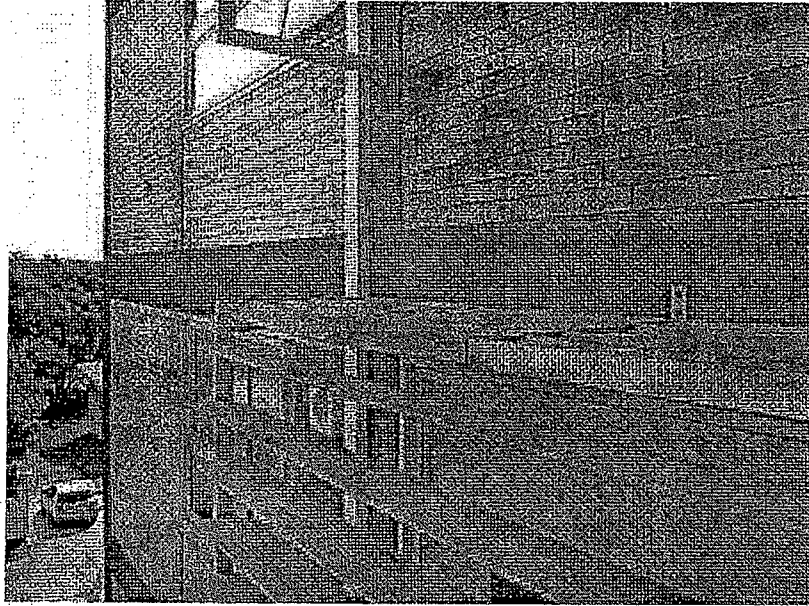
Figure B3-1: Sunshades – Damaged and corroded sunshade systems.

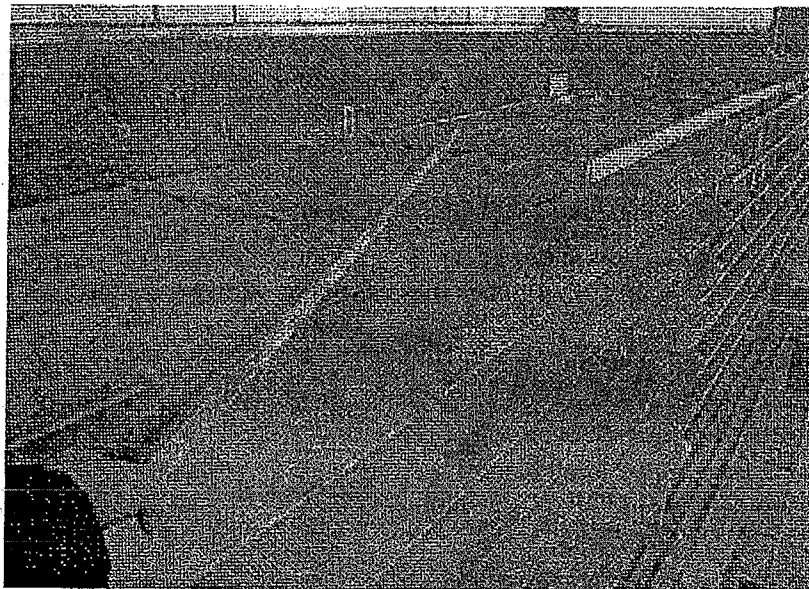
Figure B3-2: Sunshades – Loose and corroded sunshade louvre systems.

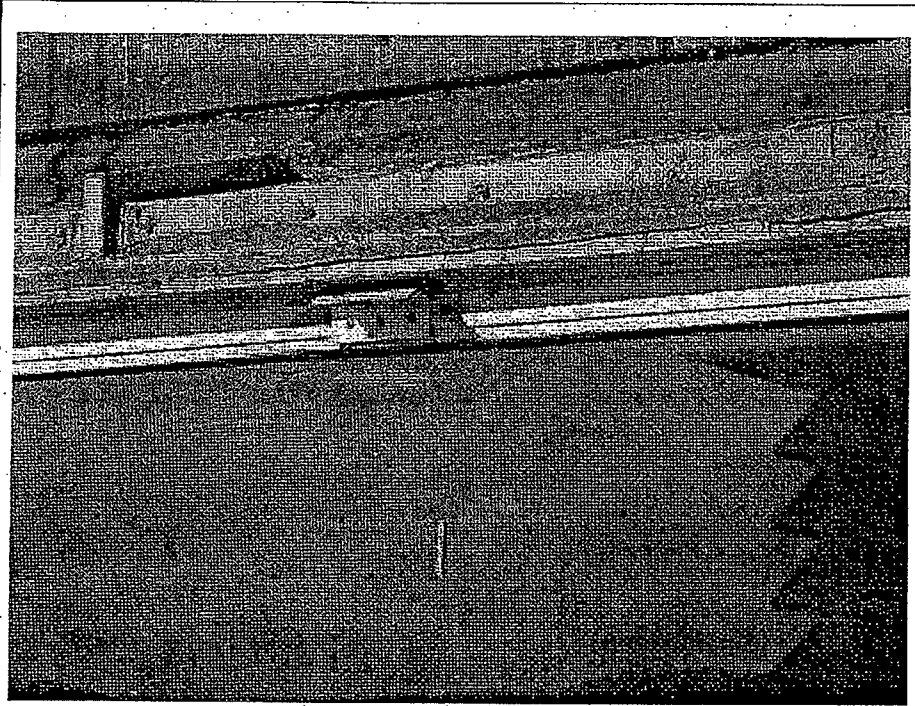
Figure B2-27: Windows and Louvres – Triple hinged sash held by only two hinges on the curtain wall tower. Note excessive use of silicone.

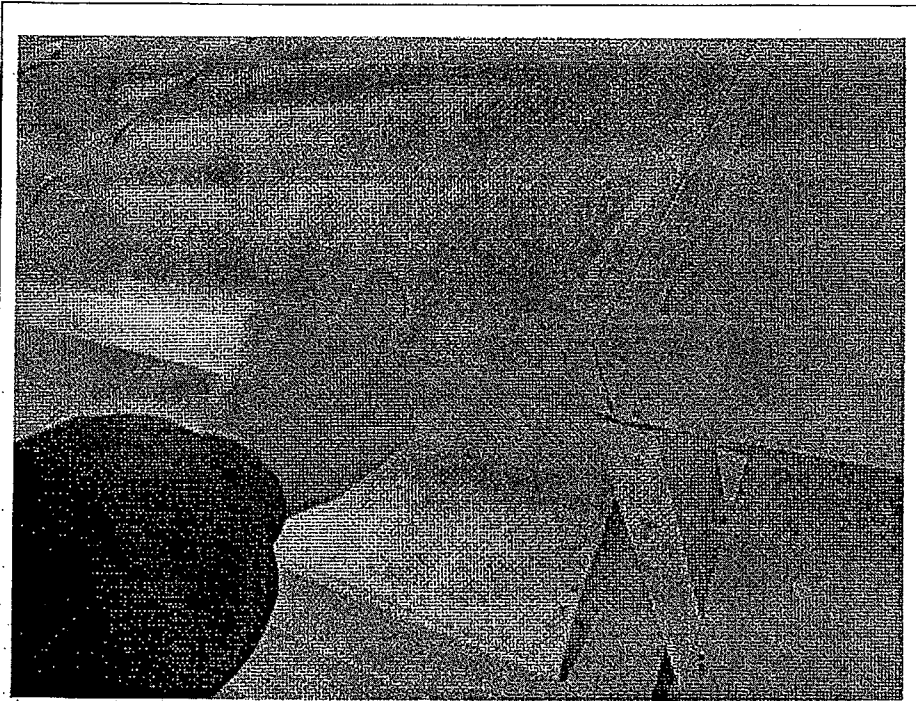
Figure B3-3: Sunshades – Loose and corroded sunshade fixings.

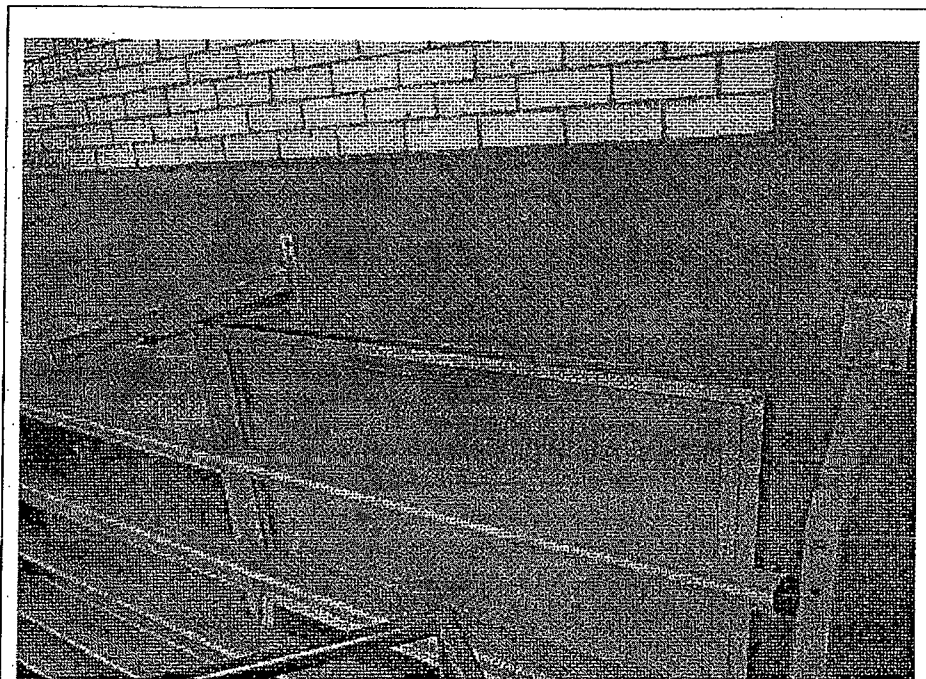
Figure B3-4: Sunshades – Missing sunshade louvre section.

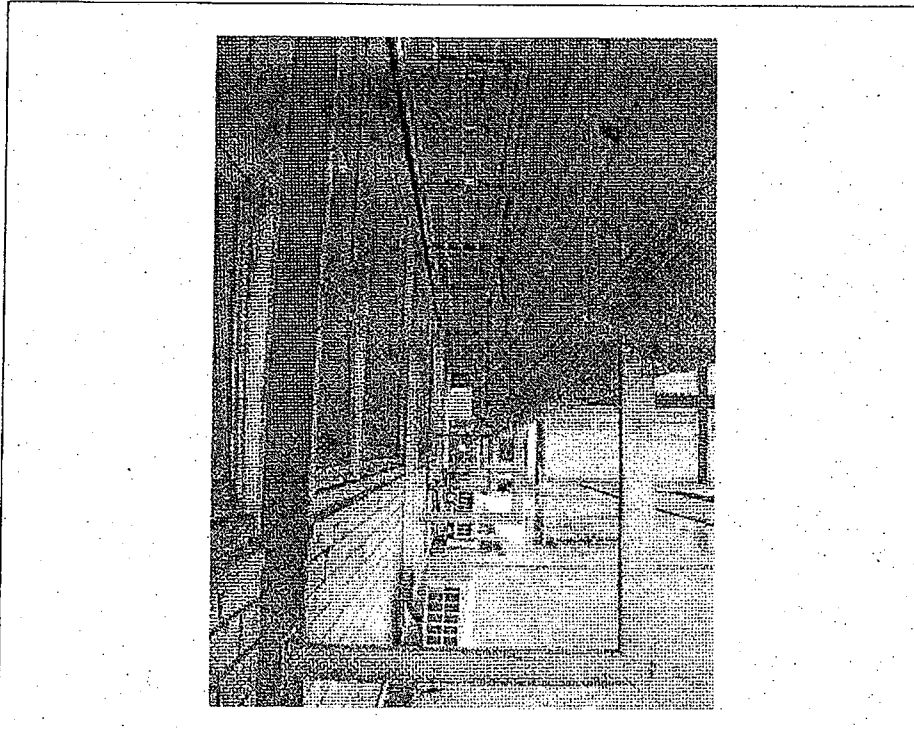
Figure B3-5: Sunshades – Damaged and corroded sunshade systems.

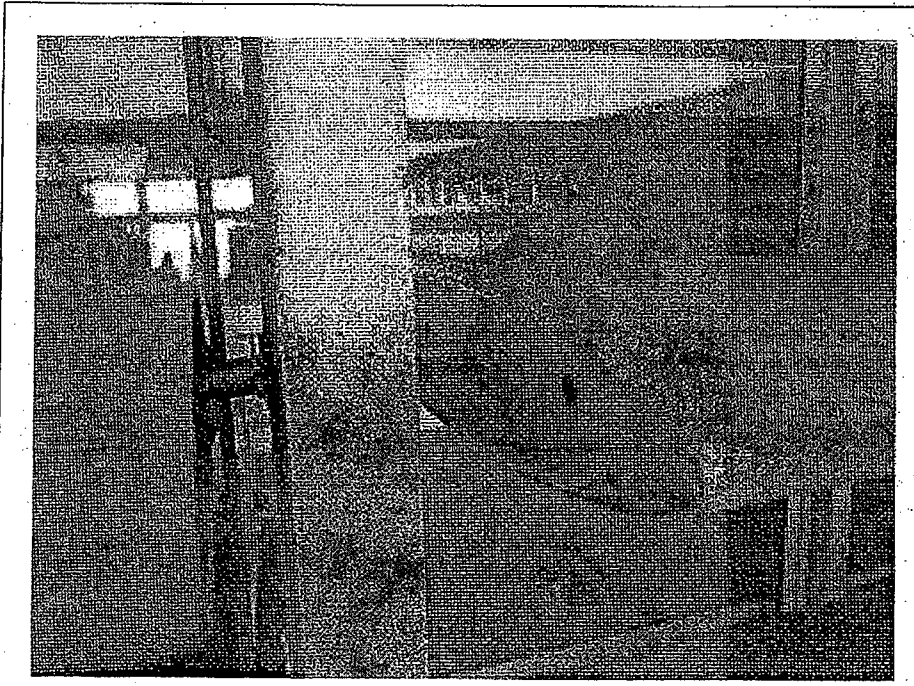
Figure B3-6: Sunshades – Corroded sunshade systems.

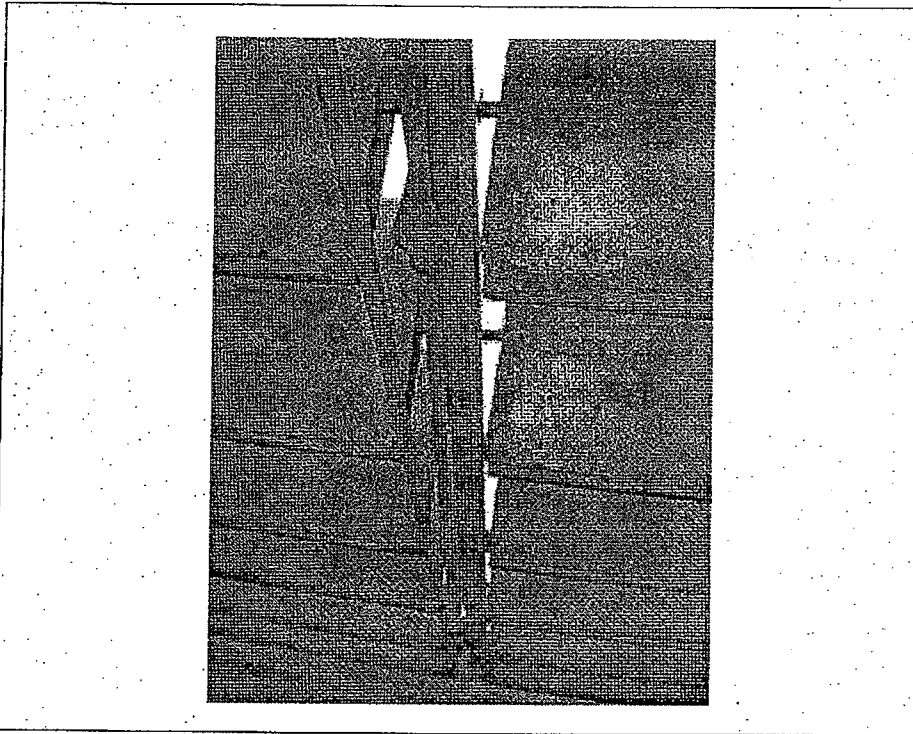
Figure B3-7: Sunshades – Damaged and corroded sunshade systems.

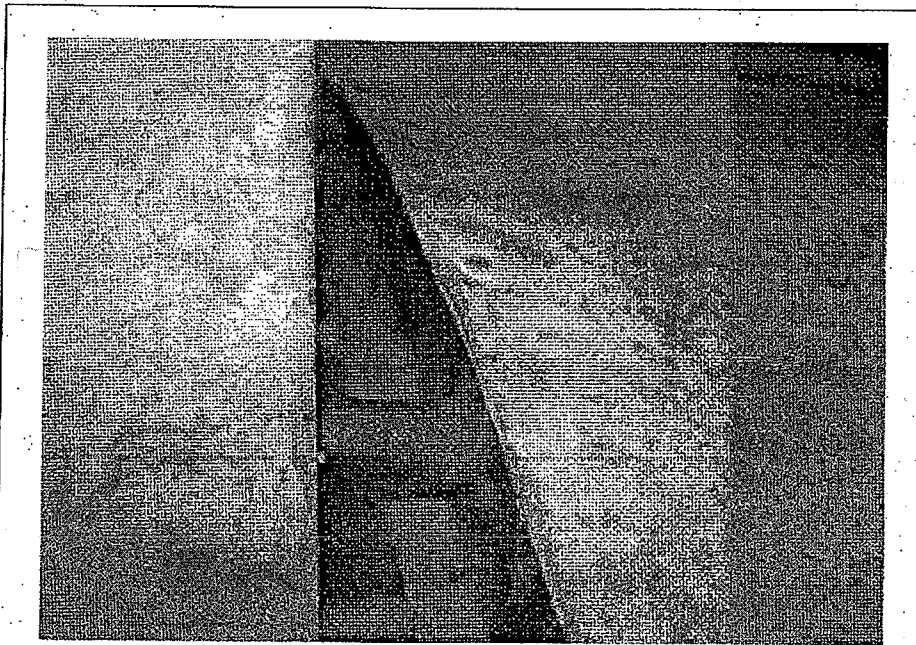
Figure B3-8: Sunshades – Pitted sunshade edges and corroded sunshade fixings.

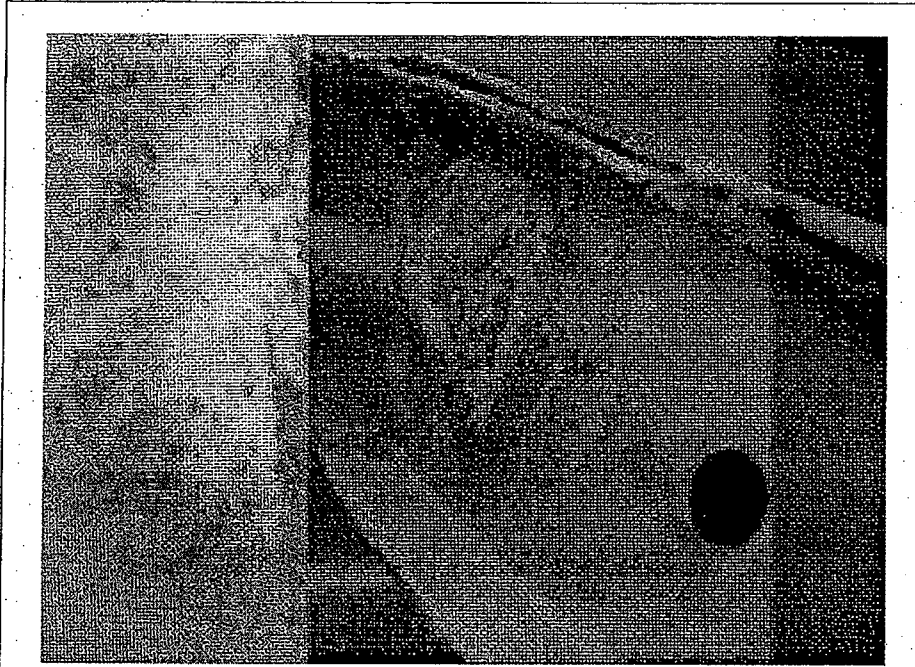
Figure B3-9: Sunshades – Pitted sunshade edges and corroded sunshade fixings.

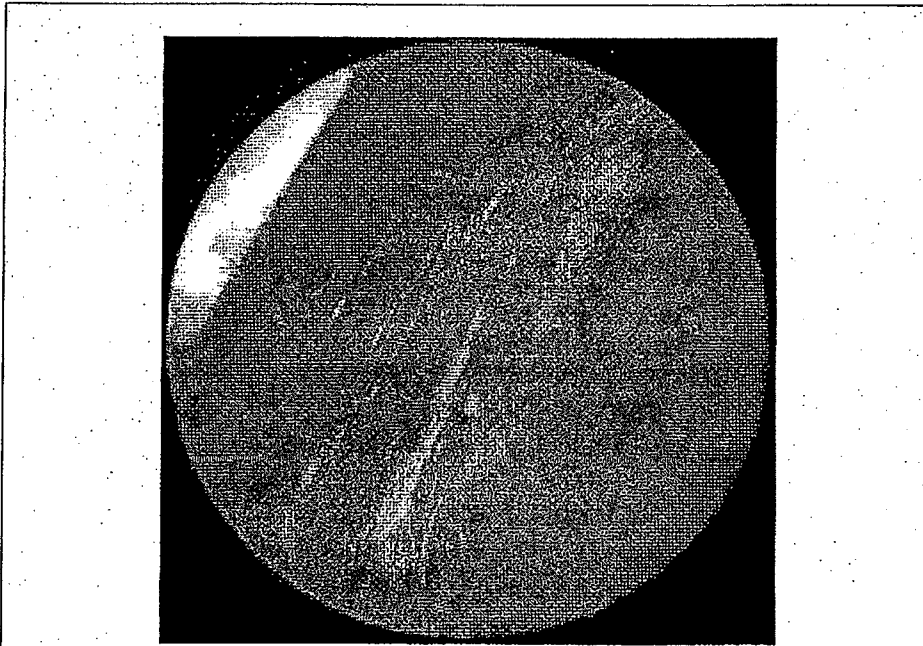
Figure B3-10: Sunshades – Corroded internal sunshade fixings (borescope imaging).

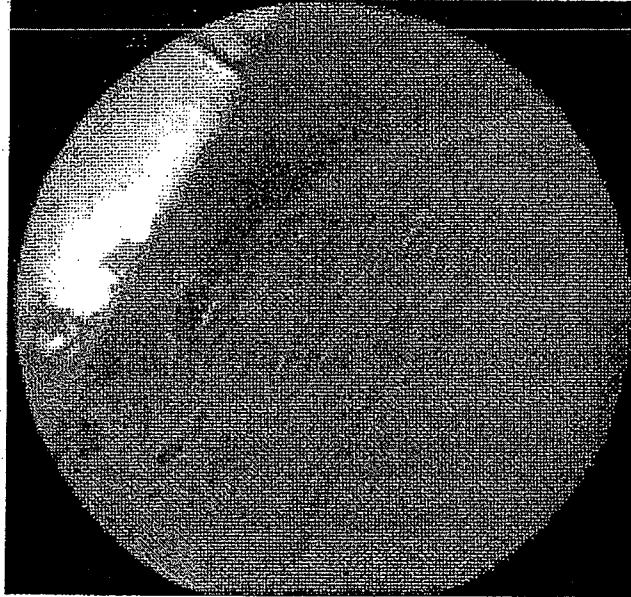
Figure B3-11: Sunshades – Corroded internal sunshade fixings (borescope imaging).

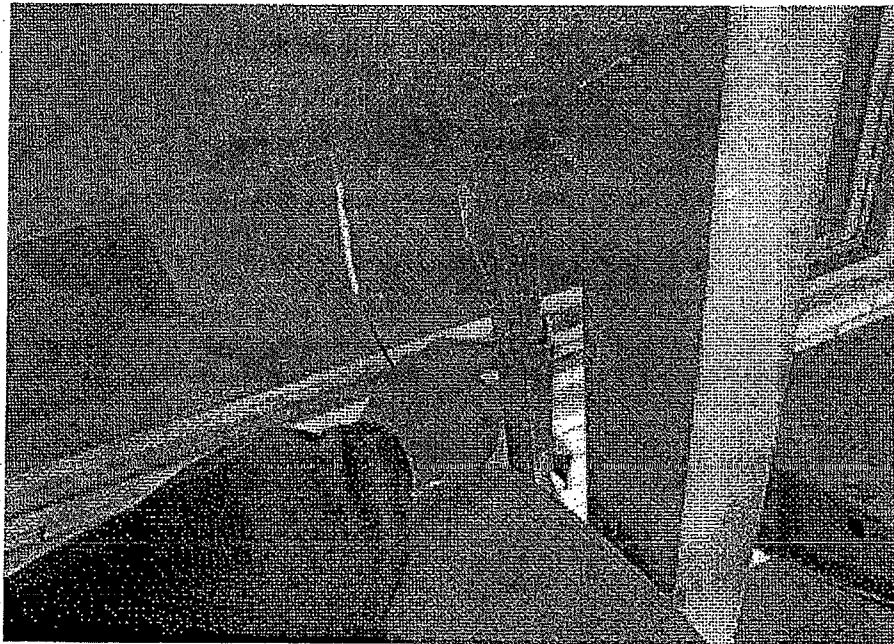
Figure B3-12: Sunshades – Disconnected and non-functional operable louvres.

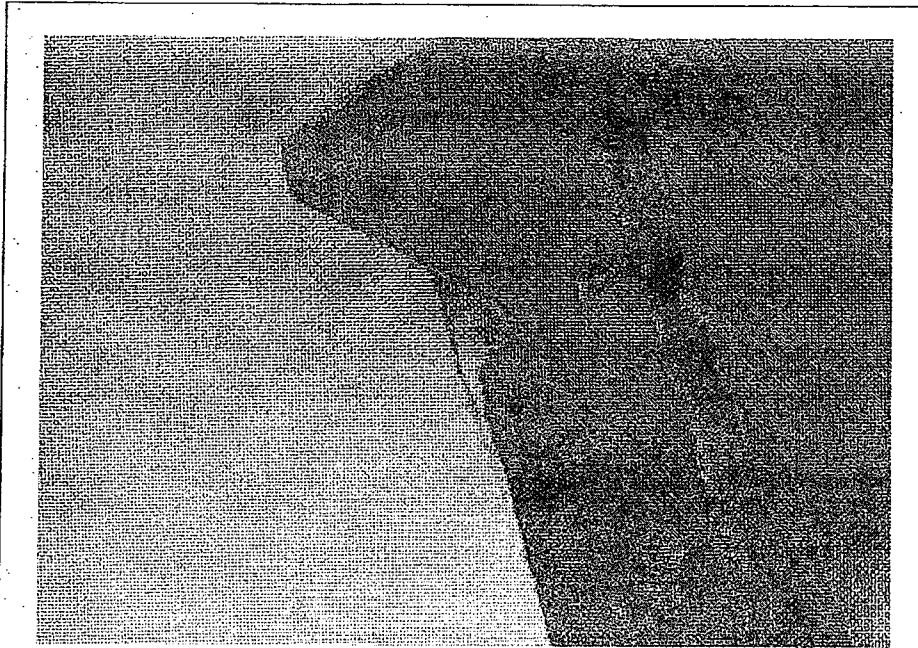
Figure B3-13: Sunshades – Corroded mild steel sunshade fixings.

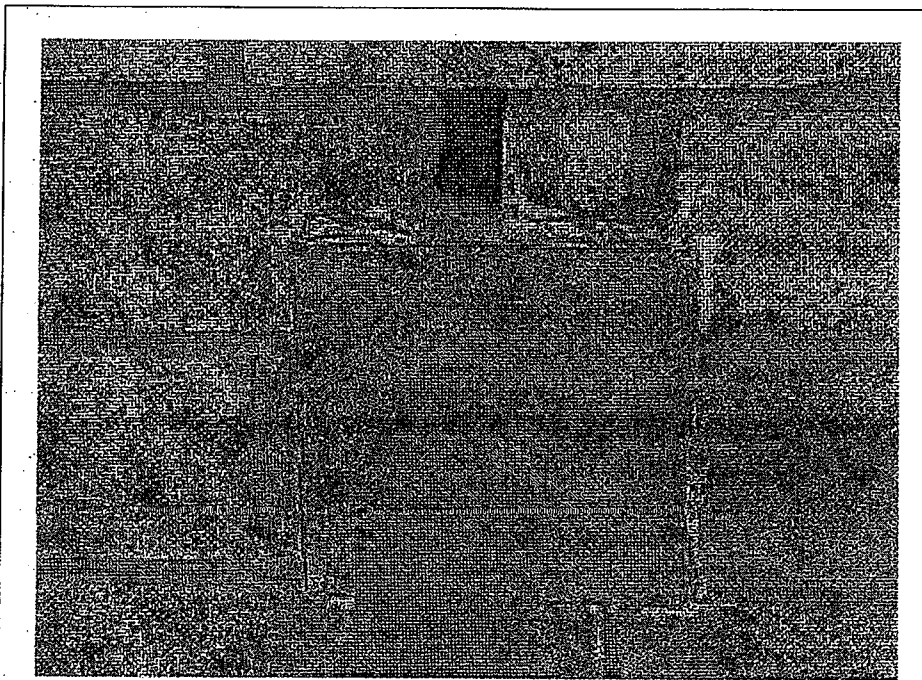
Figure B3-14: Sunshades – Mid span sunshade fixings on poor brickwork.

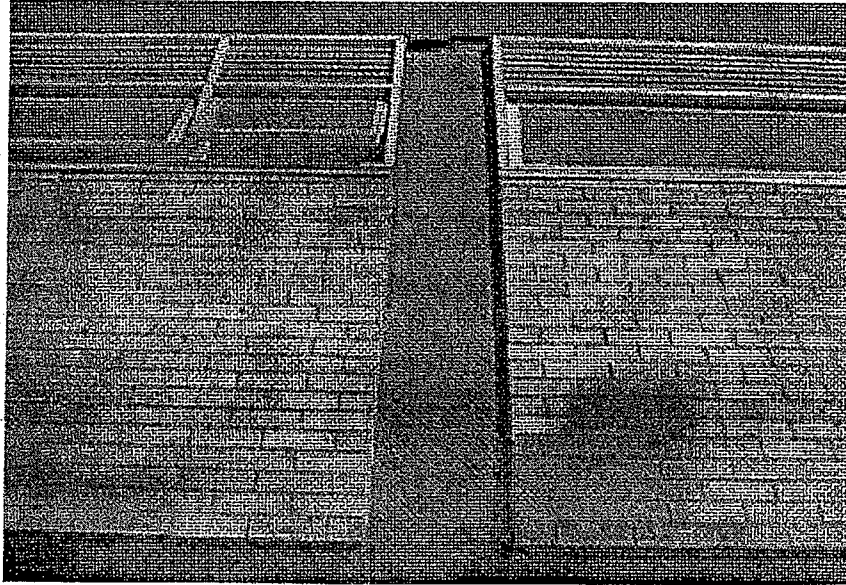
Figure B4-1: Rendered Beams & Columns – Missing render from columns on the northern wing.

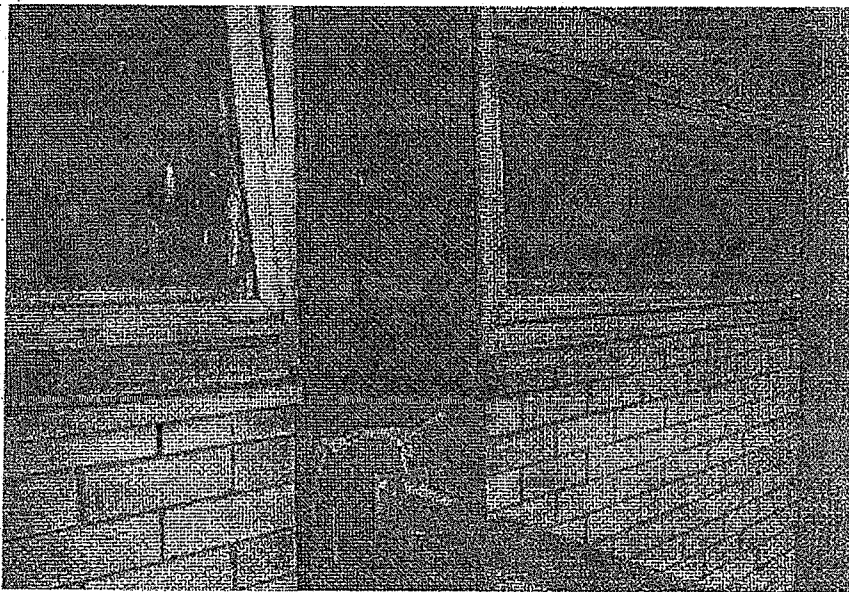
Figure B4-2: Rendered Beams & Columns – Damaged render columns on the northern wing.

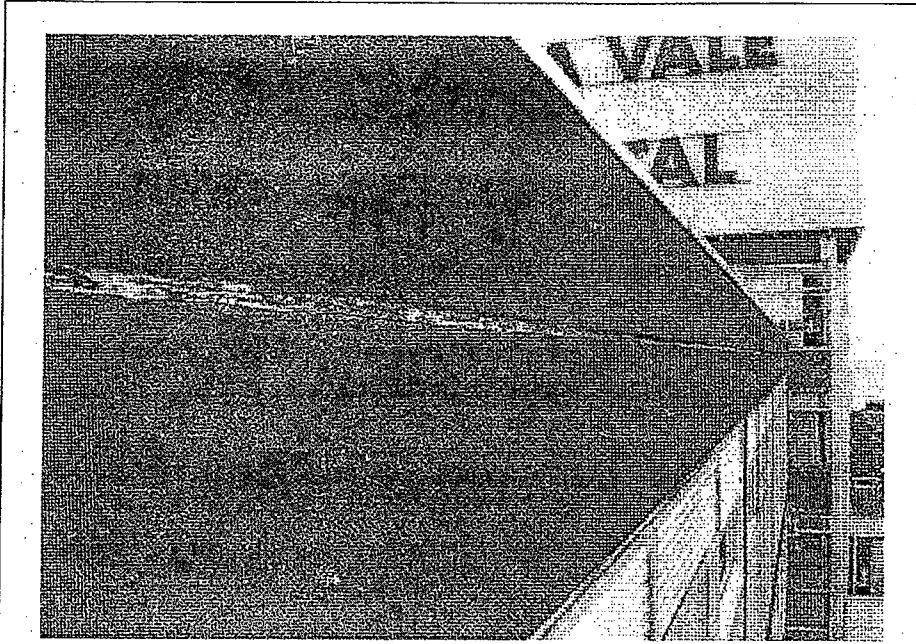
Figure B4-3: Rendered Beams & Columns – Pinned rendered beams on the western wing.

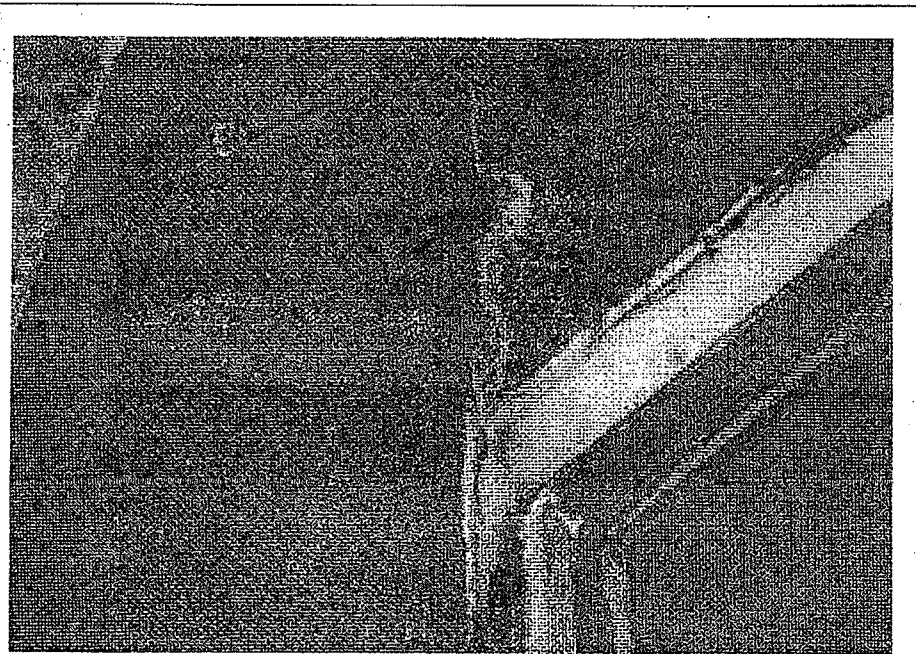
Figure B4-4: Rendered Beams & Columns – Damaged render columns

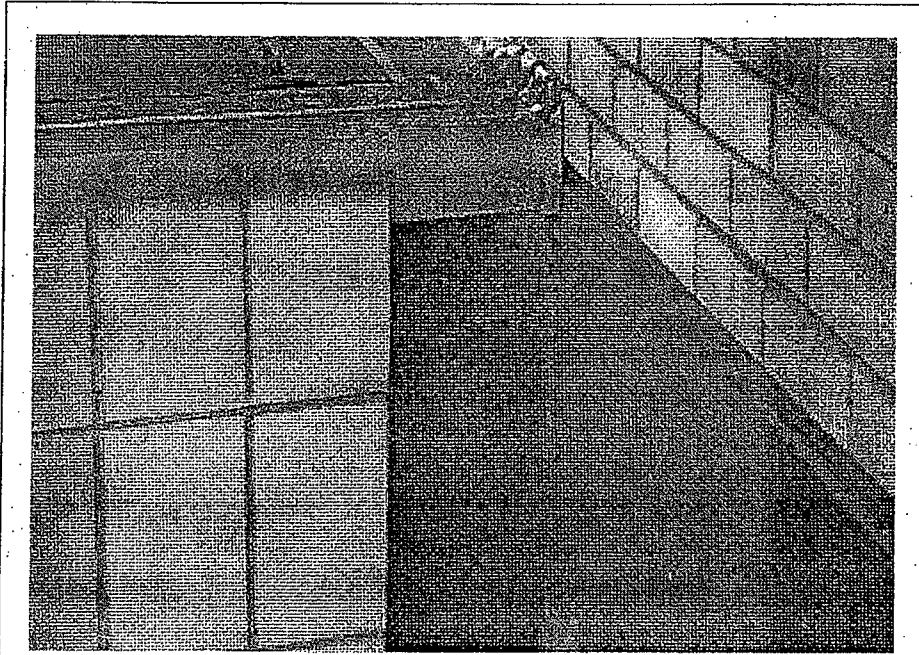
Figure B4-5: Rendered Beams & Columns – Damaged render columns on the western wing.

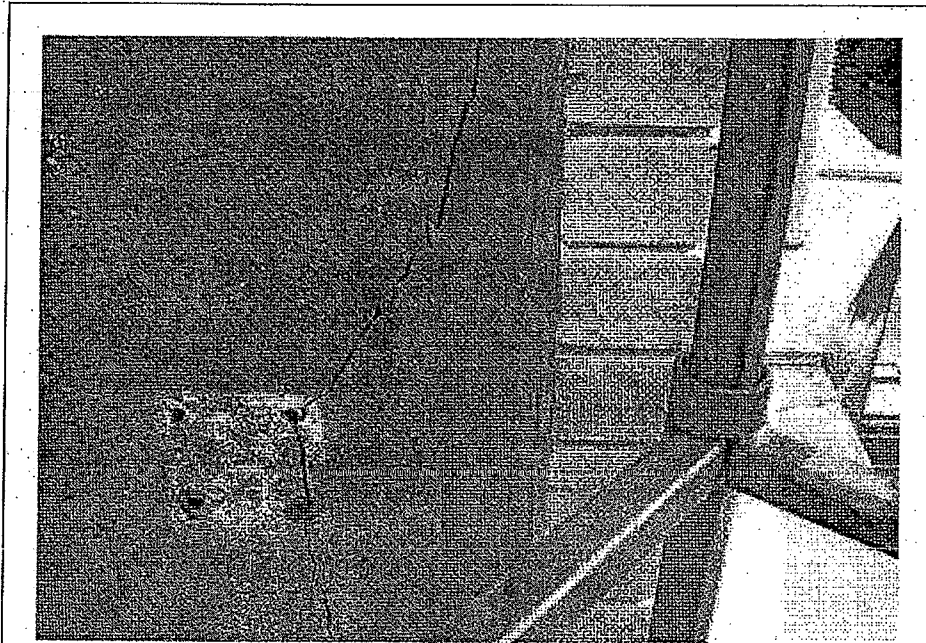
Figure B4-6: Rendered Beams & Columns – Damaged render columns on the northern wing.

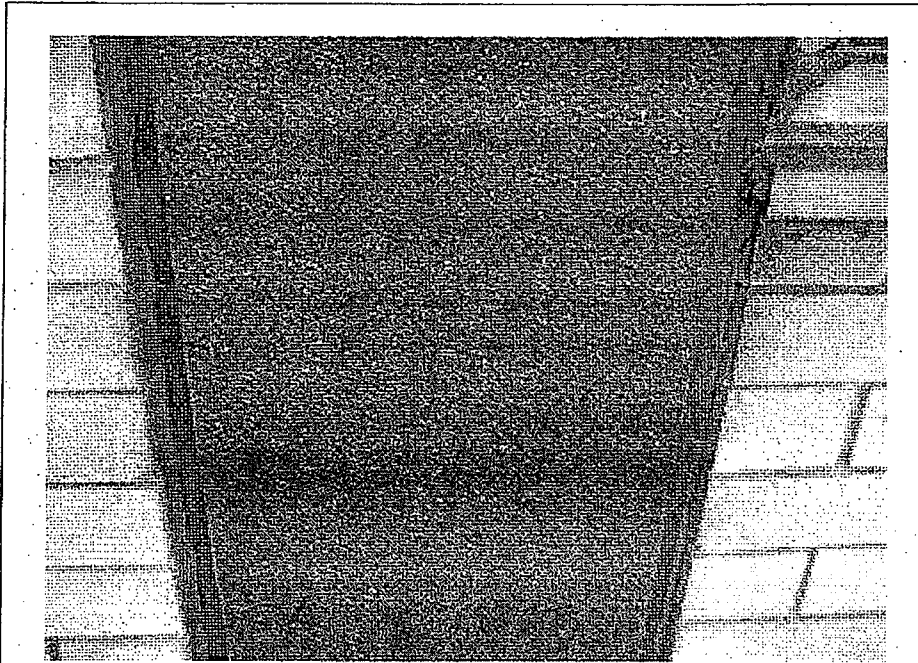
Figure B4-7: Rendered Beams & Columns – Damaged render columns.

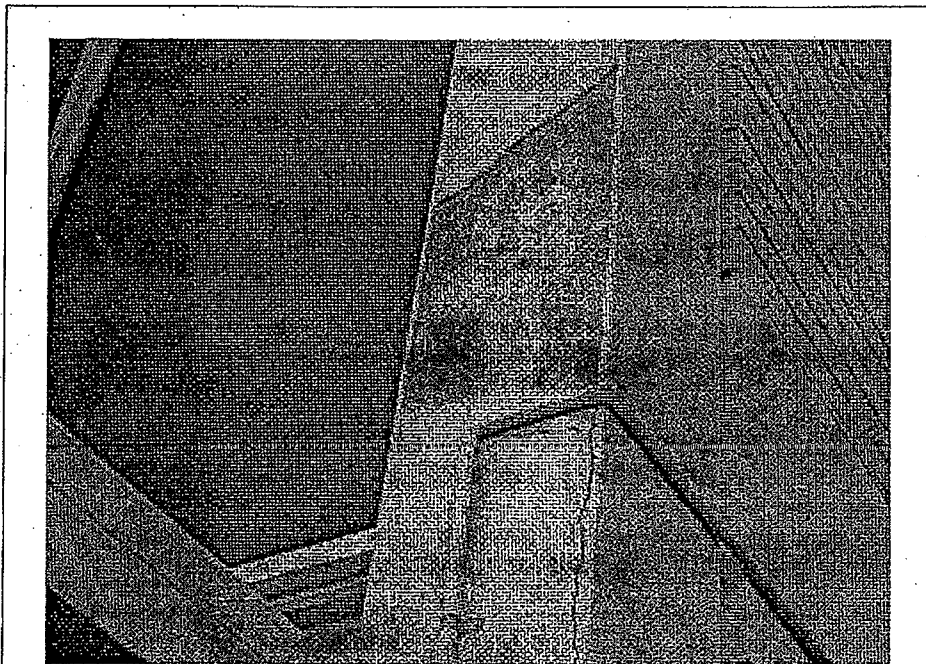
Figure B4-8: Rendered beams & columns – Damaged rendered

columns.

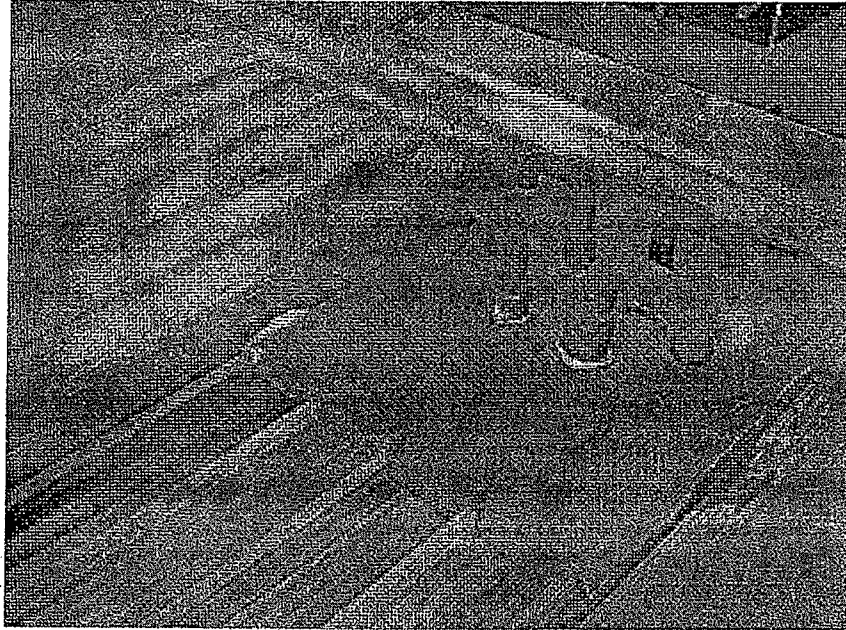
Figure B5-5: East wing: Severe corrosion present on roof sheeting of the western wing likely due to bimetallic action.

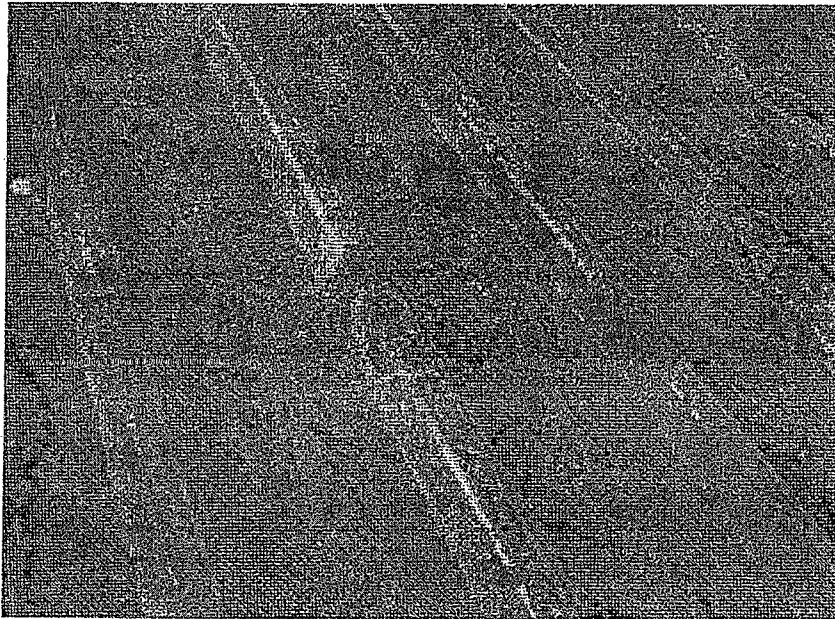
Figure B5-6: Corrosion spots on roof sheeting on the western wing likely due to bimetallic action. Note corroding fixings.

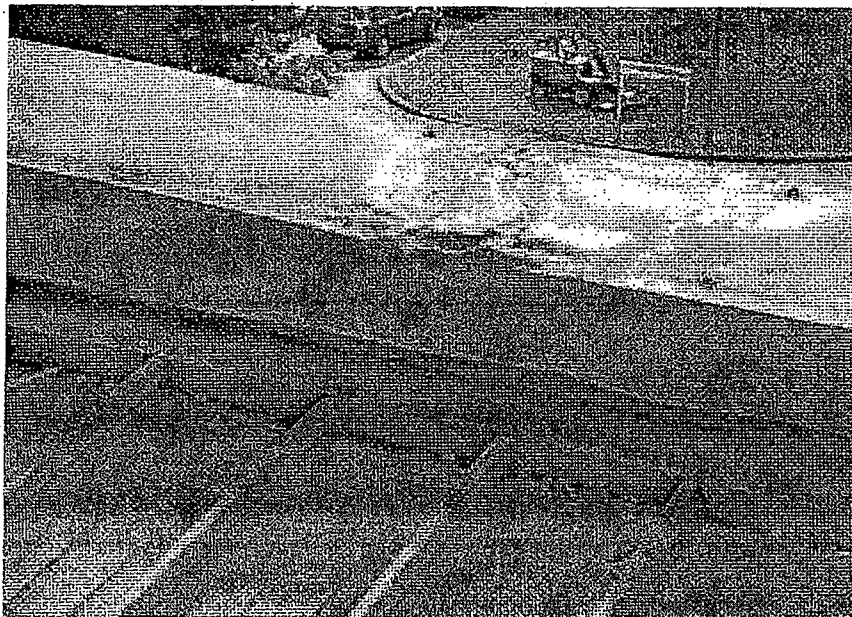
Figure B5-7: Roof areas – Damaged parapet capping on the western wing.

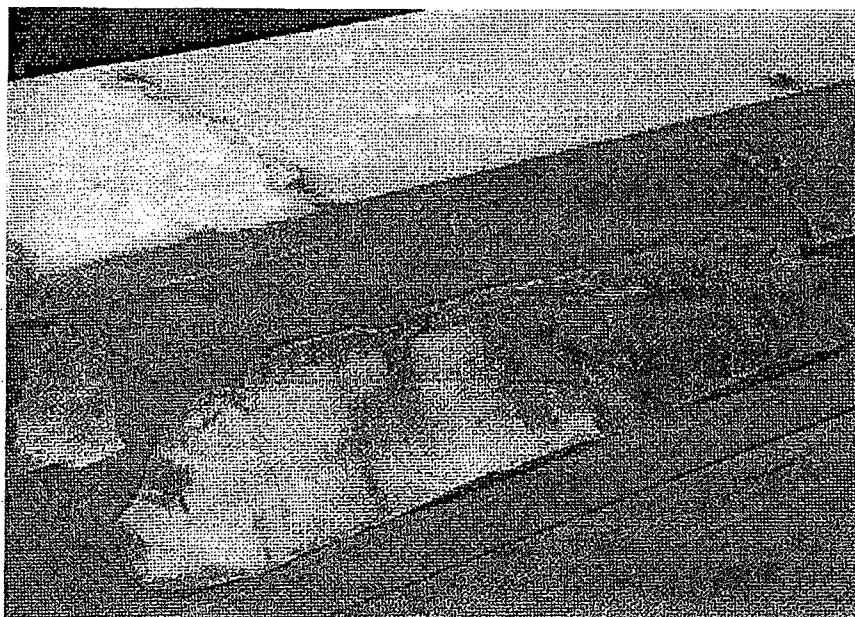
Figure B5-8: Roof areas – Displaced and damaged flashing on the western wing.

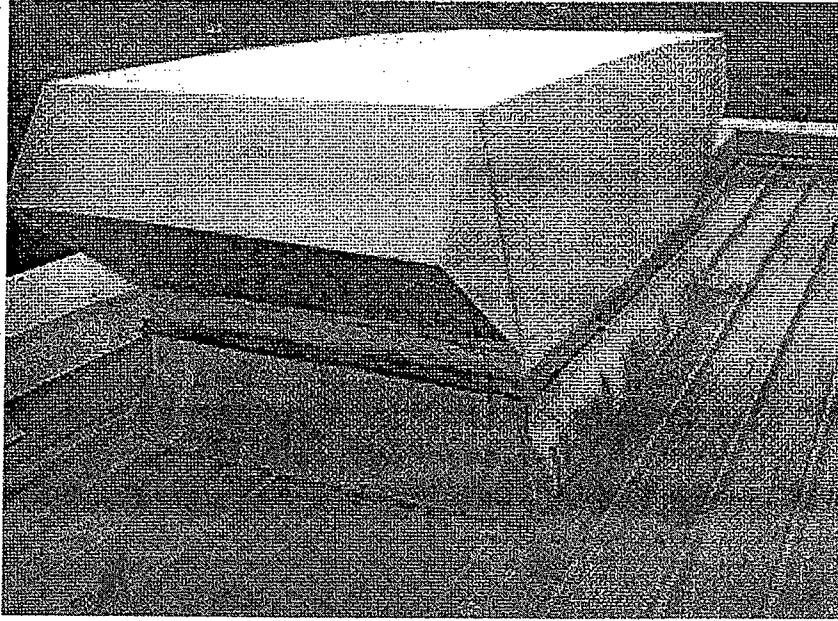
Figure B5-9: Roof areas – Surface corrosion of exhaust ducting on the western wing.
