Northern Sydney Local Health District Mona Vale Hospital

Facade Conditions Inspection Report

Inspection was undertaken on 14/2/17 and 18/2/17

by Sprack Construction Inspections

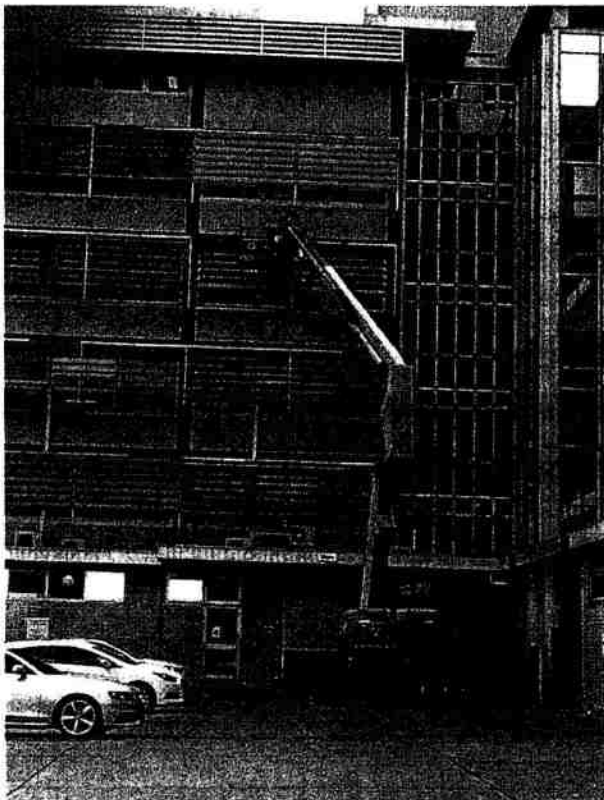
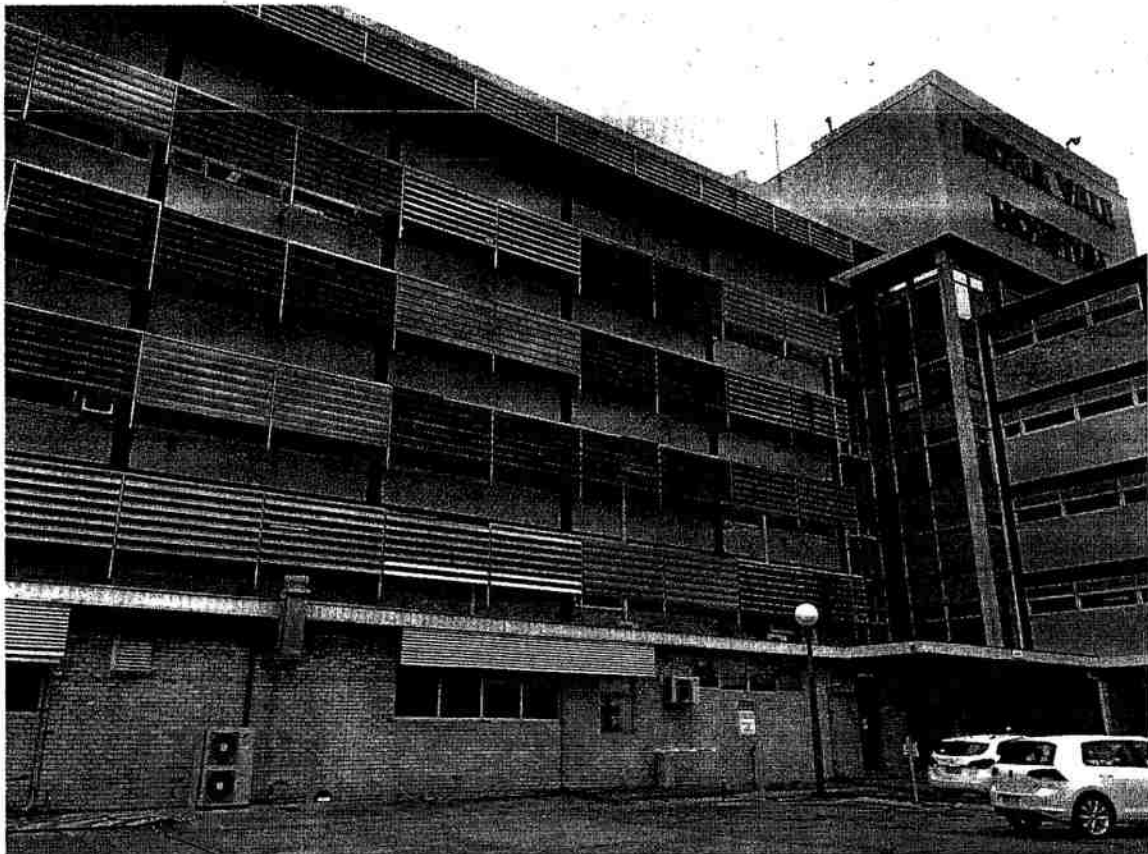
Image 2 - Continuation of Western Elevation of Mona Vale Hospital

- Fagade was found to be in a reasonable condition
- Brickwork and render was in in a reasonable condition with some render being drummy but not unstable
- 10 aluminium louvers were removed
- All the louvers were checked for structural soundness and found to be satisfactory

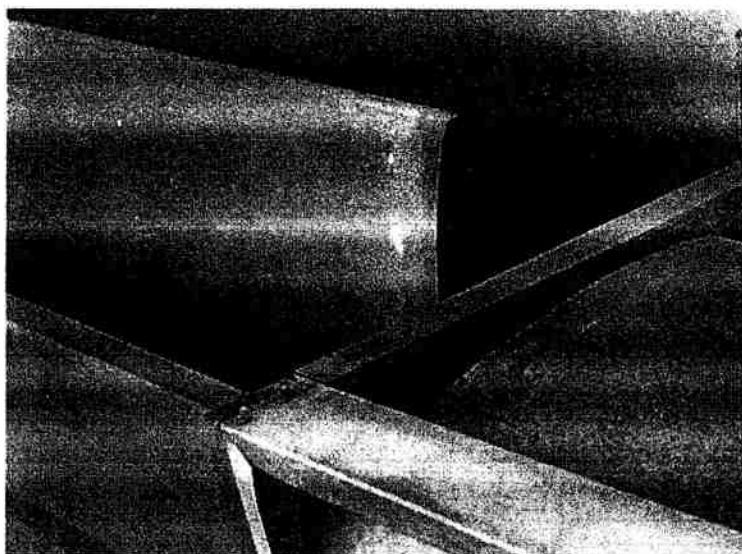
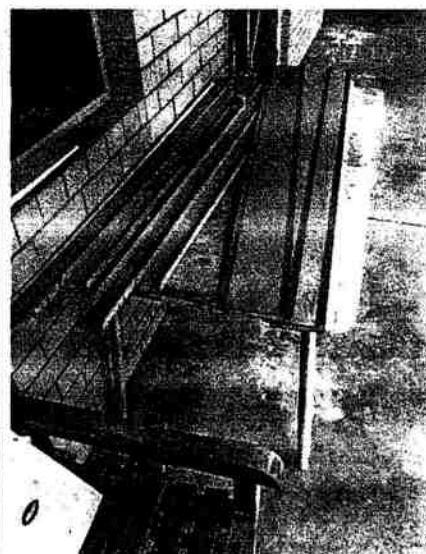
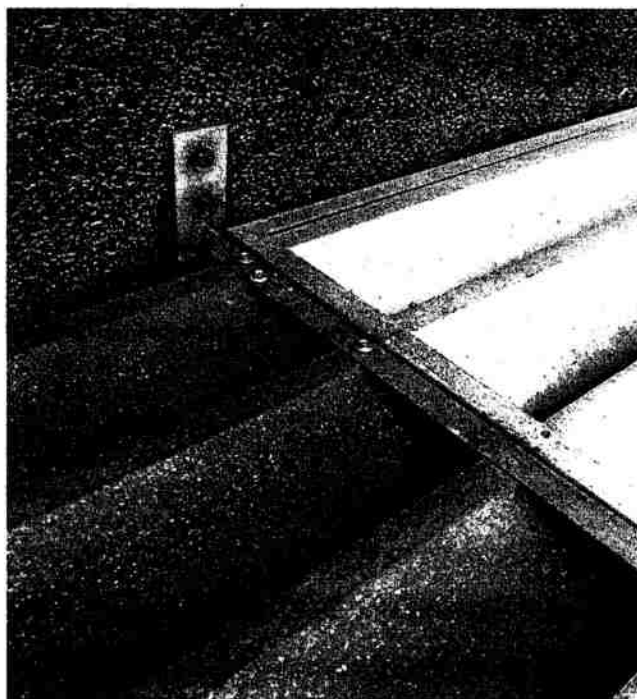
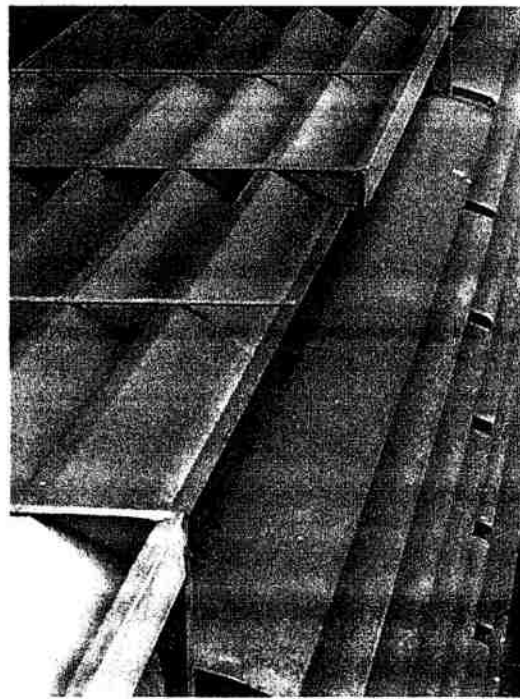
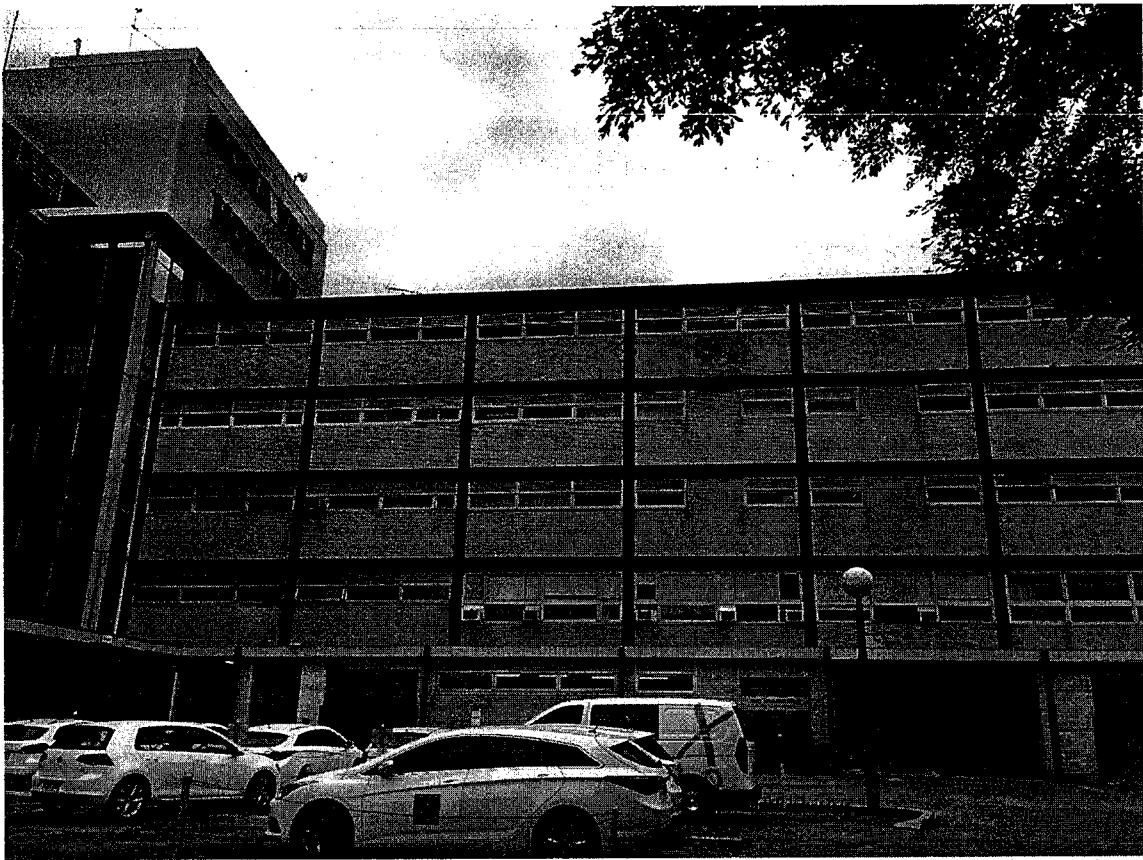
Image 3- North-West Elevation

- Facade was found in a reasonable condition.
- Brickwork was in a reasonable condition. Some of the render was found to be drummy but the greater extent was in good condition. No action is required but this area must be monitored and will be reinspected in June 2017.
- Aluminium windows were checked for soundness.
- Some of the old flashing that had come loose were Sika flexed down again and secured against wind loads.

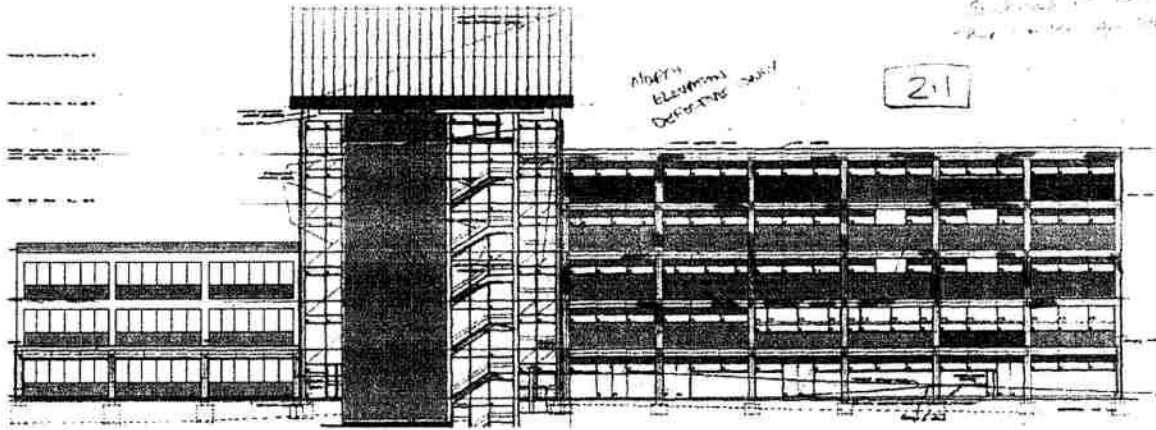
Image 4 (Area 2.1)

The image below shows the drummy areas in the North-West elevation that were reported in 2015 and this remains unchanged.

As previously reported, the pink areas show early stages of render being drummy and have not increased in size. These areas are in a reasonable condition and are not in danger of being dislodged.

All brickwork was inspected and there is no sign of brickwork failure.

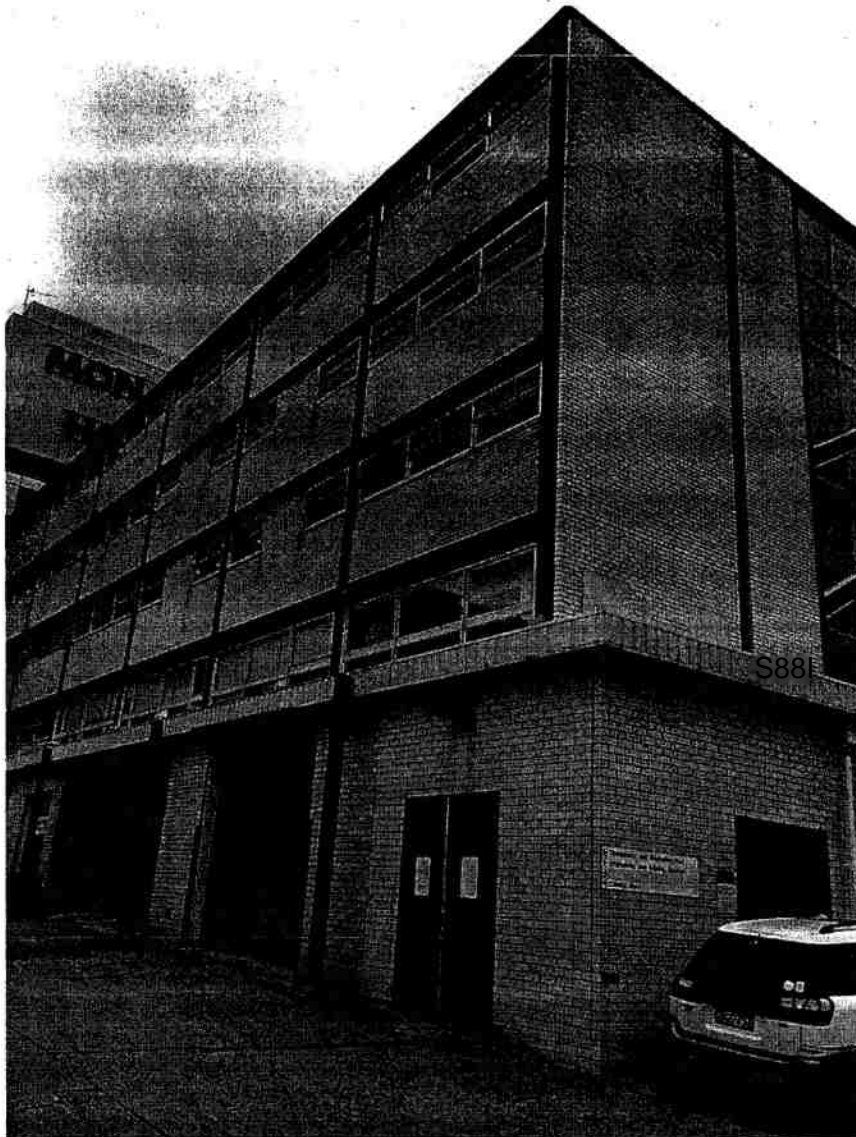
Image 5 (Area 2.2) - Wall connecting North-West and Southern Elevation

- Fagade was found to be in reasonable condition.
- Brickwork and render was in a reasonable condition.
- Aluminium windows were checked for soundness and found to be in fair condition.

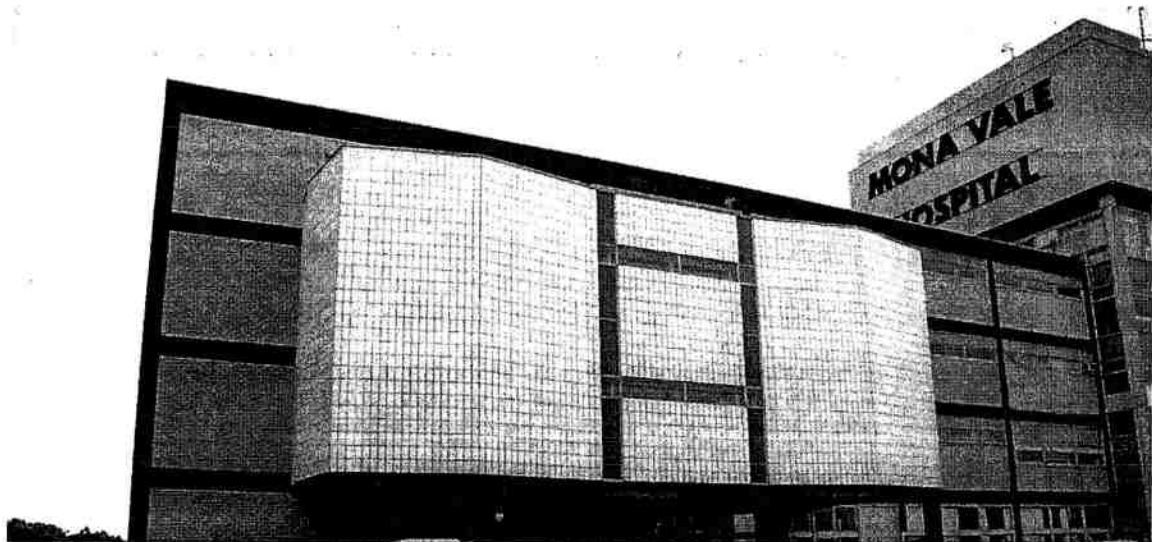
Image 7 - Southern Elevation of the building showing car park below.

- Fagade generally was found to be in a reasonable condition.
- Brickwork and render were in a reasonable condition (loose sections of render removed on site).
- Aluminium windows were checked for stability and found to be in a fair condition.
- Fagade tiles were inspected and there are a number of areas that seem to be drummy. No action is required at this stage but these areas will need to be carefully watched and must be reinspected in June 2017.

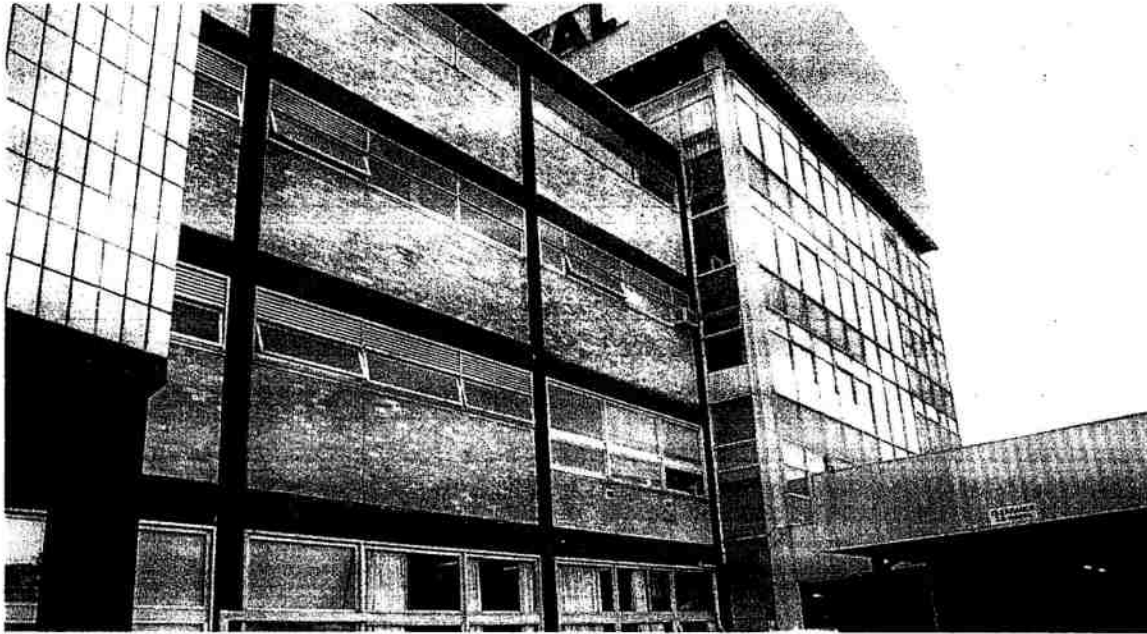
Image 8 - Closer view of Southern Elevation

- Fagade was found to be in a reasonable condition.
- Some cracking of brickwork around windows and this was filled with stabilised grout.
- Aluminium windows were checked for stability and found to be in a reasonable condition.

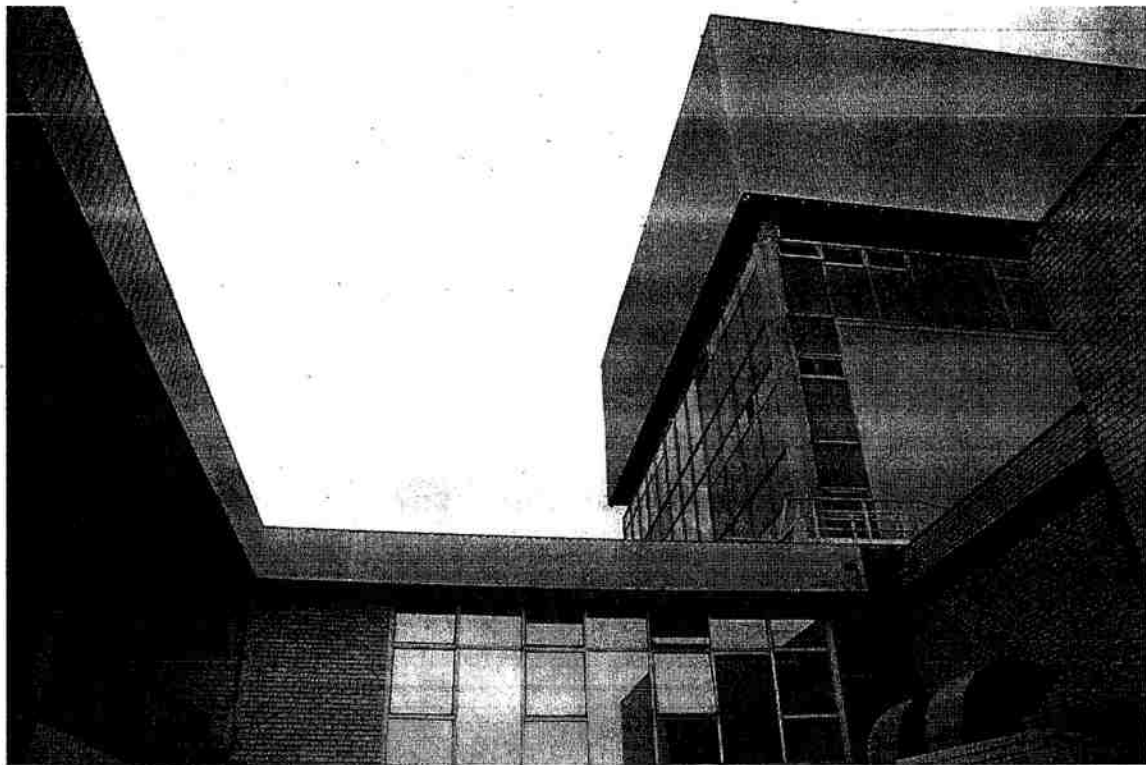
The ambulance entry area is of obvious concern due to vehicles and personnel moving through the area. This area was inspected on 15/2/2017 in the same manner as the other areas. Close inspection found the brickwork and fagade fabric in a reasonable condition.

Image 9 - View of the tower section of the building above the ambulance entry area of the hospital premises.

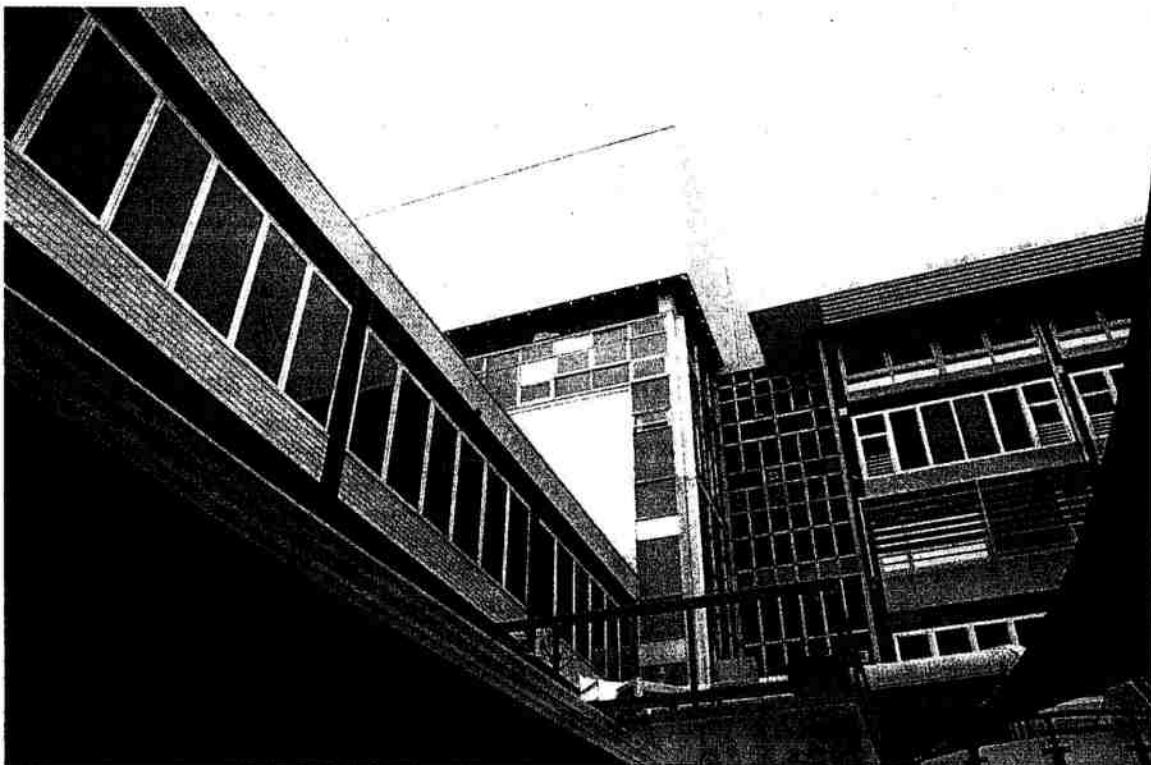
This area could not be inspected effectively. Close inspection of brick work and other facade fabric could not be reached by access equipment.

Image 11 - View of tower section and Eastern Elevation of the hospital building above the balcony.

Access to this area can only be through using a crane box. It is recommended that a crane box is used for the six-monthly inspection in June 2017. Alternatively, a IOkPa hoarding is recommended to be installed in this area.

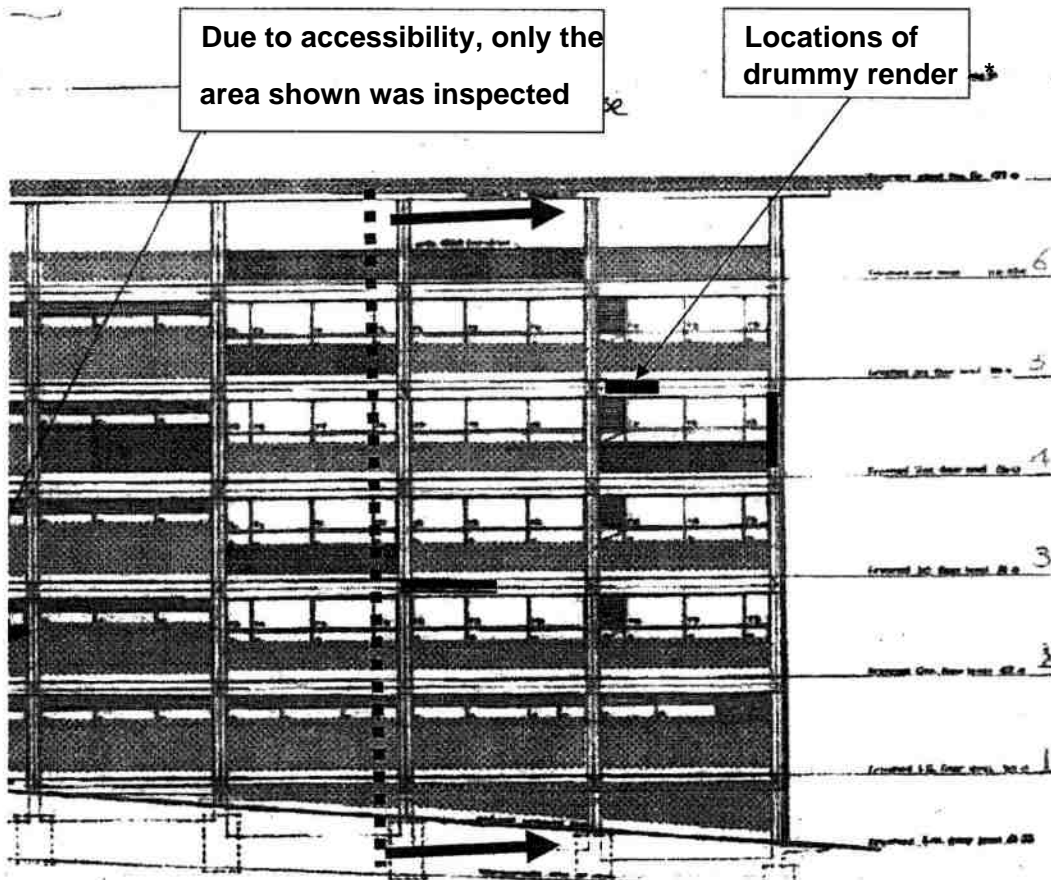
Eastern Elevation of the hospital building: (Inspection date 15/2/17)

The inspection of the Eastern facade revealed 3 areas of drummy render and one area where there is loose brick work. Window vents were also checked and 6 of the dislodged blades of the vents were removed.

No further action is required in this area as it has been made safe by fencing off the North/Eastern corner.

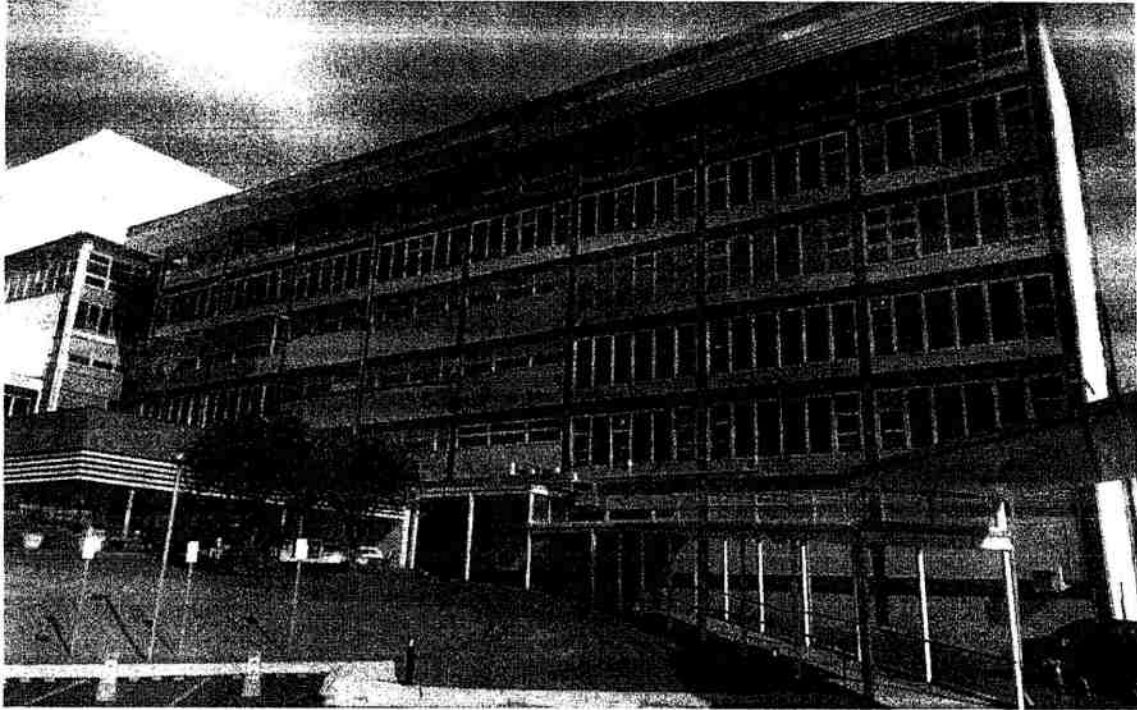
Eastern facade view: On our last inspection the Pink area found loose brick work and yellow area small section of loose aluminium which was removed.

The area as shown in the image above could not be inspected but we recommend that it is inspected in the June inspection using a crane box.

The Northern most area is now fenced off and no further action is required.

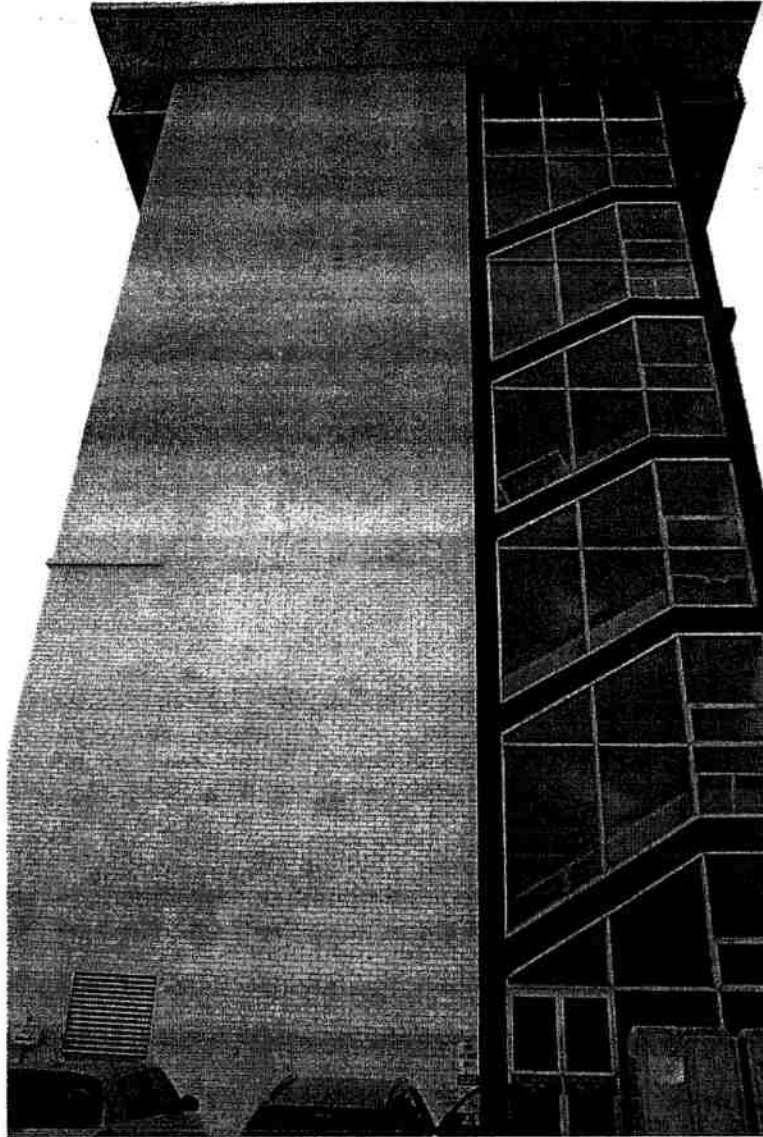
Image 14 - View of the Northern Elevation of the hospital building.

Area 7.1 This area of the facade had multiple areas of drummy render identified in 2015 but it has been stabilised for the time being using cladding over the rendered areas.

The brick work was found to be in good condition and unlikely to be dislodged.

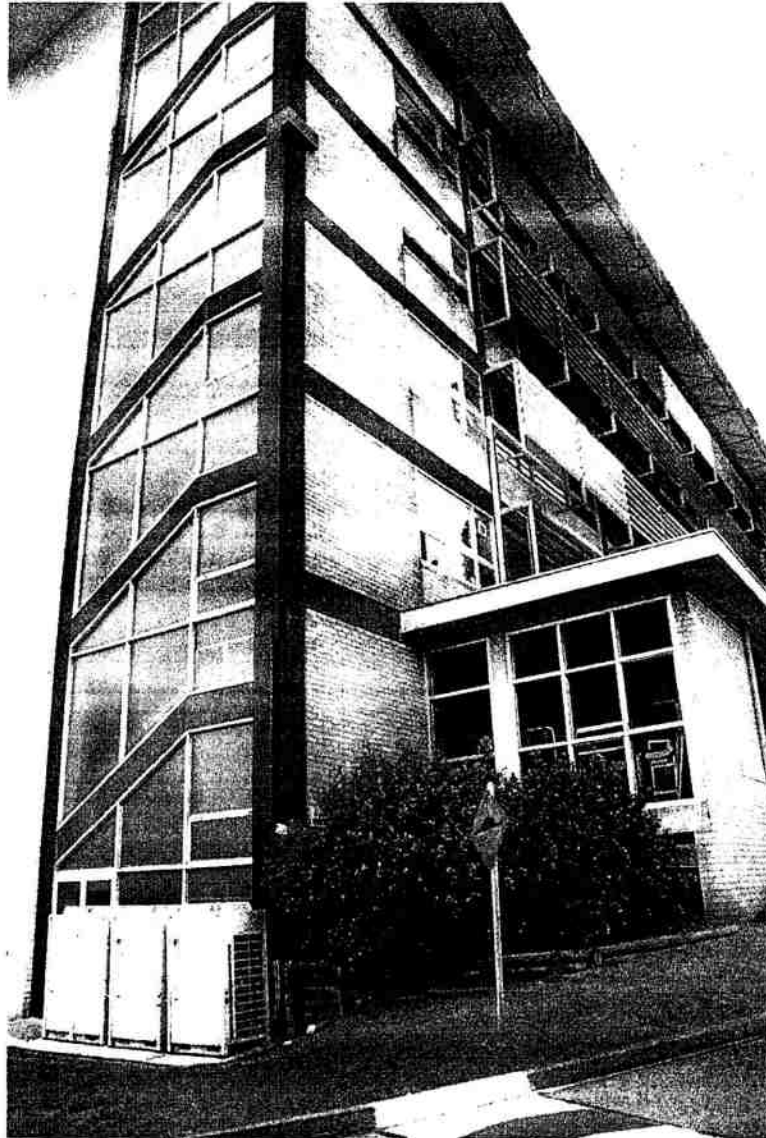
Image 15 - Continuation of Northern Elevation where it meets the Western Elevation showing grass area below.

Area 7.2 This corner area has sections with early signs of drummy render. At this stage we see no reason for any action. This corner will be closely investigated during the next inspection in June 2017.

This area is not usually used by pedestrians so we see no reason for it to be fenced off.
