**Northern Sydney Local Health District**  
**Mona Vale Hospital**  
**Facade conditions Inspection Report**

**Project Supervisor: Grant Jardine/ Sam Ebeid (E A & Associates)**

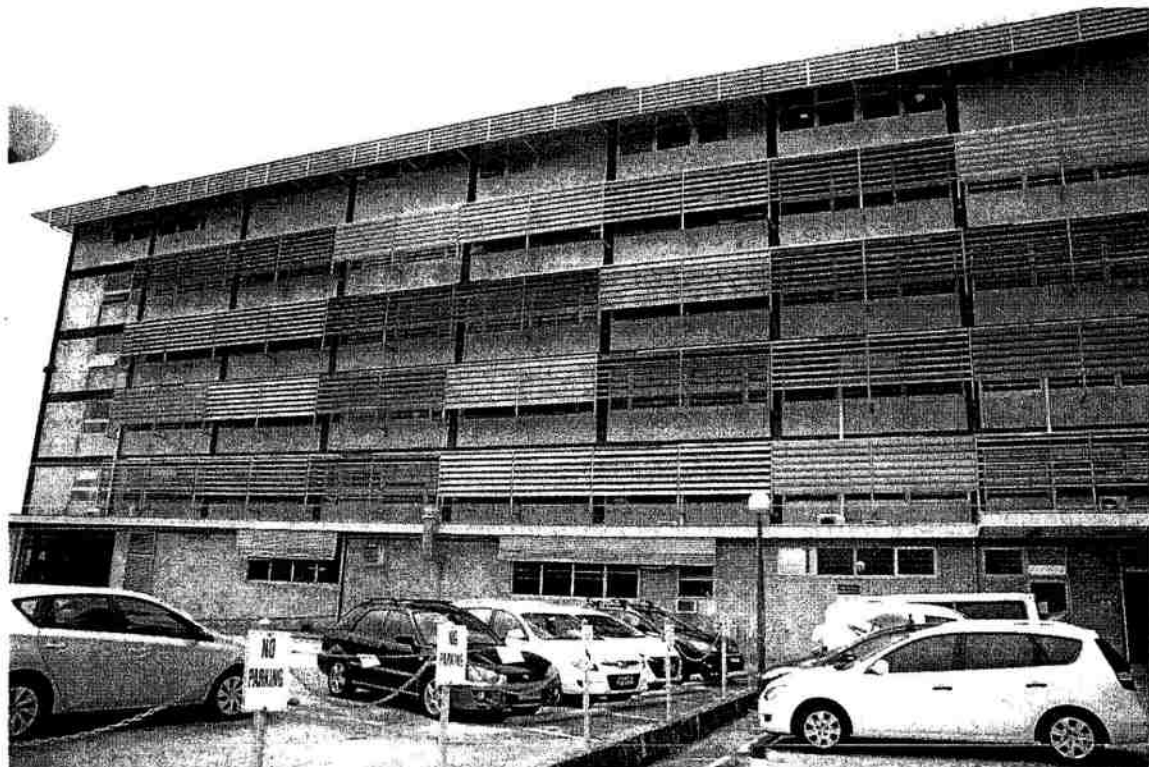
- Fagade was found sound.
- Brickwork and render was in sound condition
- 6 aluminium louvers were removed
- All the louvers were checked for structural soundness and declared satisfactory.

**Image 2** - Continuation of Western Elevation of Mona Vale Hospital

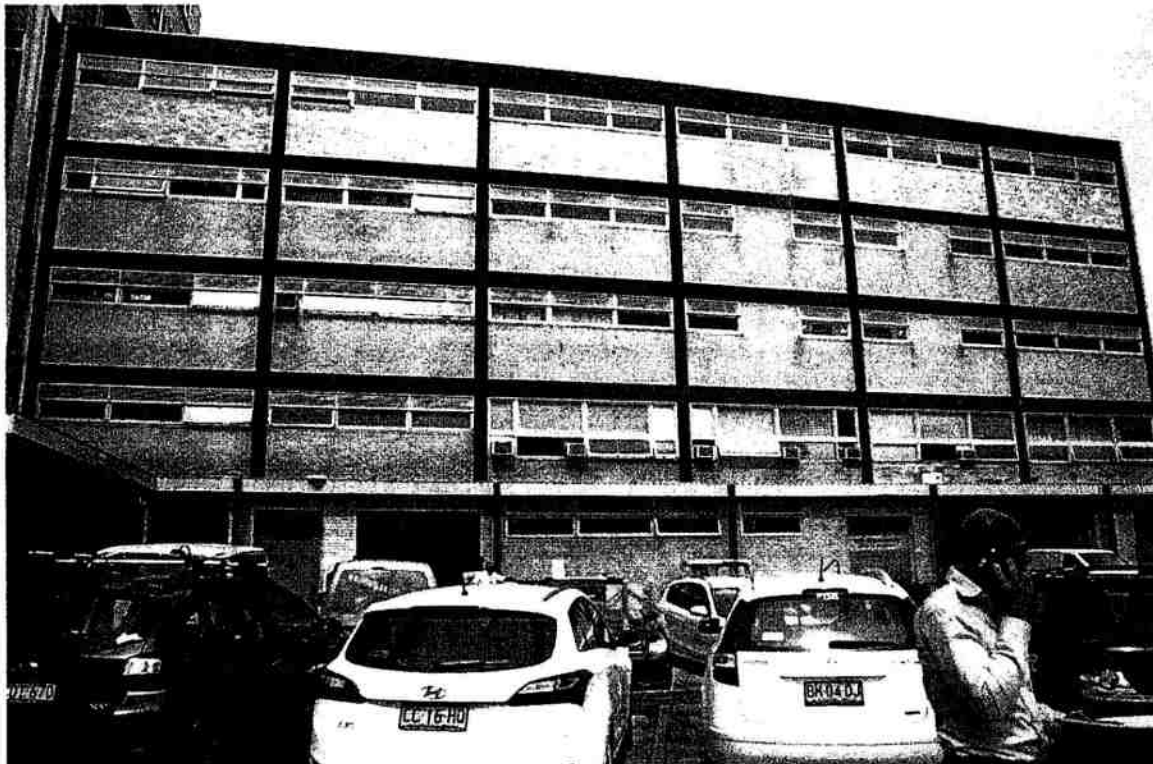
- Facade was found in sound condition.
- Brickwork and render was in sound condition
- Aluminium windows were checked for soundness, all were in fair condition.

**Image 3-** North-West Elevation showing hospital vehicles and employees

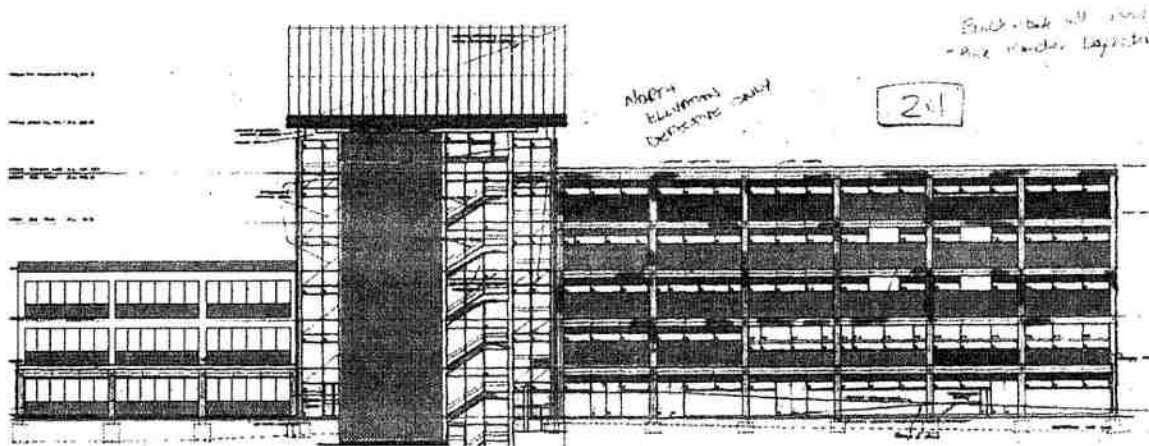
**Image 4-( area 2.1)**

North-West Elevation showing area where render is drummy but in a stable condition unlikely to dislodge.

Pink area indicate early stage of render being drummy. These area's are in sound condition and are not in danger of being dislodged.

Brickwork was all inspected and there is no signs of brickwork failure.

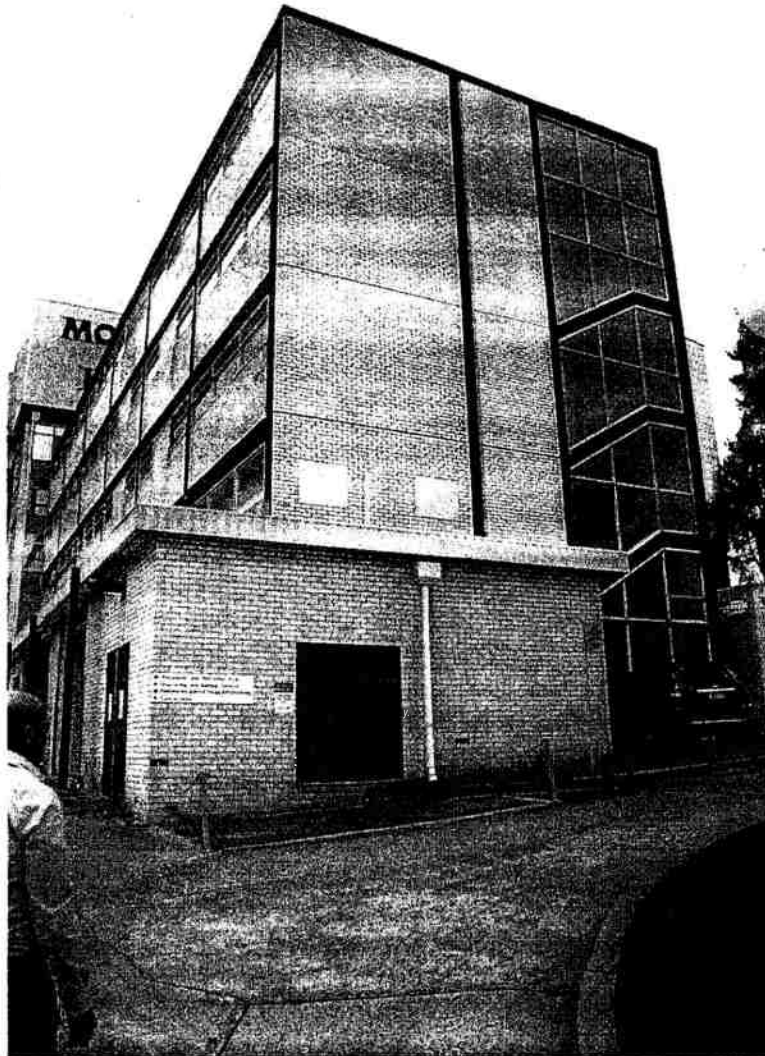
**Image 5 - (area 2.2) Wall connecting North-West and Southern Elevation**

- Fagade was found in sound condition.
- Brickwork and render was in sound condition

Aluminium windows were checked for soundness & found to be in fair condition.

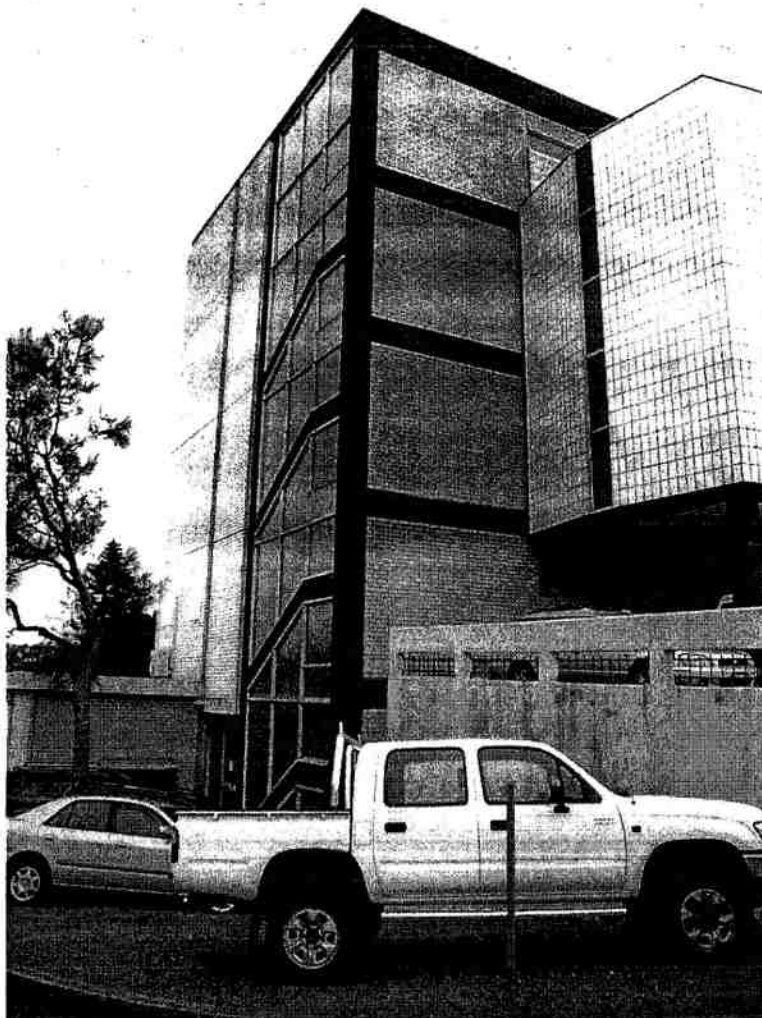
**Image 6 - (area 2.2)** Continuation of wall connecting North-West and Southern Elevation.

- Fagade was found in sound.
- Brickwork and render was in sound condition
- Aluminium windows were checked for stability & found to be in fair condition.

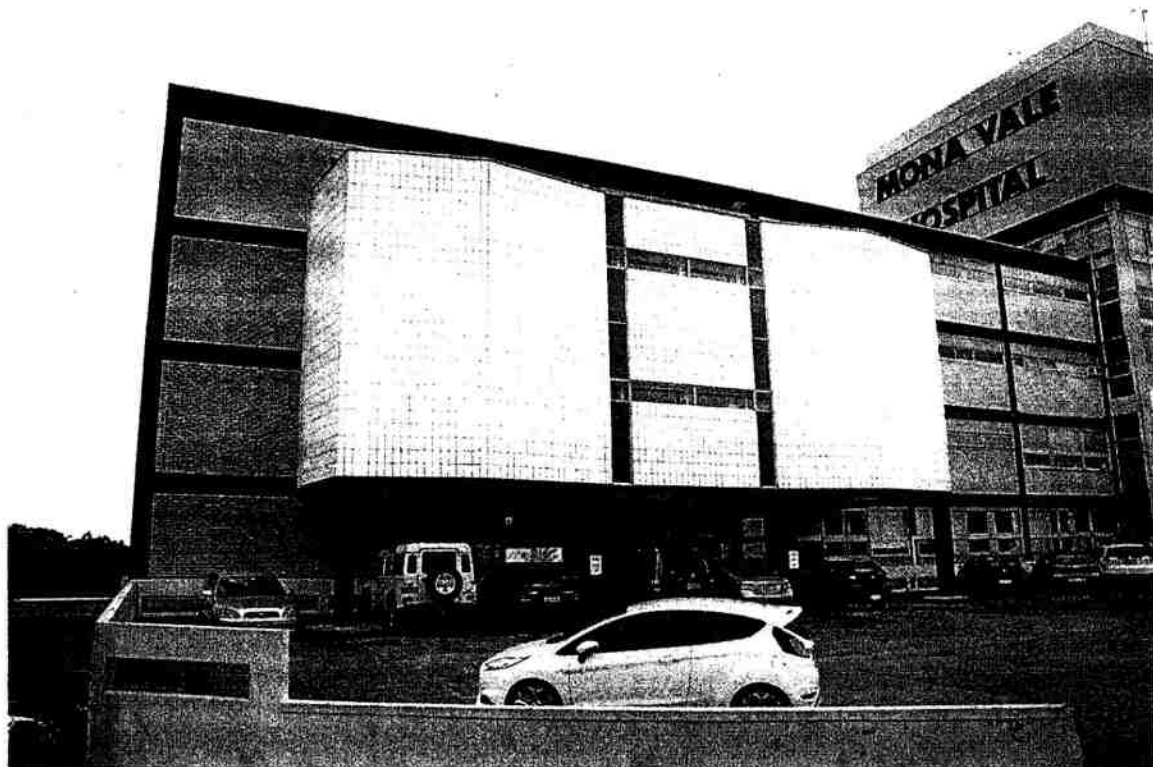
**Image 7** - Southern Elevation of the building showing car park below.

- Façade was found to be in sound condition.
- Brickwork and render was in sound condition (sections of render removed)
- Aluminium windows were checked for safety & found to be in fair condition.
- Façade tiles were inspected, unsafe sections removed.

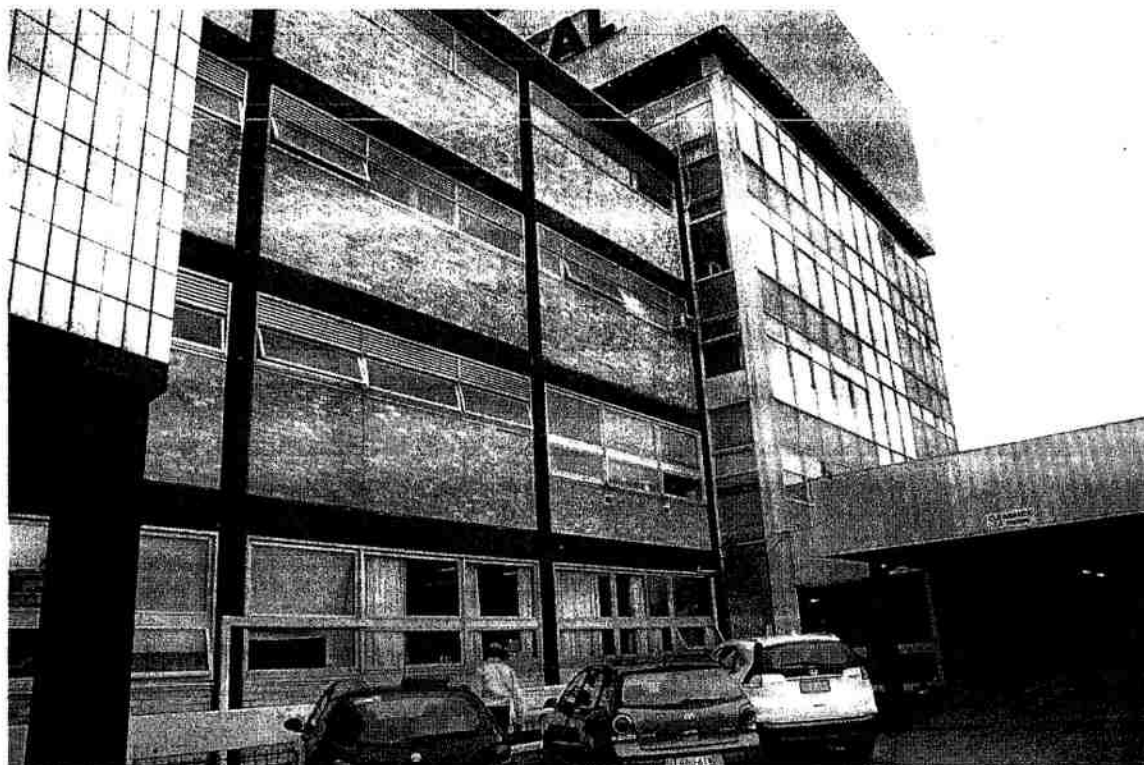
**Image 8** - Closer view of Southern Elevation directly above cars parked below near the entrance of the tower section of the building.

- Fagade was found to be in sound condition.
- Brickwork and render was in sound condition
- Aluminium windows were checked for stability and found in sound condition.

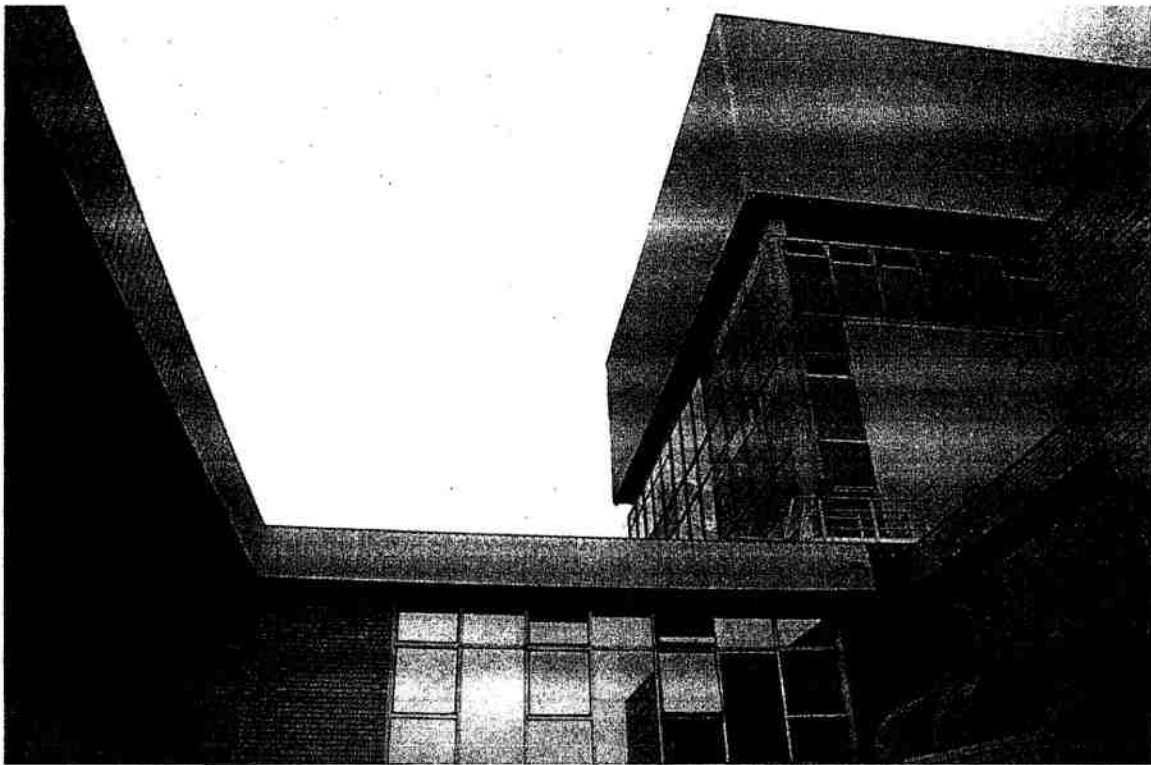
The ambulance entry area is of obvious concern due to vehicles and personnel moving through the area. This area was inspected also on the 22/5/2015 in the same manner as the other area, close up inspection found the brickwork and fagade fabric in a sound condition.

**Image 9** - View of the tower section of the building above the ambulance entry area of the hospital premises.

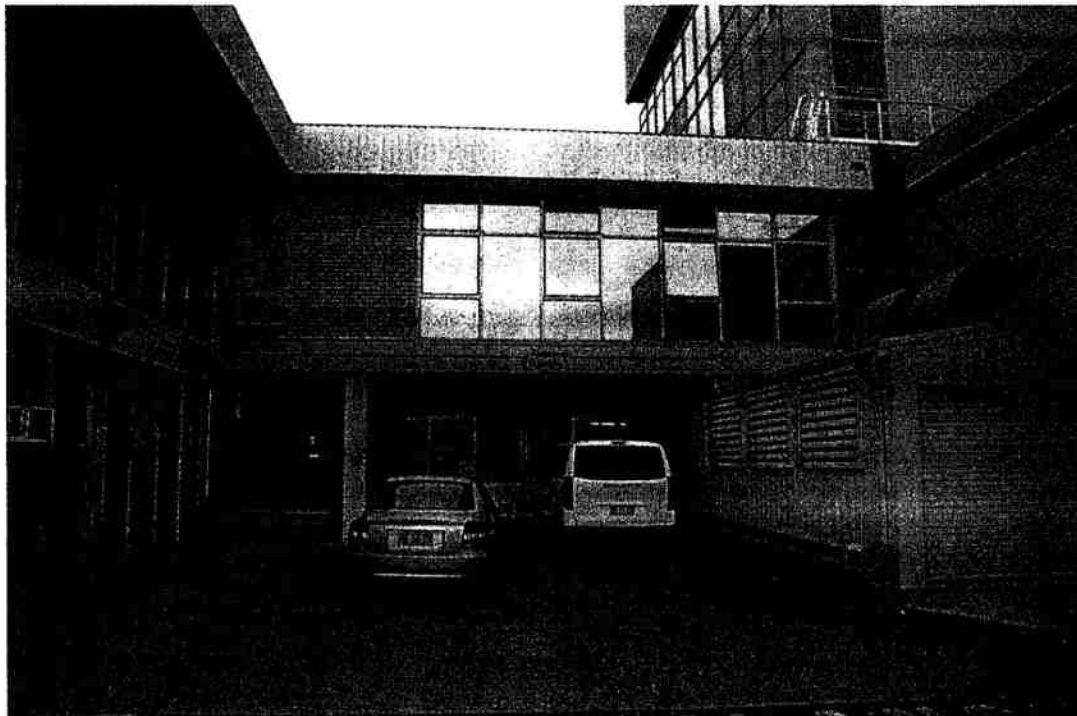
**Image 10** - Ambulance entry area of the hospital.

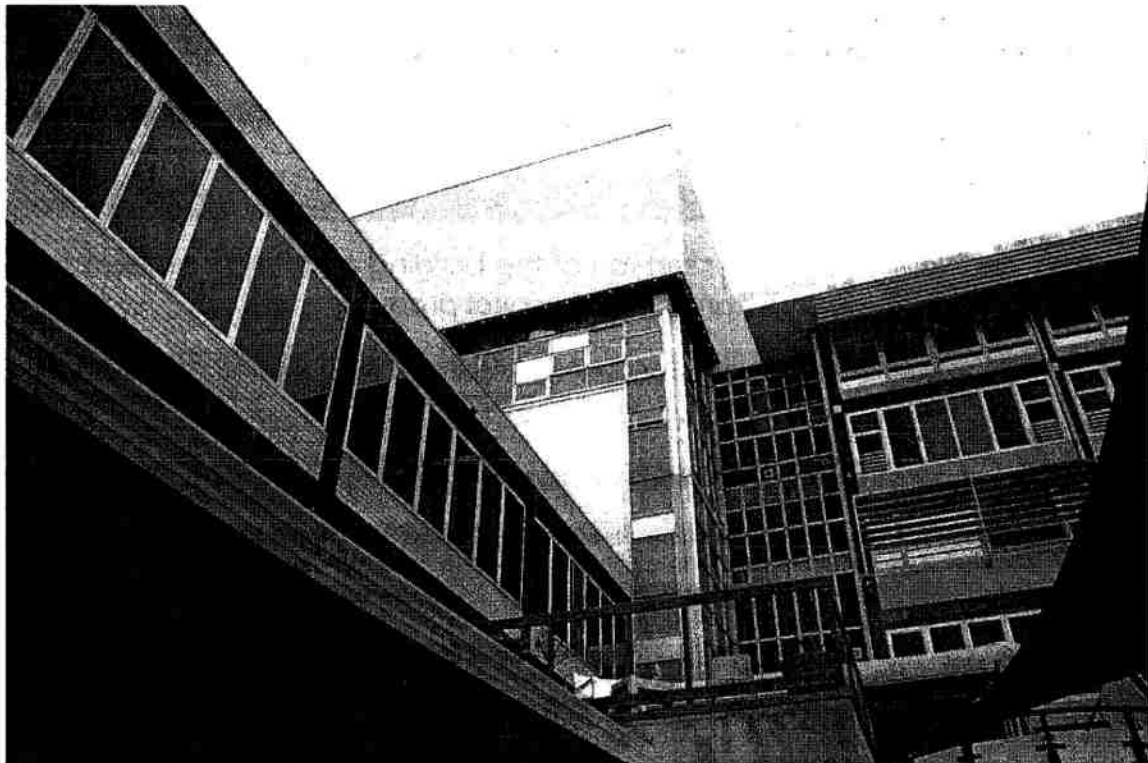
This area could not be inspected effectively. Close inspection of brick work and other facade fabric could not be reached by access equipment.

**Image 11** - View of tower section and Eastern Elevation of the hospital building above the balcony.

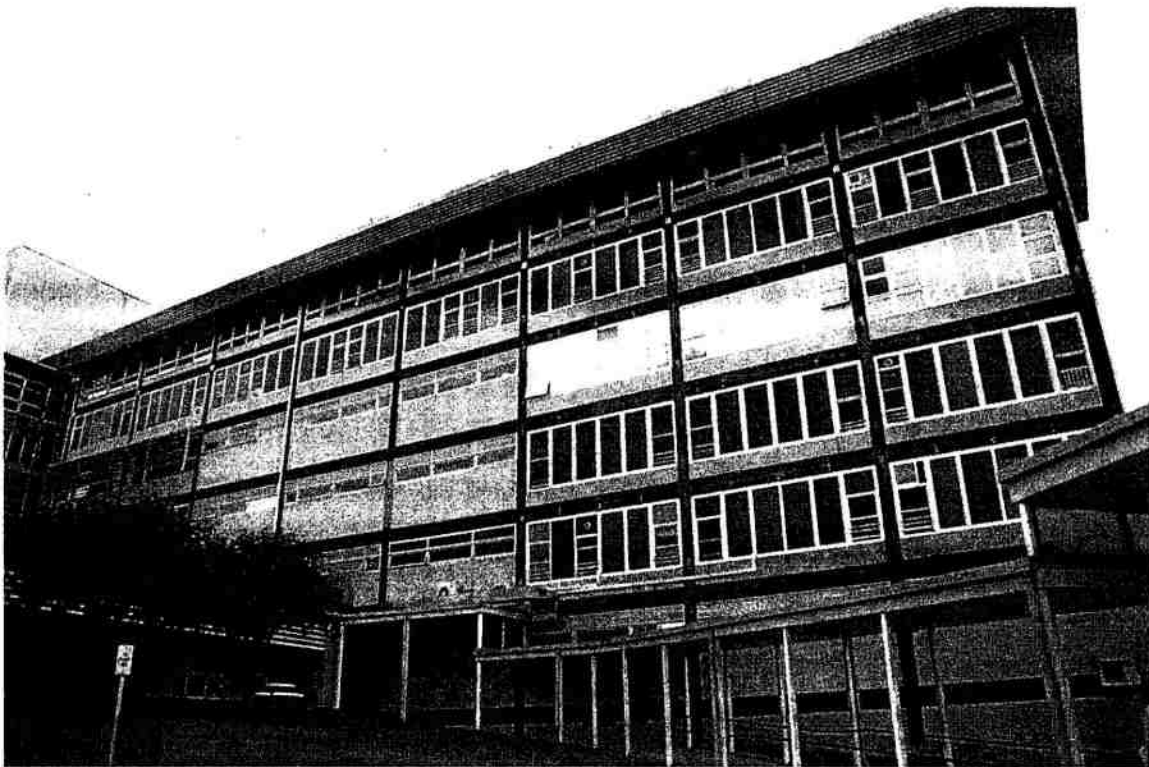
**Image 12** - View of the Eastern Elevation of the hospital building showing grass recreation area and walkway below.

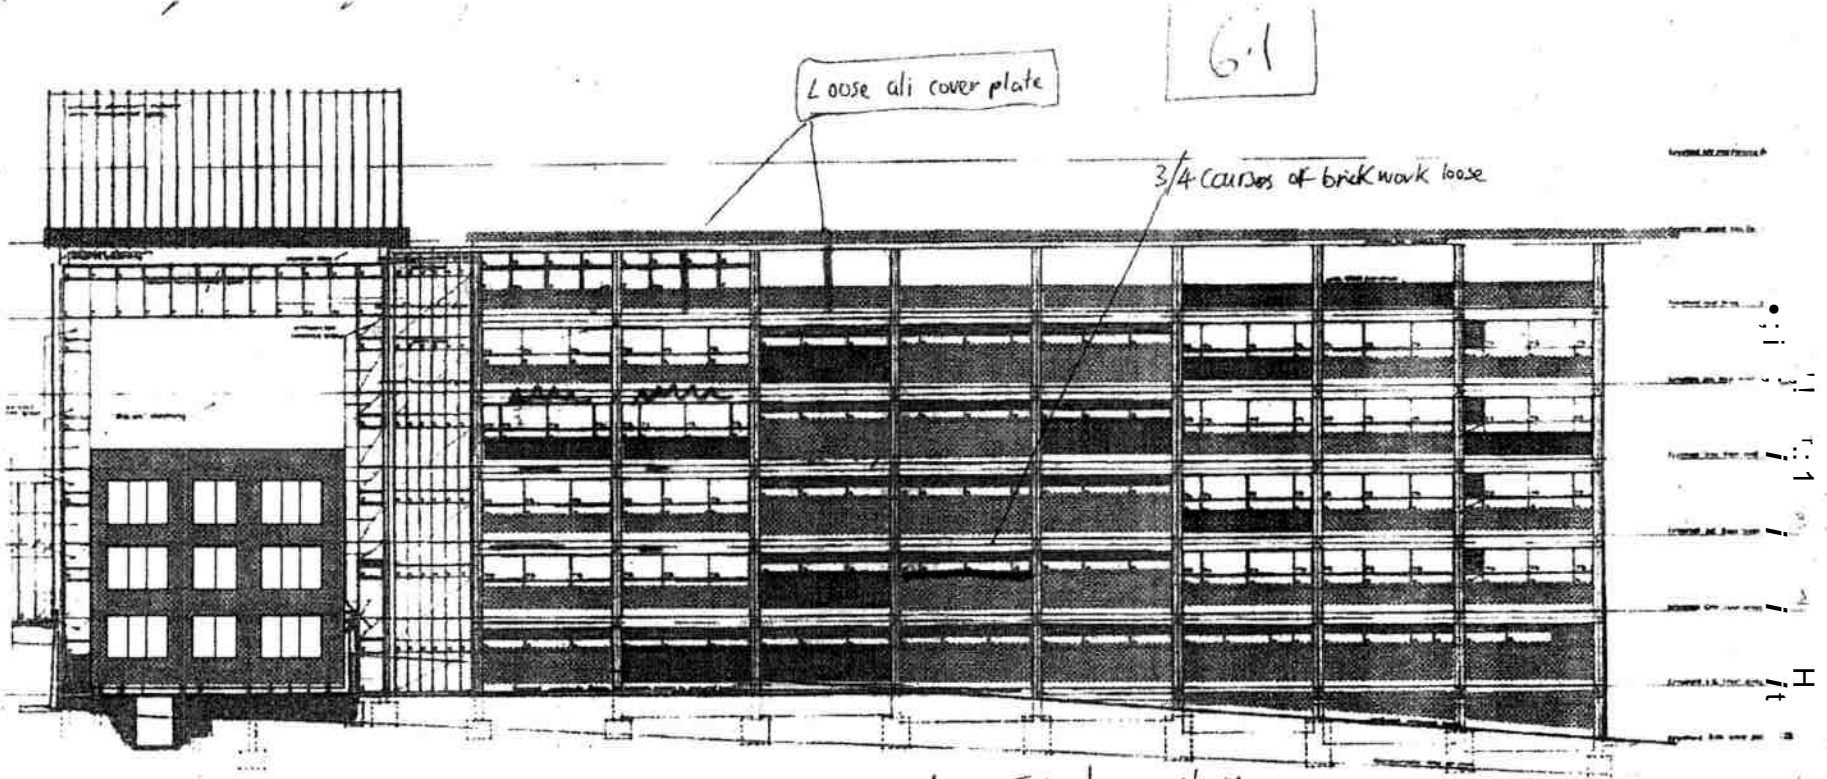
Crane Inspection Tuesday 26th May 2015

The inspection of the eastern facade revealed 3 areas of drummy render and one area where there is loose brick work. Louvers were also checked and 3 of the dislodged louvers were removed.

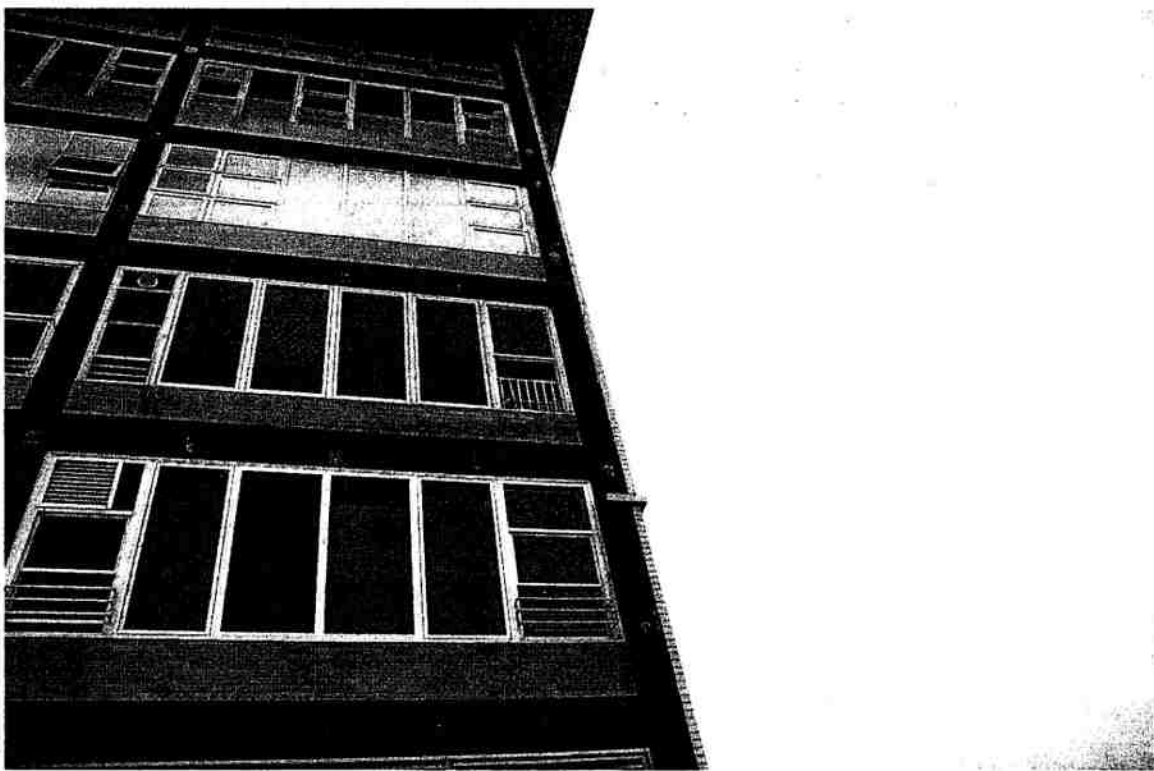
**Image 13** - Closer view of the eastern elevation showing detached concrete render which was made safe from being dislodged.

Recommend this area to be fenced off in order to restrict public access.

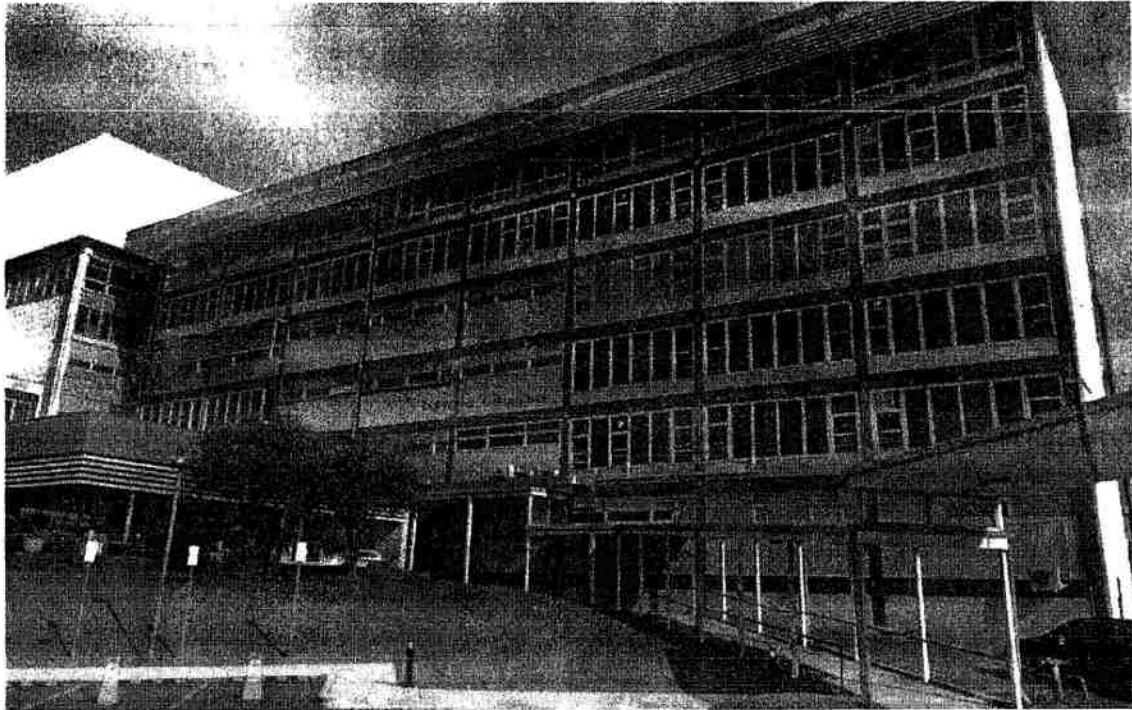
Eastern facade view: Pink area found loose brick work and yellow area small section of loose aluminium which was removed.

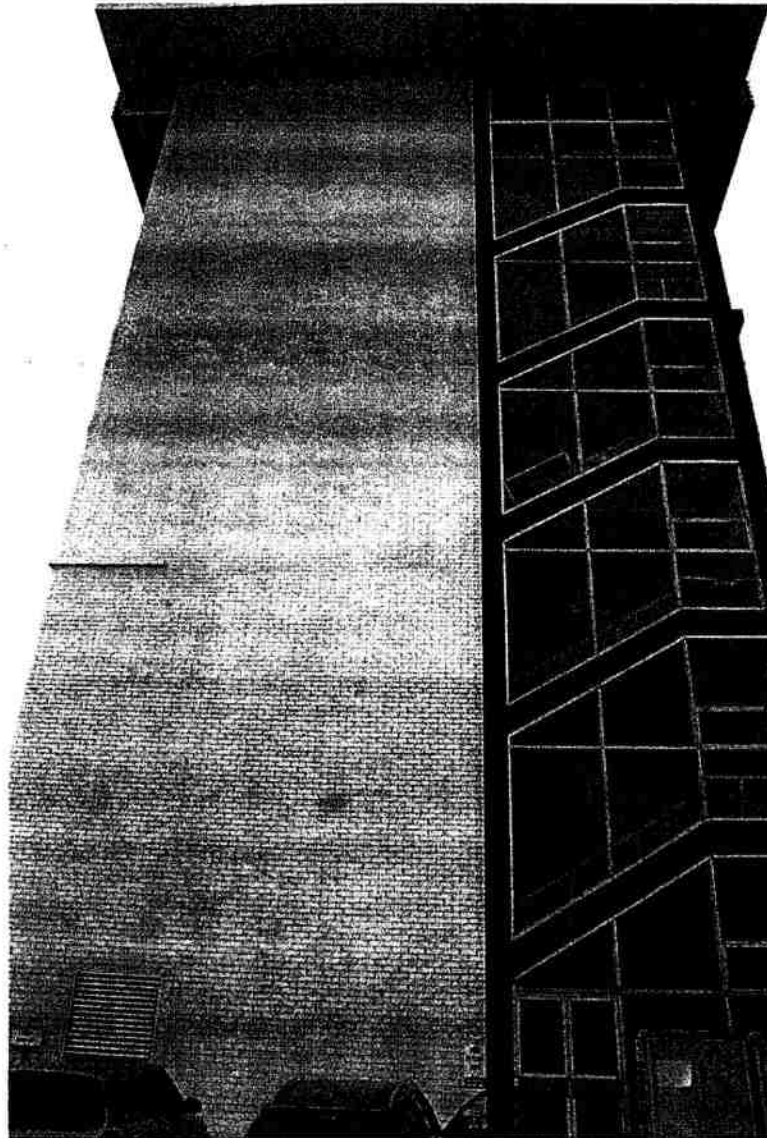
**Image 14** - View of the Northern Elevation of the hospital building.

This area of the facade had multiple areas of drummy render.

The brick work was found to be in good condition & unlikely to be dislodged.

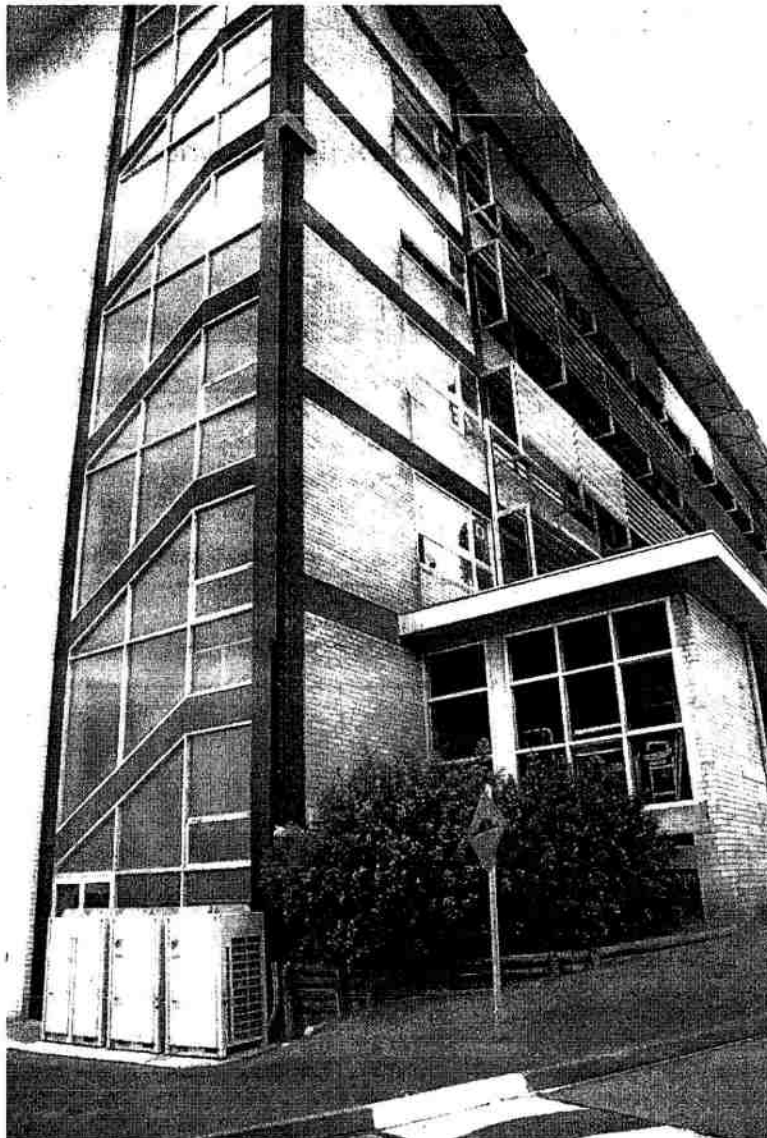
**Image 15** - Continuation of Northern Elevation where it meets the Western Elevation showing grass area below.
