FLOODING OF THE GENERAL MANAGER'S "FINELY TUNED" MONA VALE POST OFFICE CAR PARK

Extensive flooding occurs in the Mona Vale Post Office Car Park in Bungan Lane, when it rains, which is a regular occurrence in Mona Vale ! This results in not just wet concrete but flowing floodwaters through the car park, creating "unsafe situations" for the public walking through the car park.

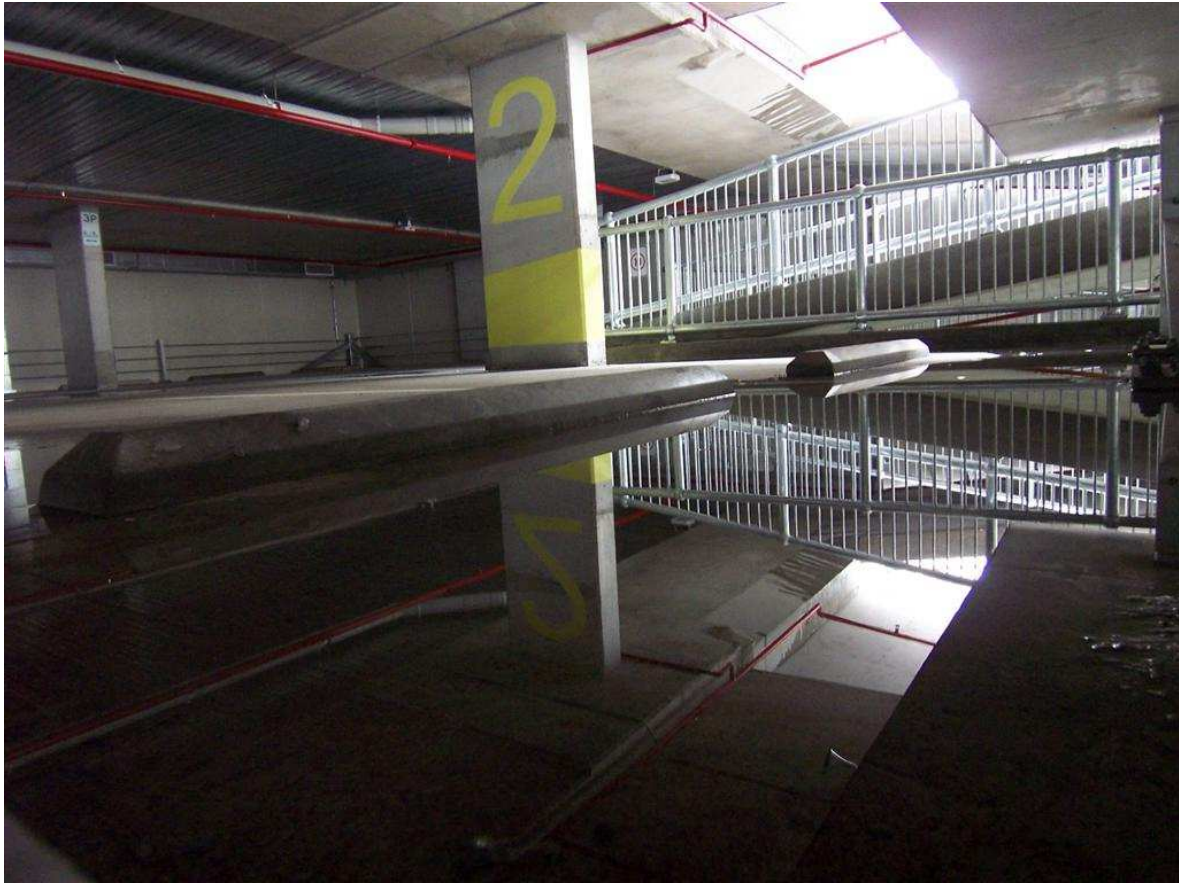
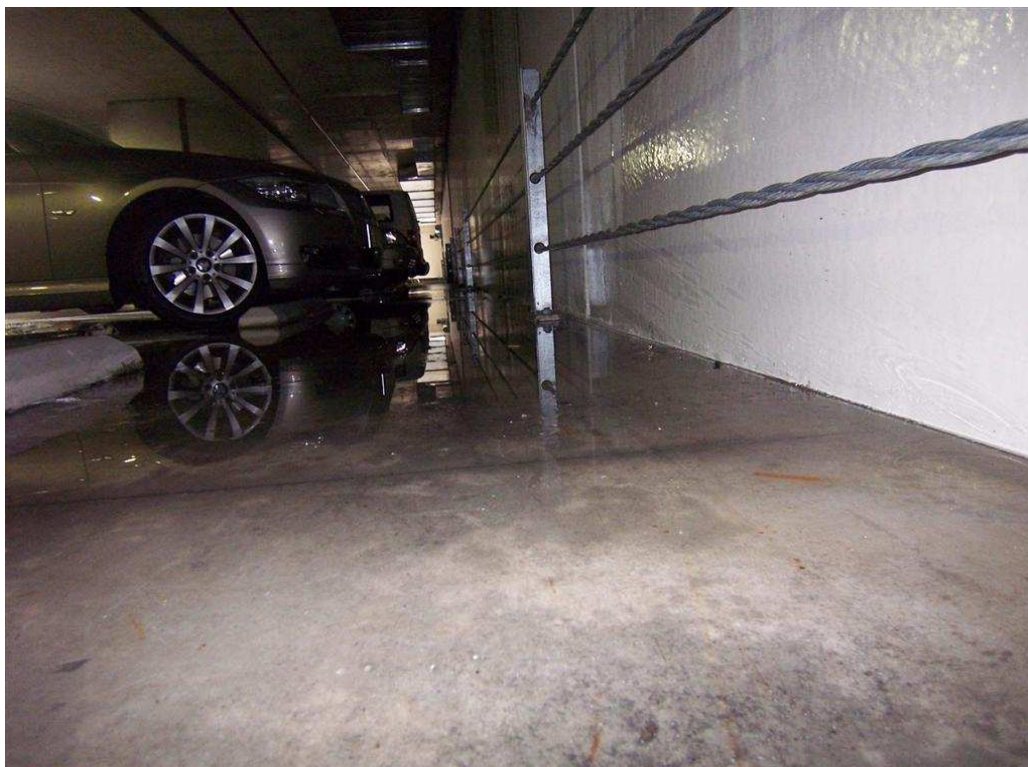
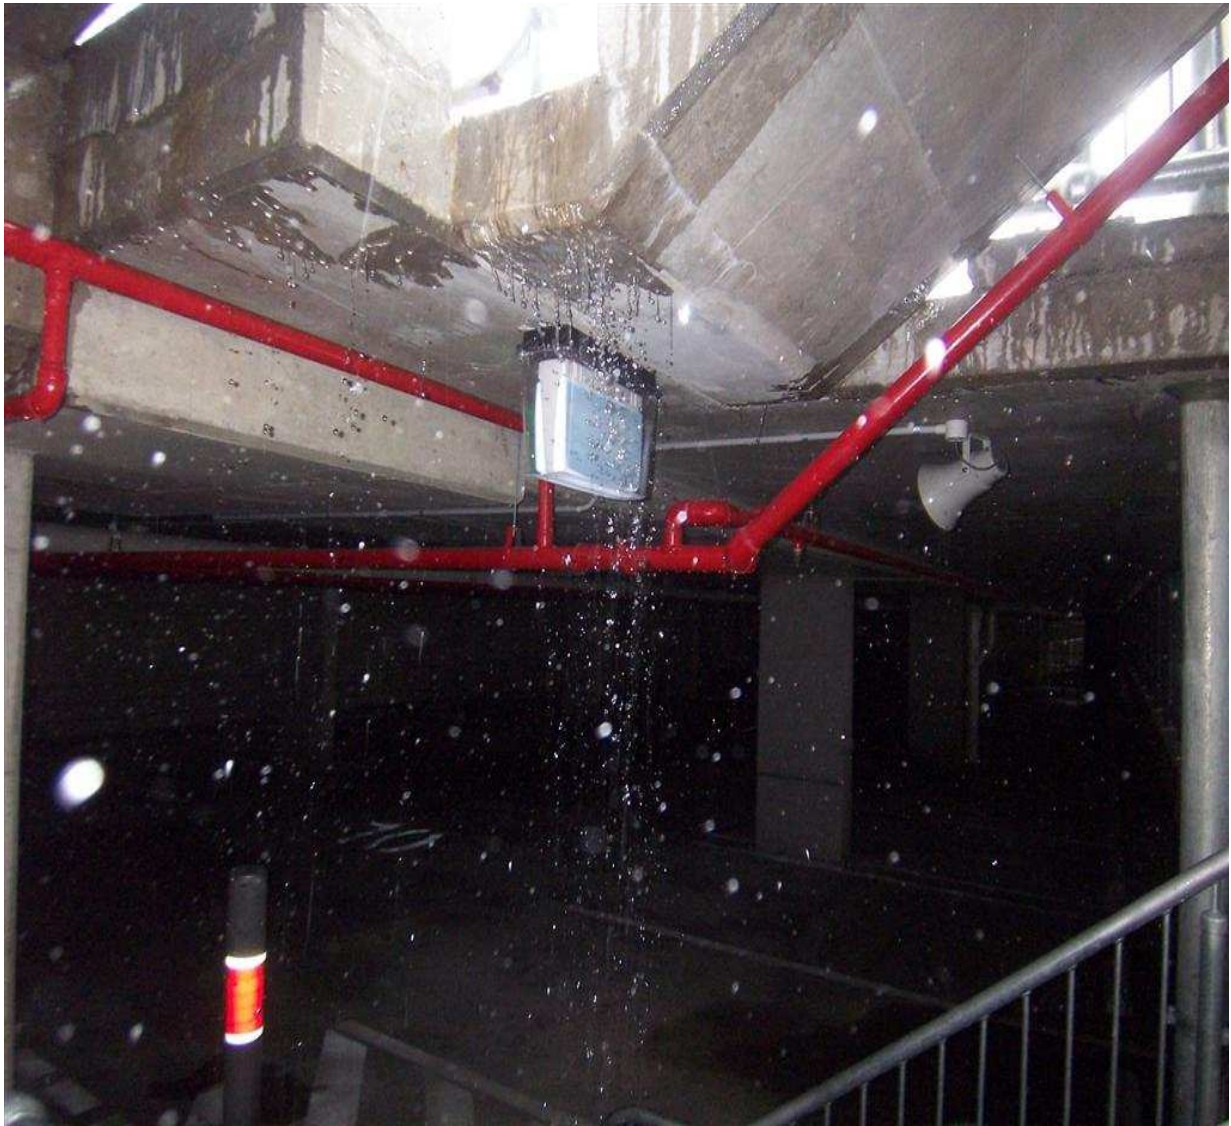
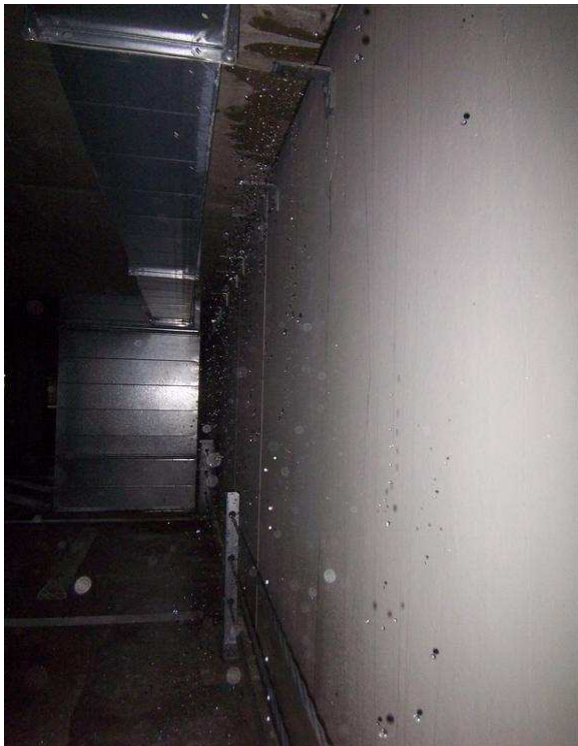
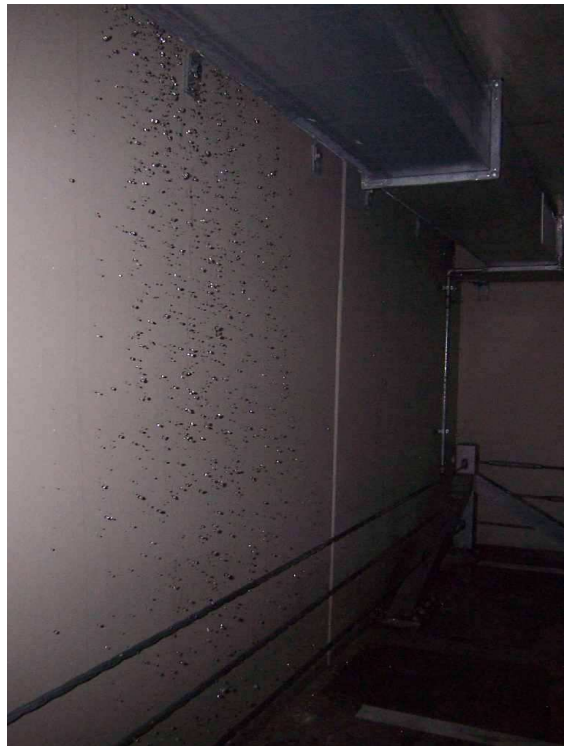
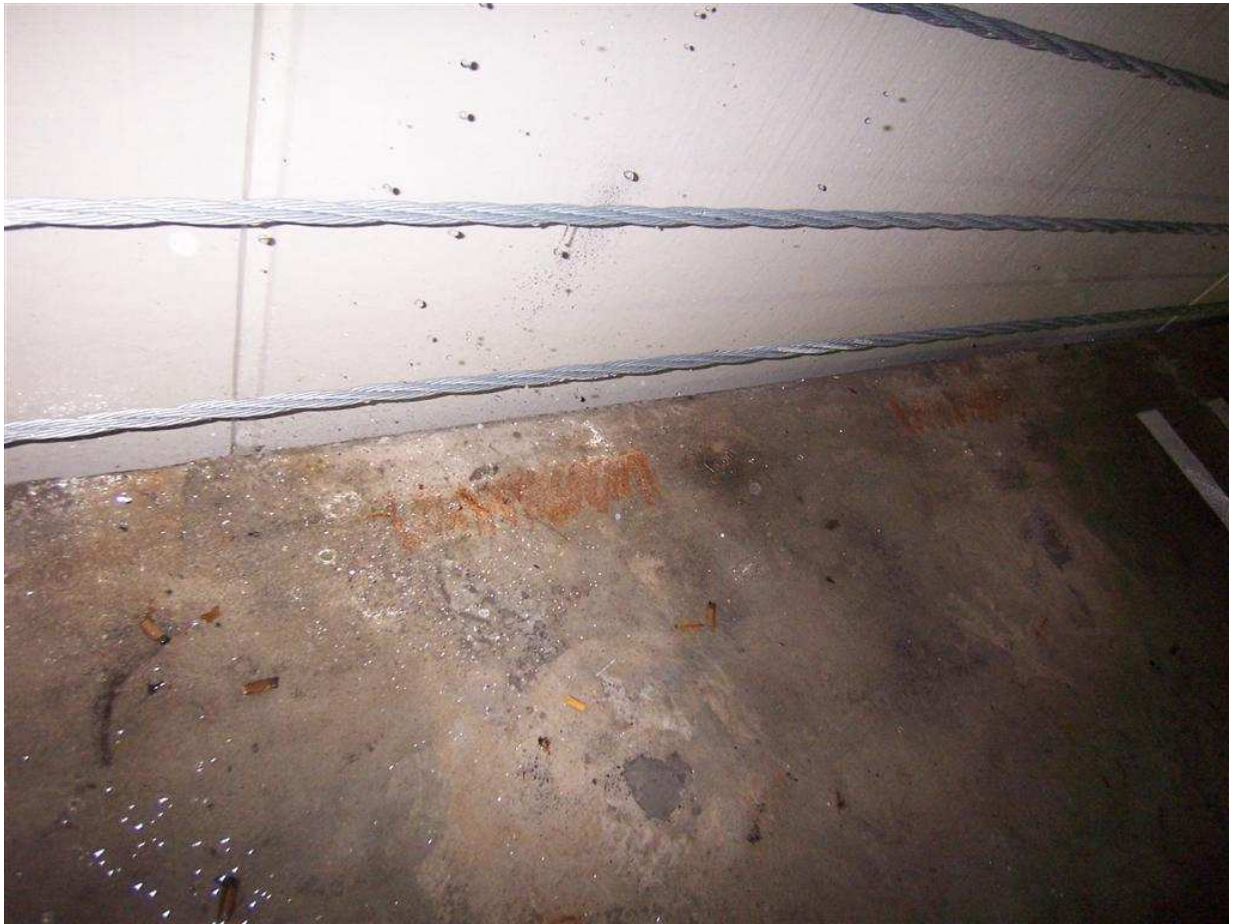
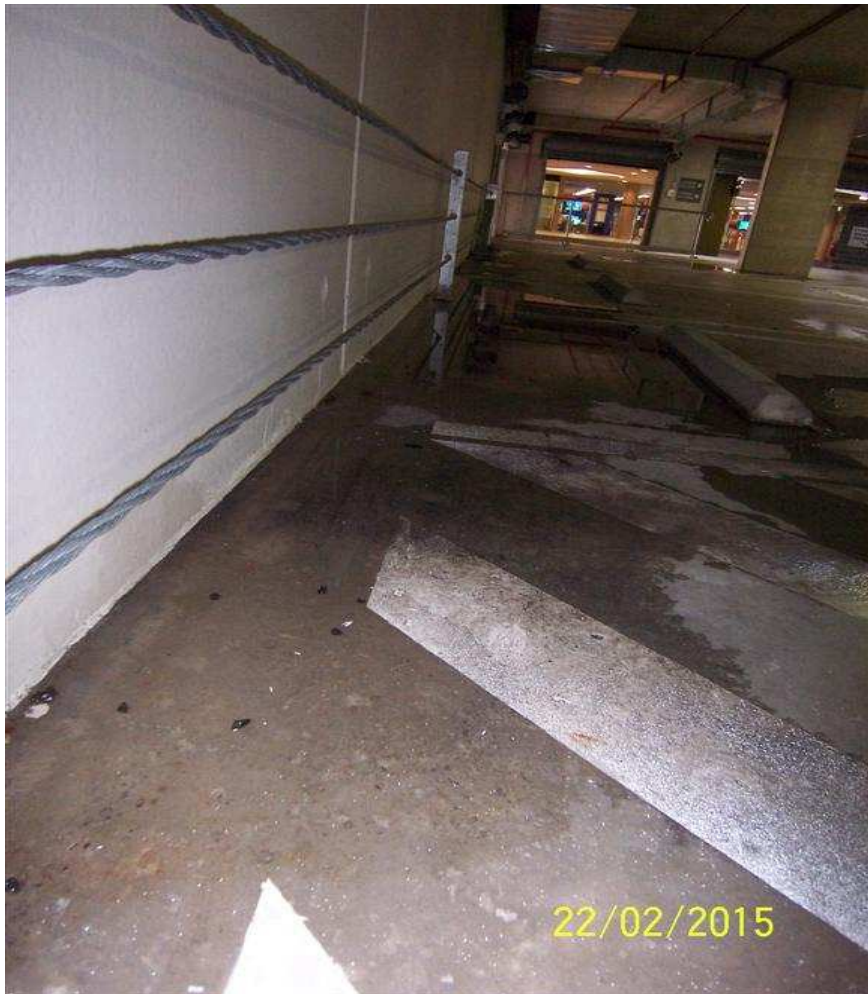
Rainwater entering car park

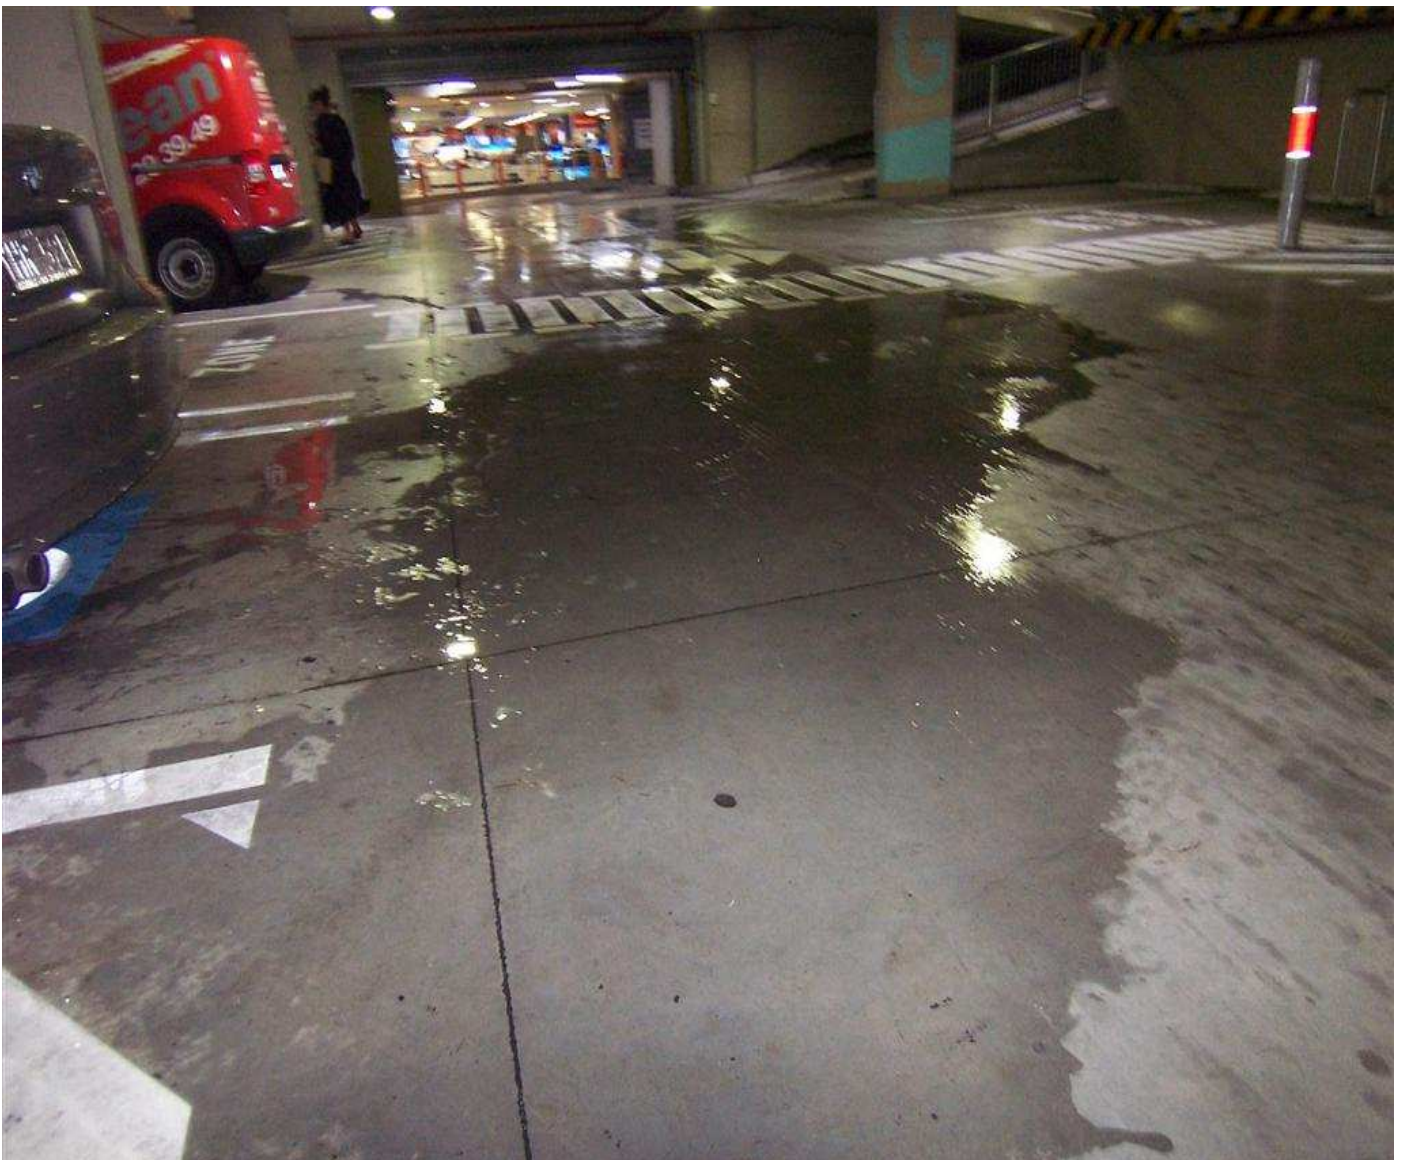
1) The smooth finished car park areas

The car park floors have been constructed with a smooth steel trowel finish which when covered with water creates a dangerous situation for slipping, similar to trying to walk on an “ice skate rink”.

The photo below shows the regular puddle where one of our committee members slipped with both feet on this smooth finish level concrete resulting in a back injury.

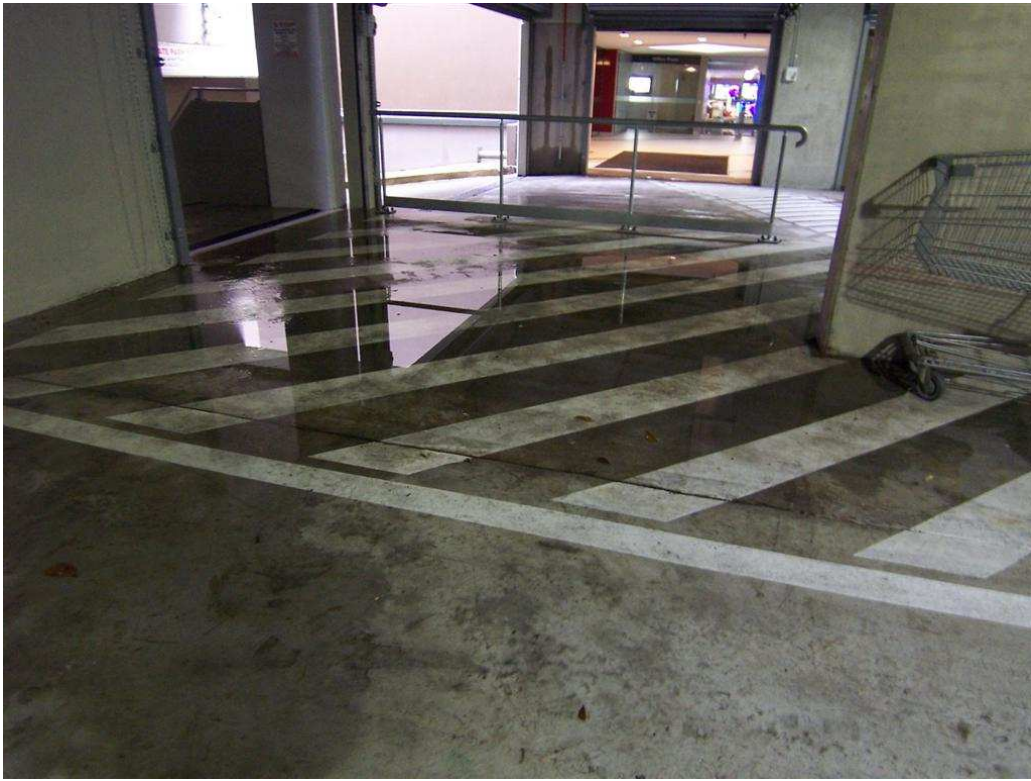
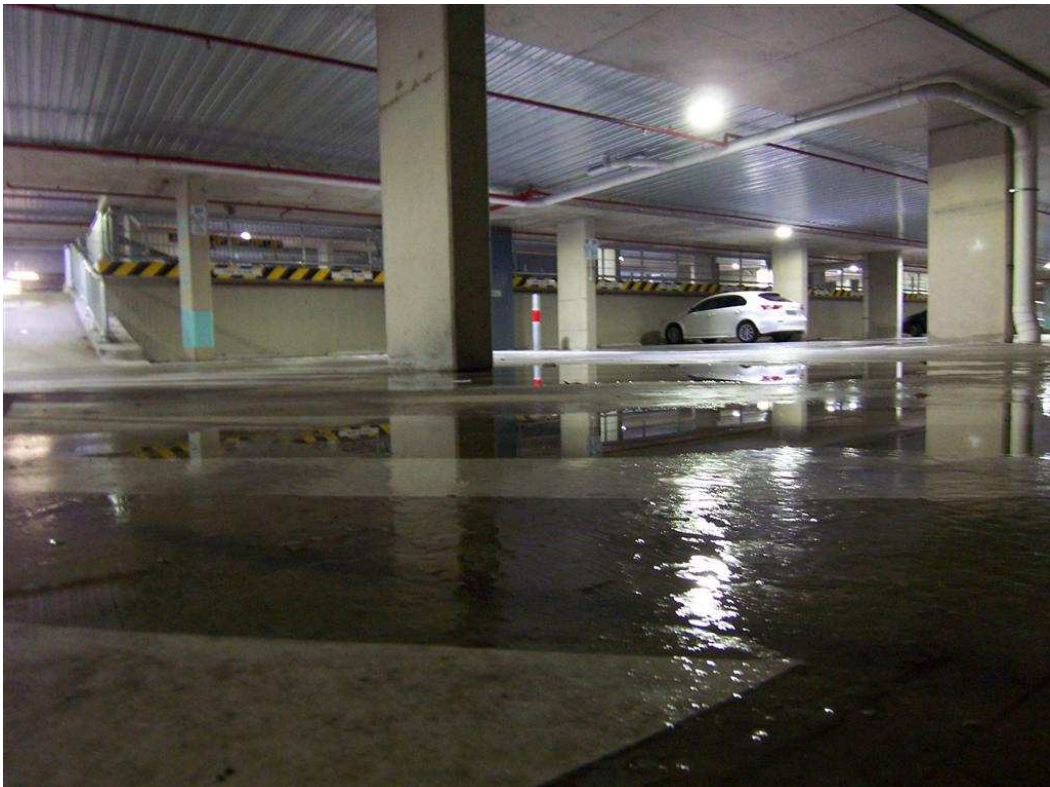
2) The steep, tiled steps and landing accessing the adjoining Aurora Building (Salvo's Shop)

This water remains here for weeks after a rain event.

The photos above and below show the regular puddle of water at the top of the stairs and the water on top of the tiled stairs and landing.

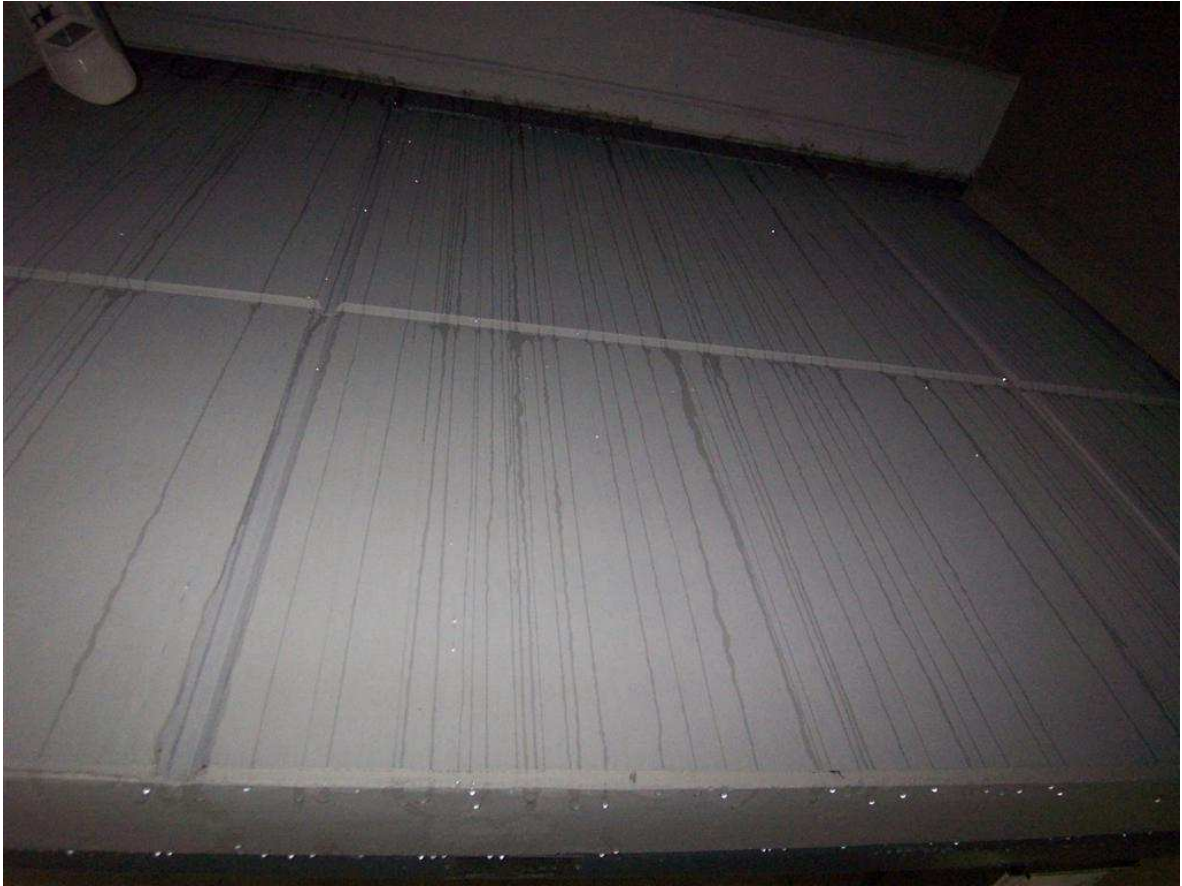
The next photo shows water flowing from above on the inside and outside of the building above the entrance to the Aurora Building.

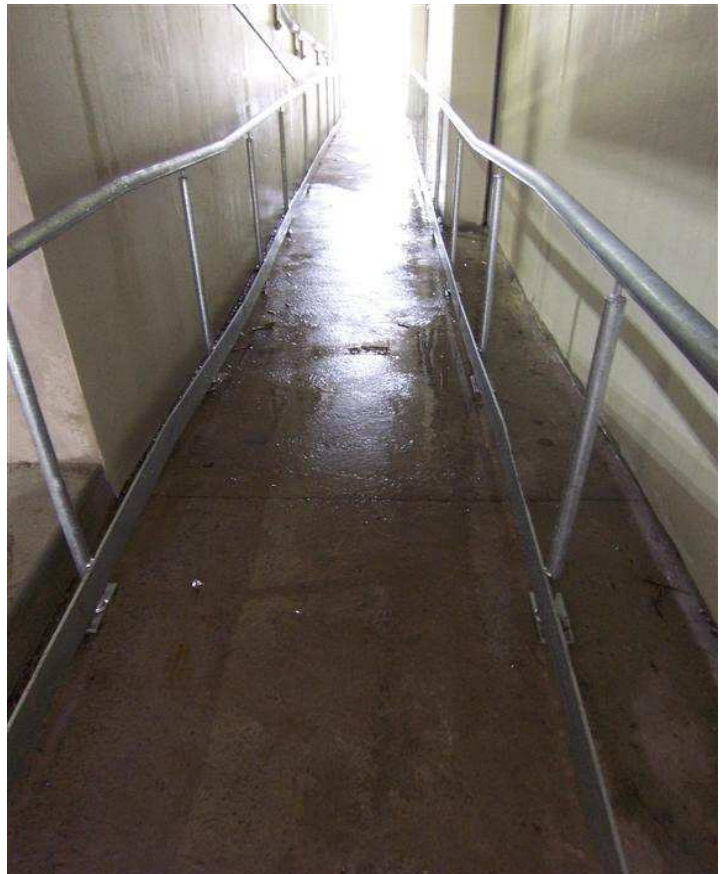
3) The Disabled Access Ramp.

The main pedestrian exit / entry ramp to the lower ground level is extensively flooded whenever it rains

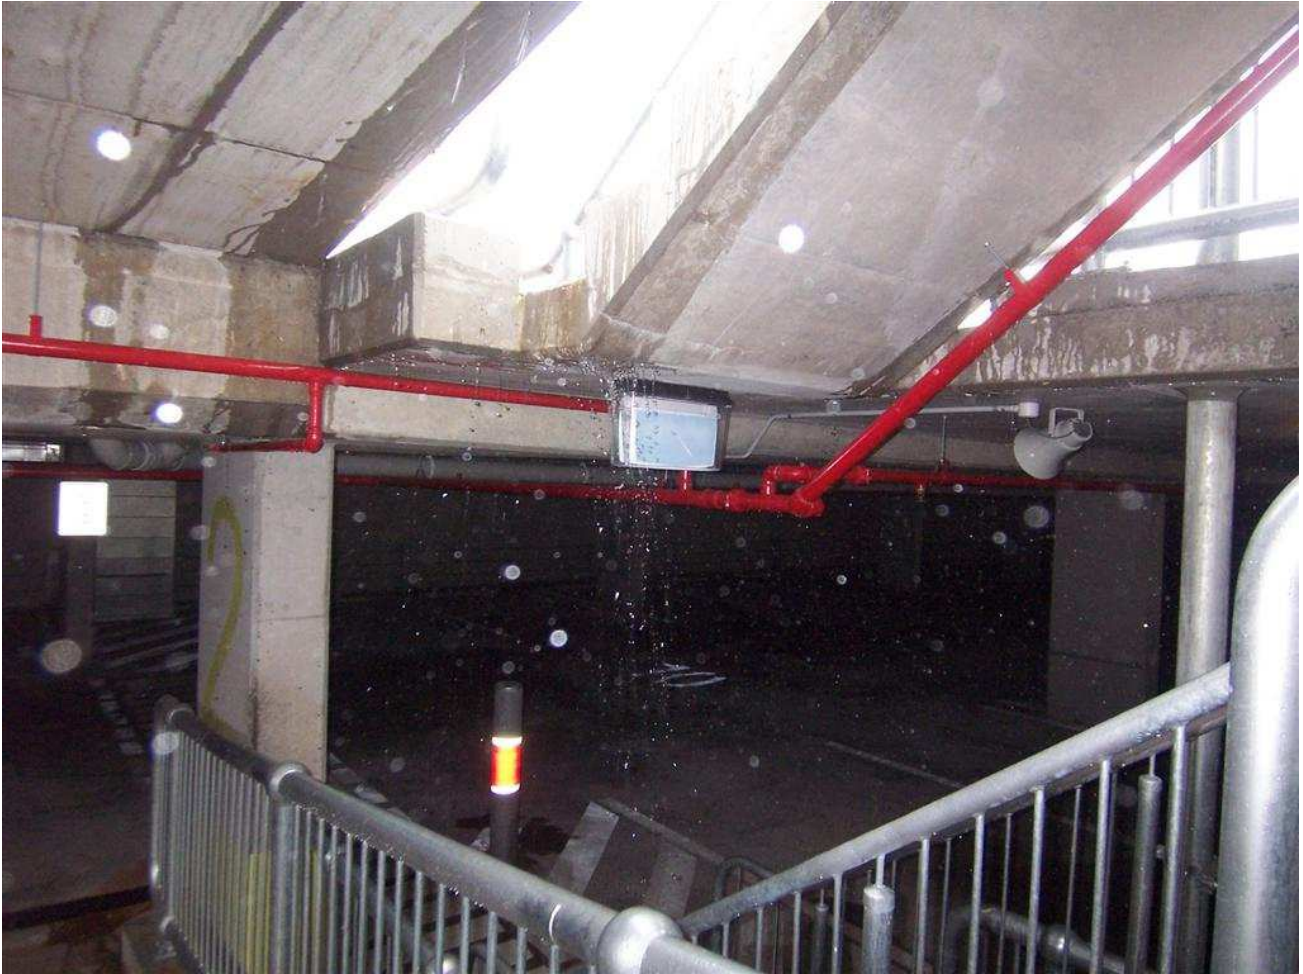
4) The Internal Stairs

Water floods into the car park from the roof top level

This results in the “*unsafe situation*” of steps on each level of the car park being wet.

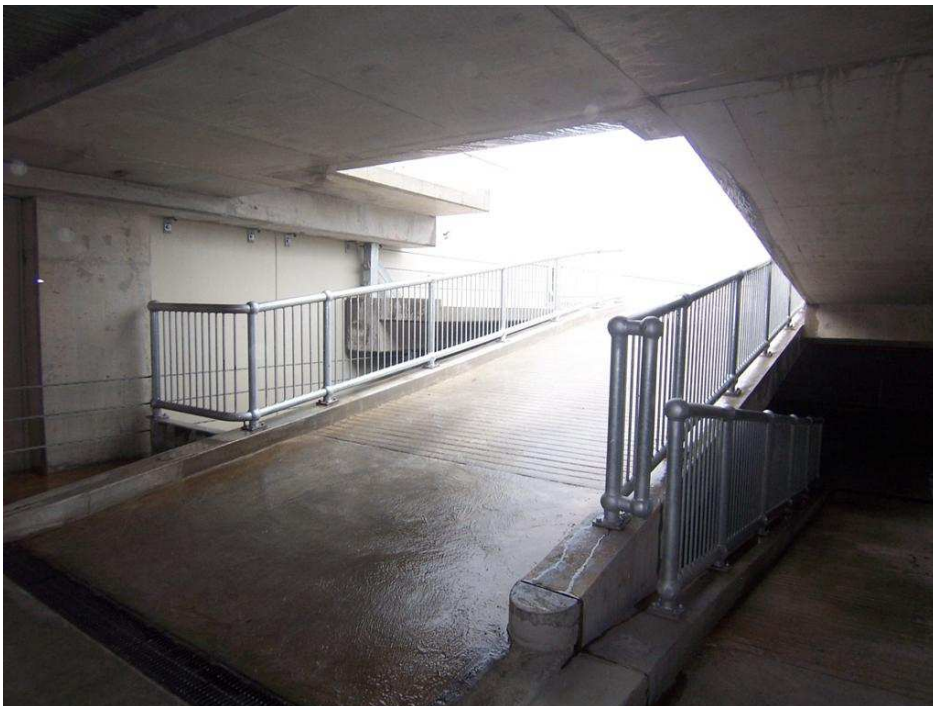
- 5) The internal vehicular ramps, which become flooded are “*unsafe situations*” as they are used extensively by pedestrians.

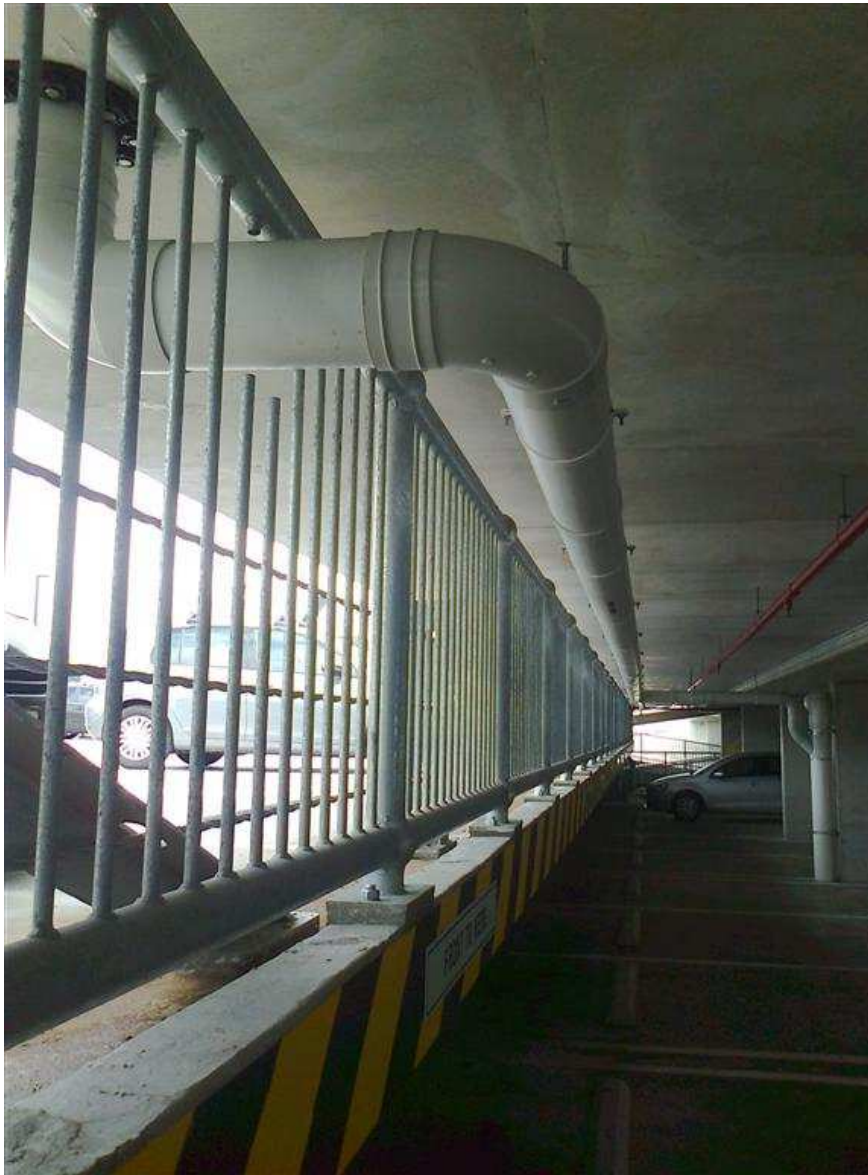
The builders have obviously been aware of this problem and have installed two extra drains along the eastern edge of the upper roof top level as shown below.

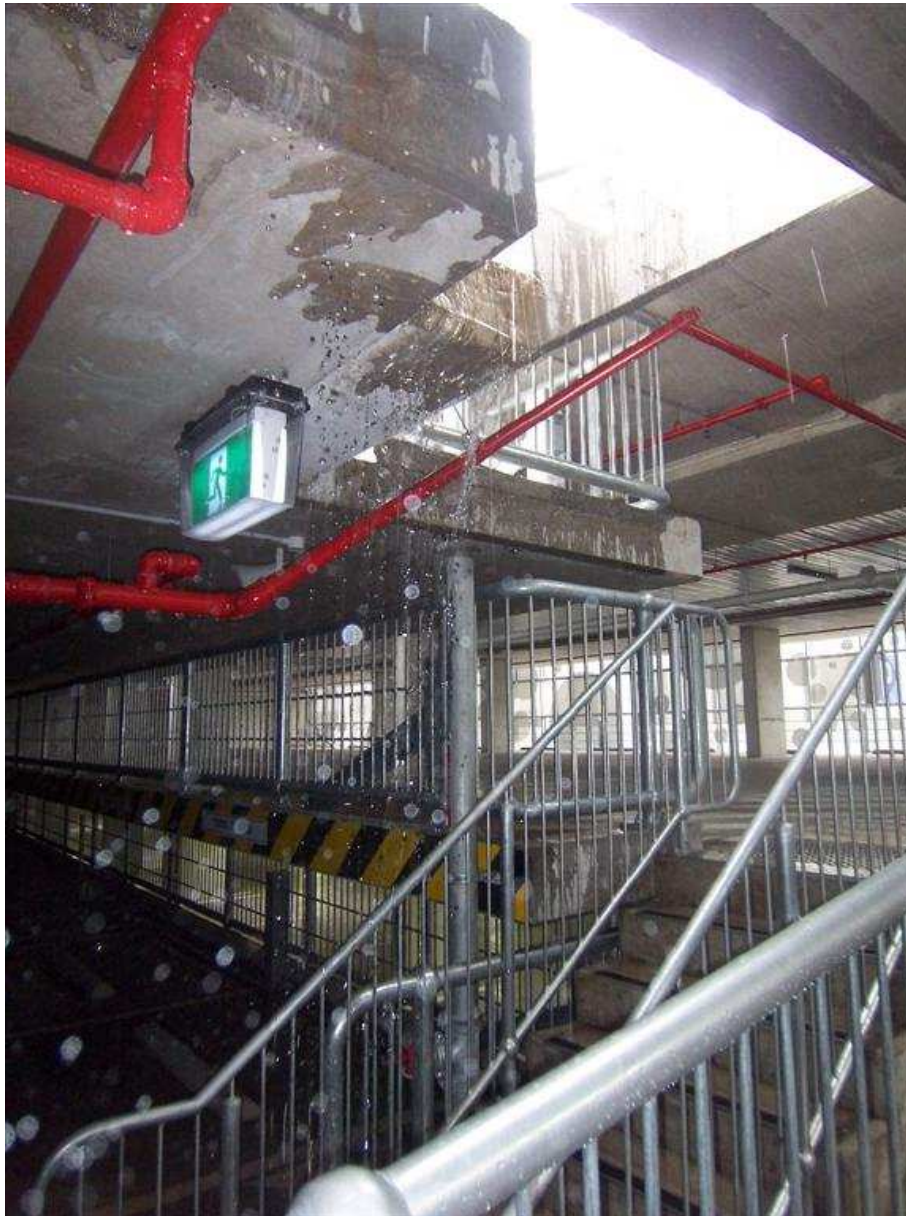
A levels survey of the roof top lower level, north western corner shows the collapse of the center level.

As a result of the levels shown in the survey above, the photo below shows the roof top flooding in the north west corner of the lower roof top level.

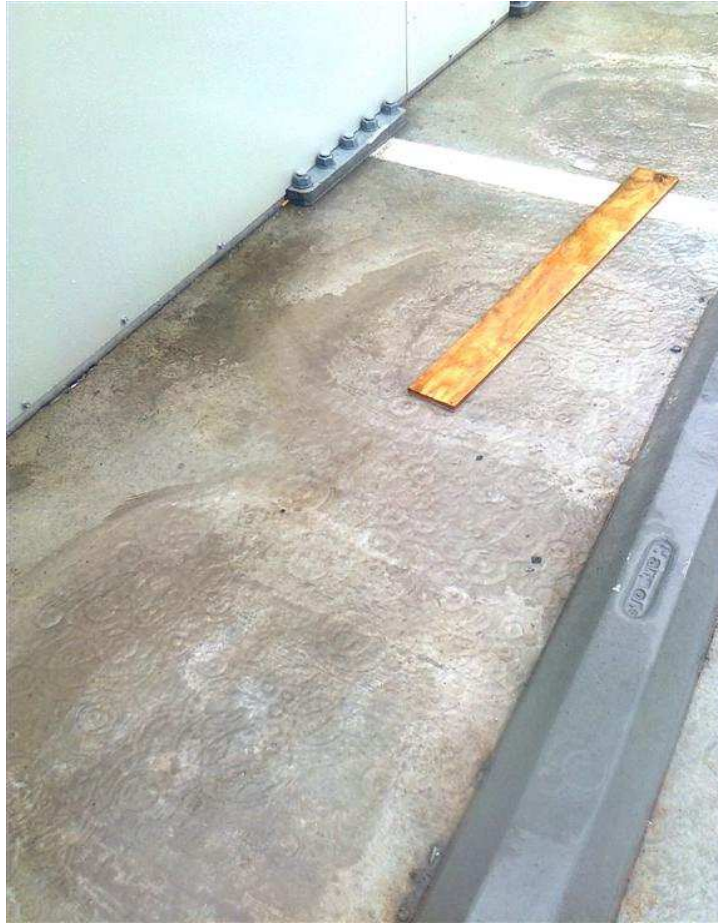
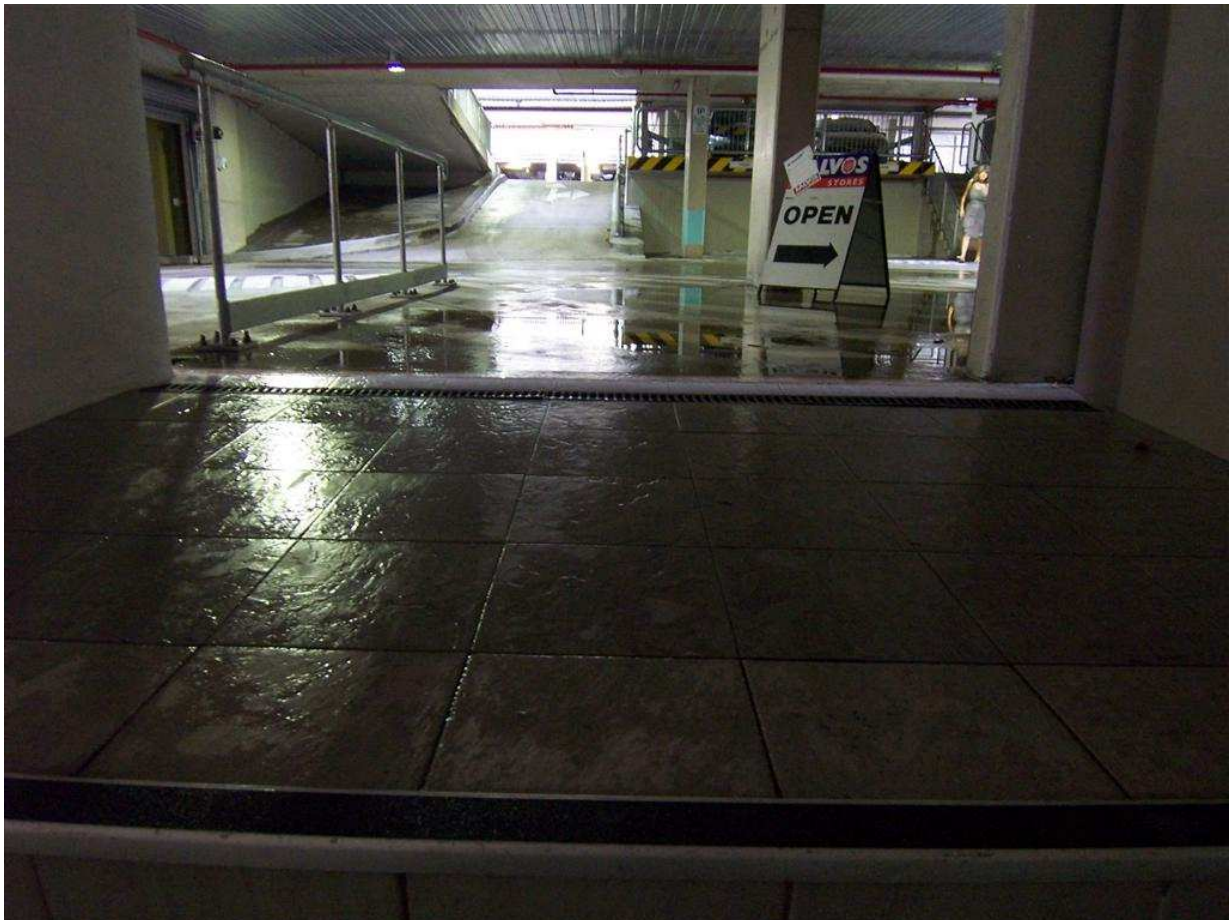
A levels survey of the roof top lower level, south eastern corner shows the collapse of the canter lever causing the major flooding over the landing and steps into the Aurora Building (Salvo's Store).

As a result of the levels shown in the survey above, the roof top flooding shown in the photo immediately below, results in the flooding of the entrance to the Aurora Building shown in the next photo below (the piece of wood shown is floating)

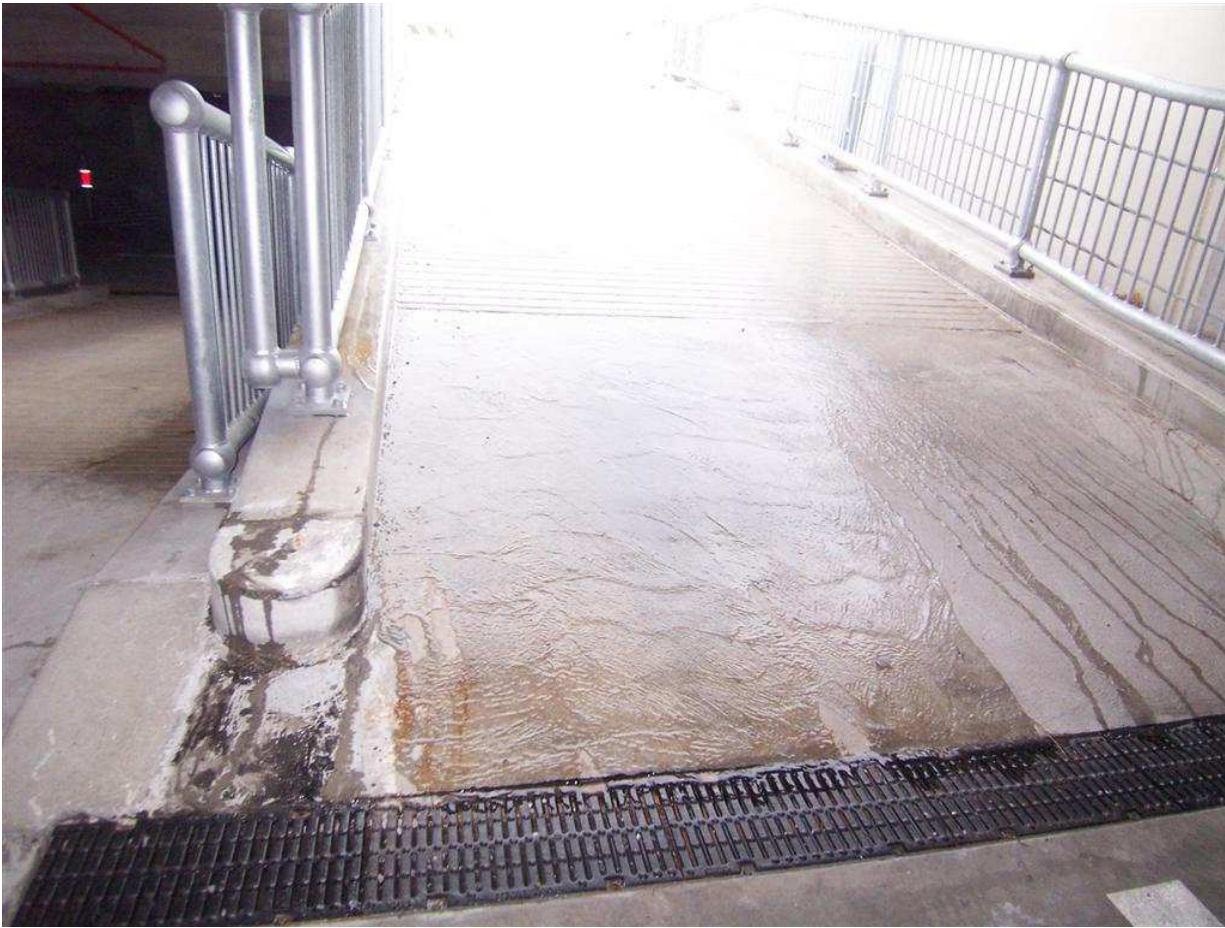
Flooding due to low level top of exit ramp (-7mm as indicated in the levels survey)

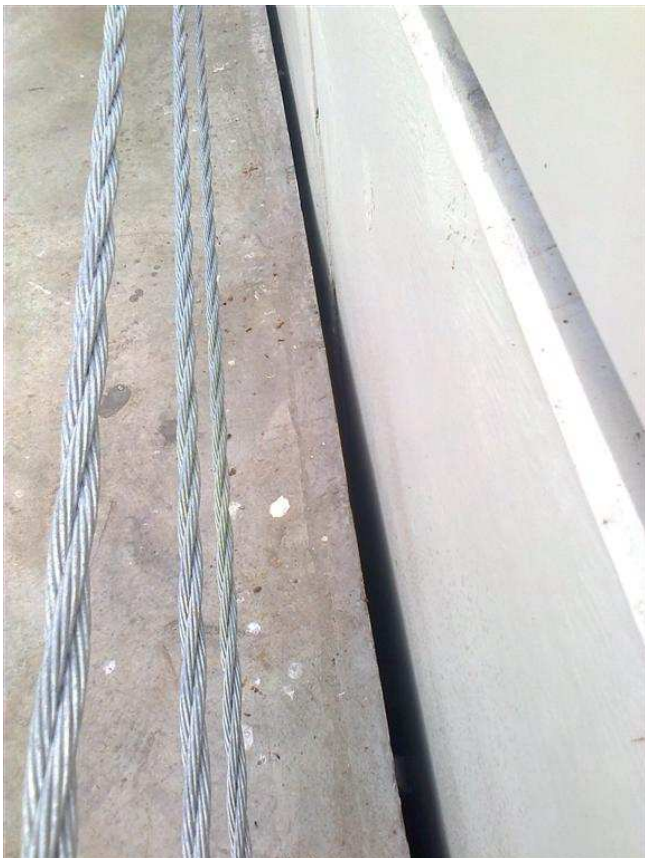
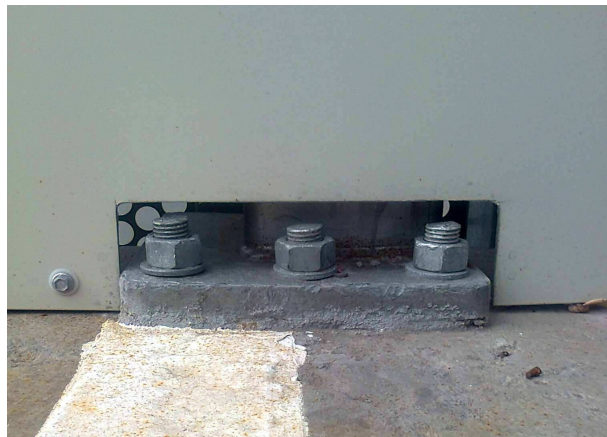
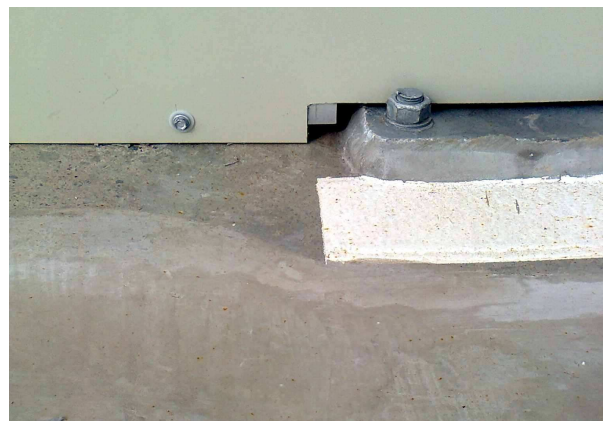
There is no flashing between the exterior walls and the car park floors, (which would not have been so necessary if the canter levers had not collapsed).

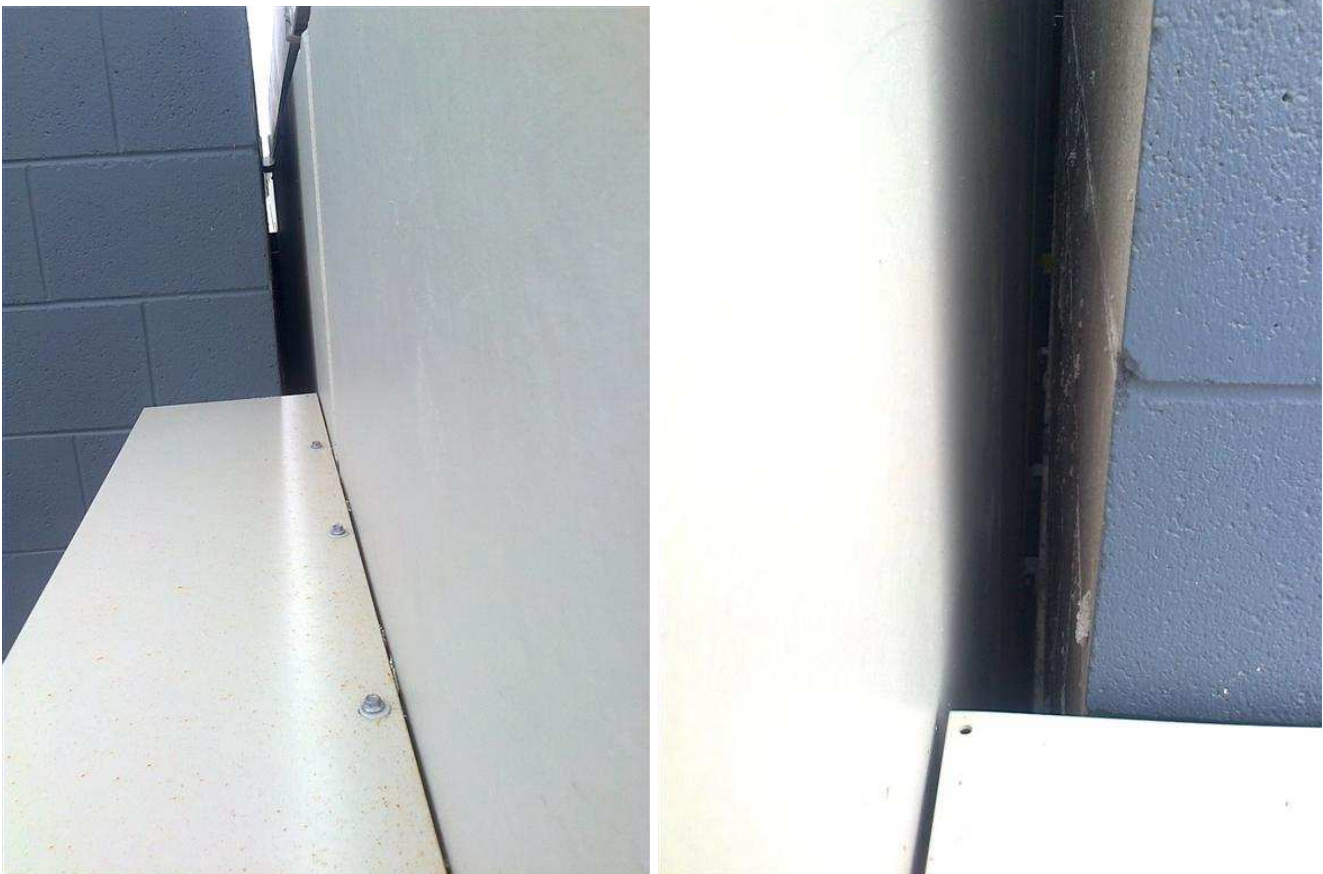
There is no flashing between the plant rooms and the exterior wall

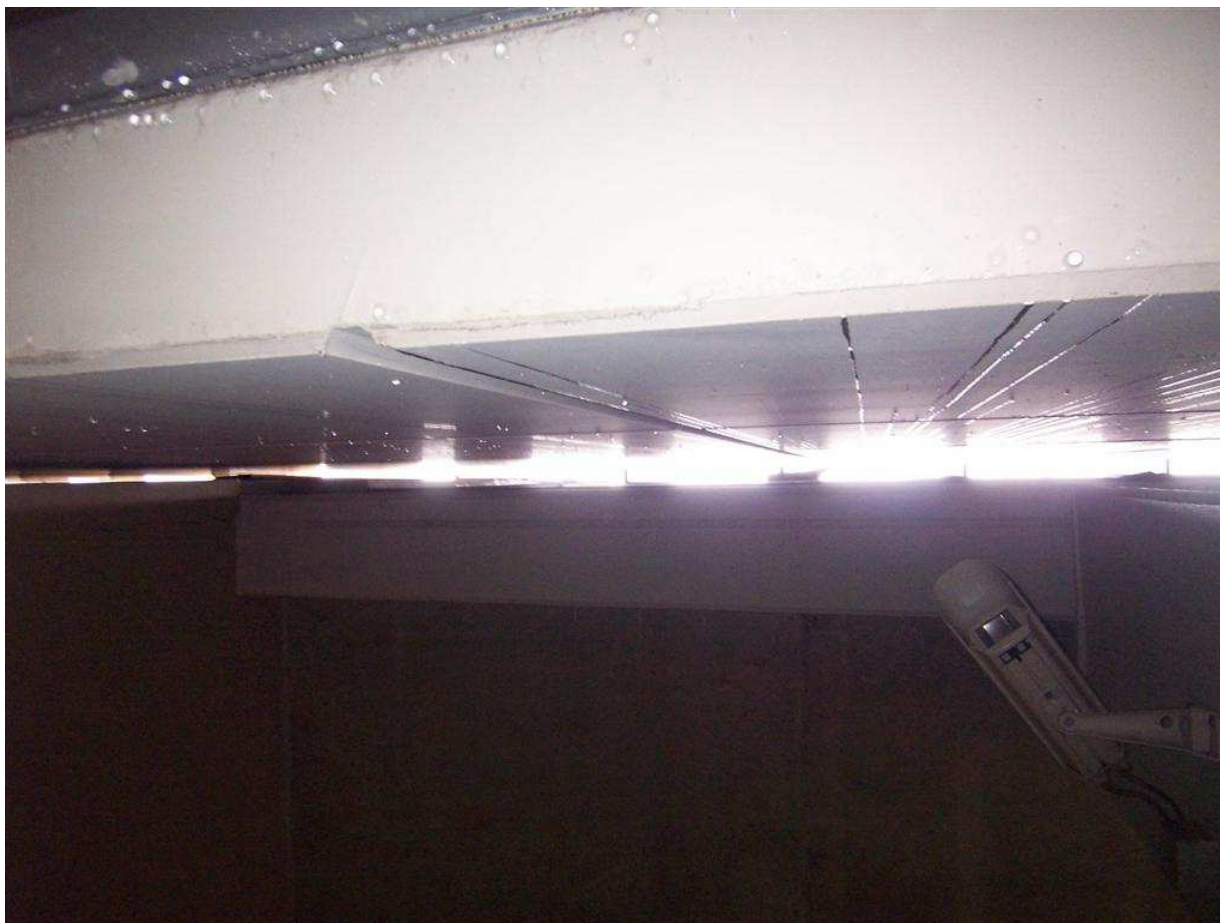
The photo shows looking up, the gap between the car park and the Aurora Building
