- MONA VALE BOLLARD CENTRAL -

**THE GENERAL MANAGER – MARK FERGUSON –
CONTINUES HIS “FINE TUNING”
OF THE MONA VALE POST OFFICE CAR PARK
(with no access to the Post Office)
WITH A CLEVER COST SHIFTING TO THE PUBLIC**

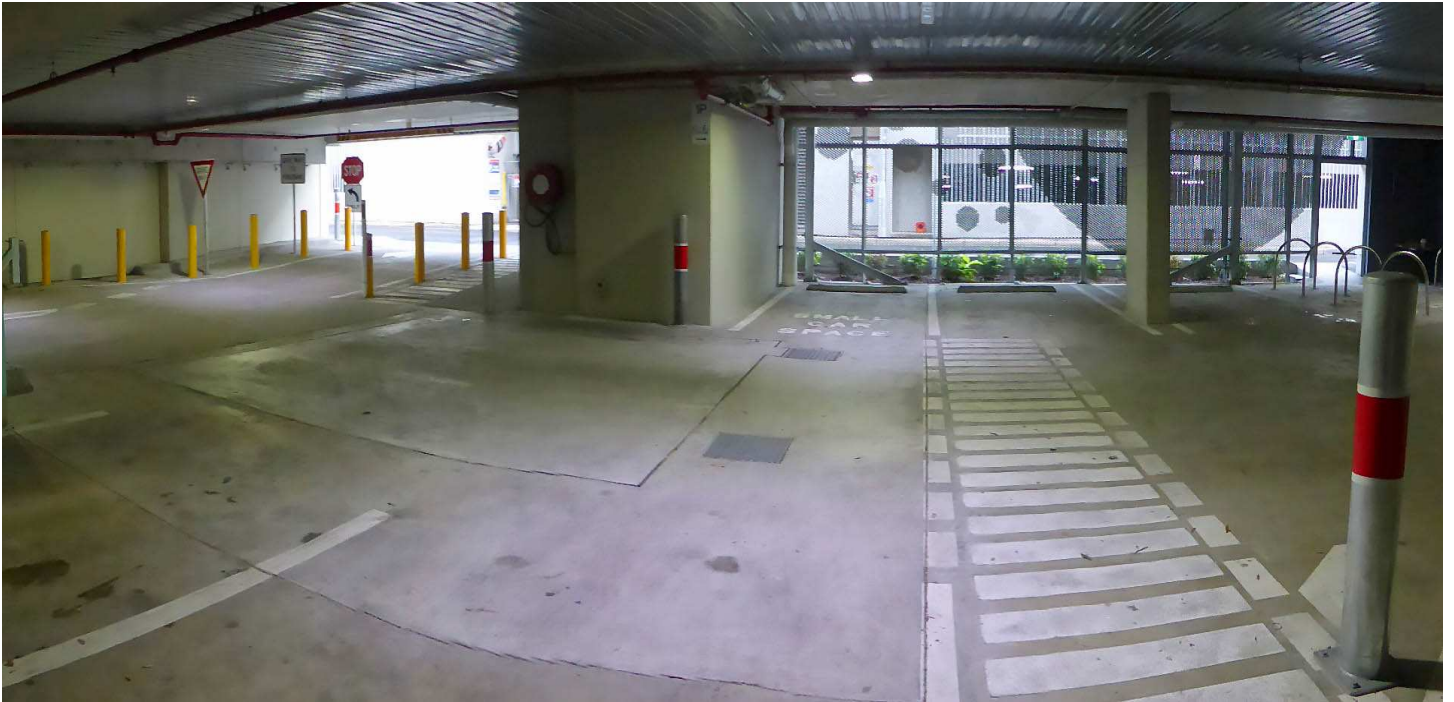
The use of bollards in this car park is excessive, 13 can be seen in just the one photo above.

Only 4 Bollards were permitted to be installed as per approved plans and these related to the Disabled Parking Spots. The remaining 62 Bollards that have been installed are therefore in breach of Consent Conditions.

This car park has been built with 90 degree parking and minimum circulating aisle width, causing problems when vehicles are reversed from their parking spaces.

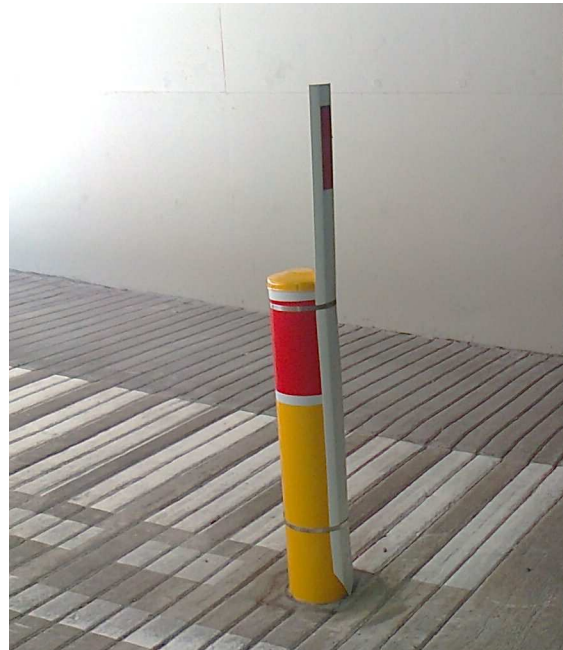
BOLLARDS RIGHT IN FRONT OF YOU BUT HIDDEN FROM YOUR SIGHT

This is the General Manager's *"Finely Tuned"* featured Bollard *"Number One"*. Drivers climbing the ascending exit ramp cannot not see these 900mm low height bollards at the exit until it is too late. Many near misses have been observed. Is this one of The Mayor's *"Quick Fixes"*, a plastic road marker with reflector was strapped to Bollard *"Number One"*. Given this *"Quick Fix"* was done late 2014 and has now been in place now for 5 months, is this Pittwater Council's *"Bandaid Solution"*, or is this the *"Final Solution"* ?

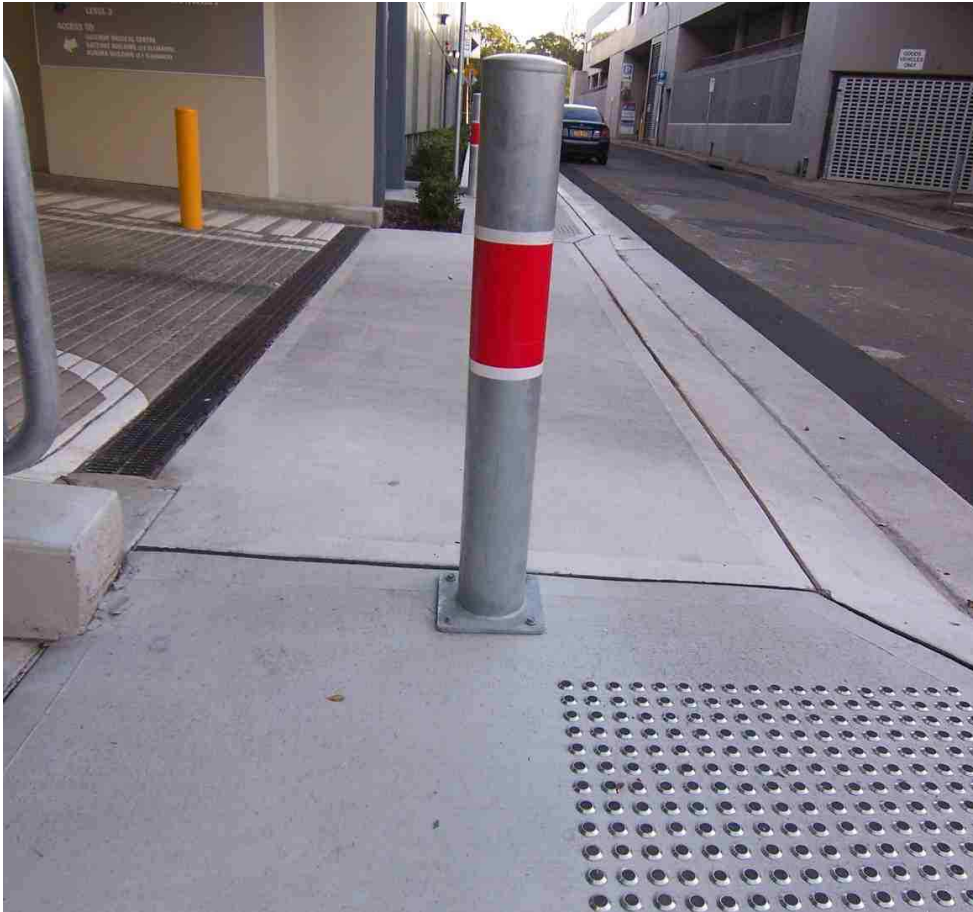
BOLLARDS IN THE FOOTPATHS

It is not only motorists that collide with bollards but also pedestrians. Four Bollards installed to the public footpath in Bungan Lane, which severely restricts the width at these points and pedestrians can now easily collide with the bollards in the street as well as in the car park.

This is the northern most bollard, and just look where Pittwater Council have installed it. Smack Bang right in the middle of the footpath resulting in a total impediment and danger for pedestrians.

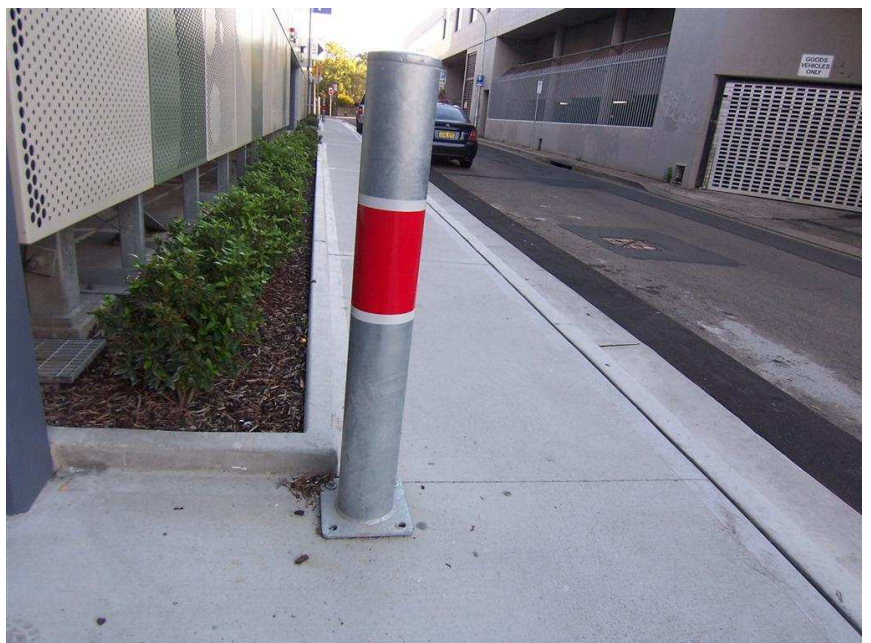
The next Bollard is located at the northern Fire Stairs exit. Unclear as to why it was installed like this protruding into the walkway zone and not further back towards the building so that danger to pedestrians colliding with it would have been reduced. Note the missing mounting bolts.

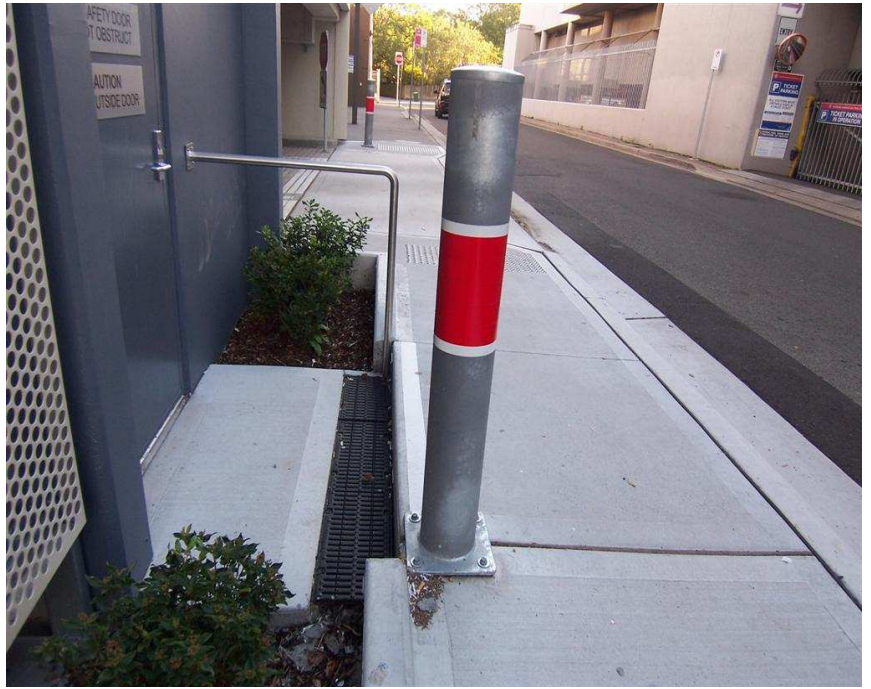
The third Bollard is located at the southern Fire Stairs exit.

Again this bollard encroaches into the pedestrian path of travel presenting as a danger to all going past.

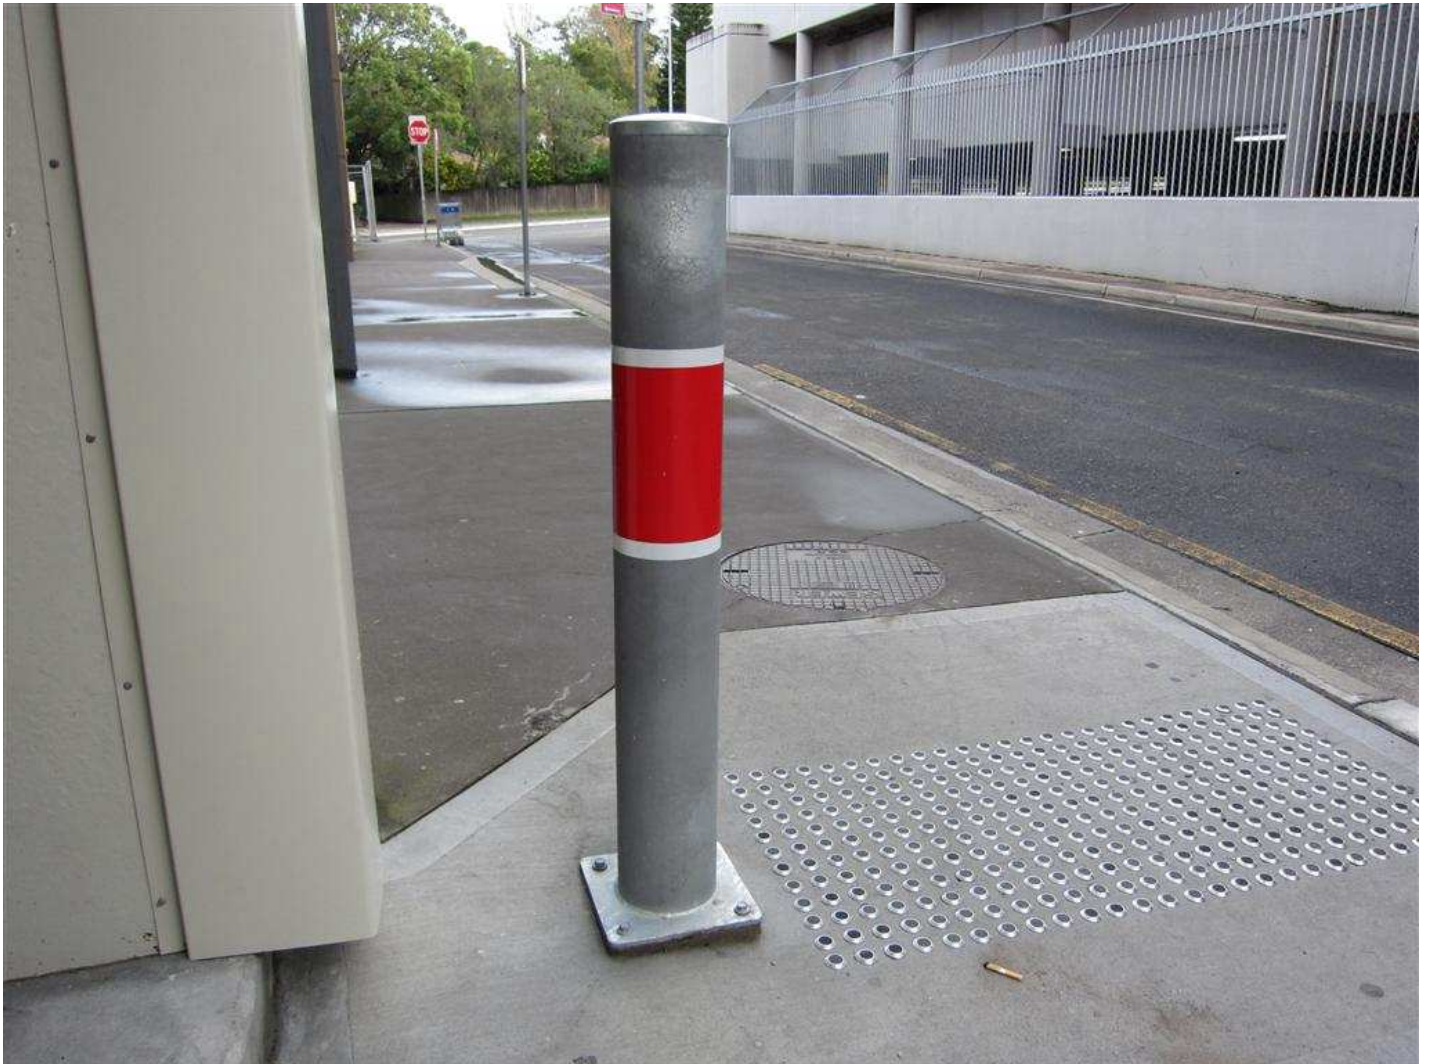
This is the fourth and southern most bollard located at the exit from the car park, it too is an obstruction and danger to pedestrians.

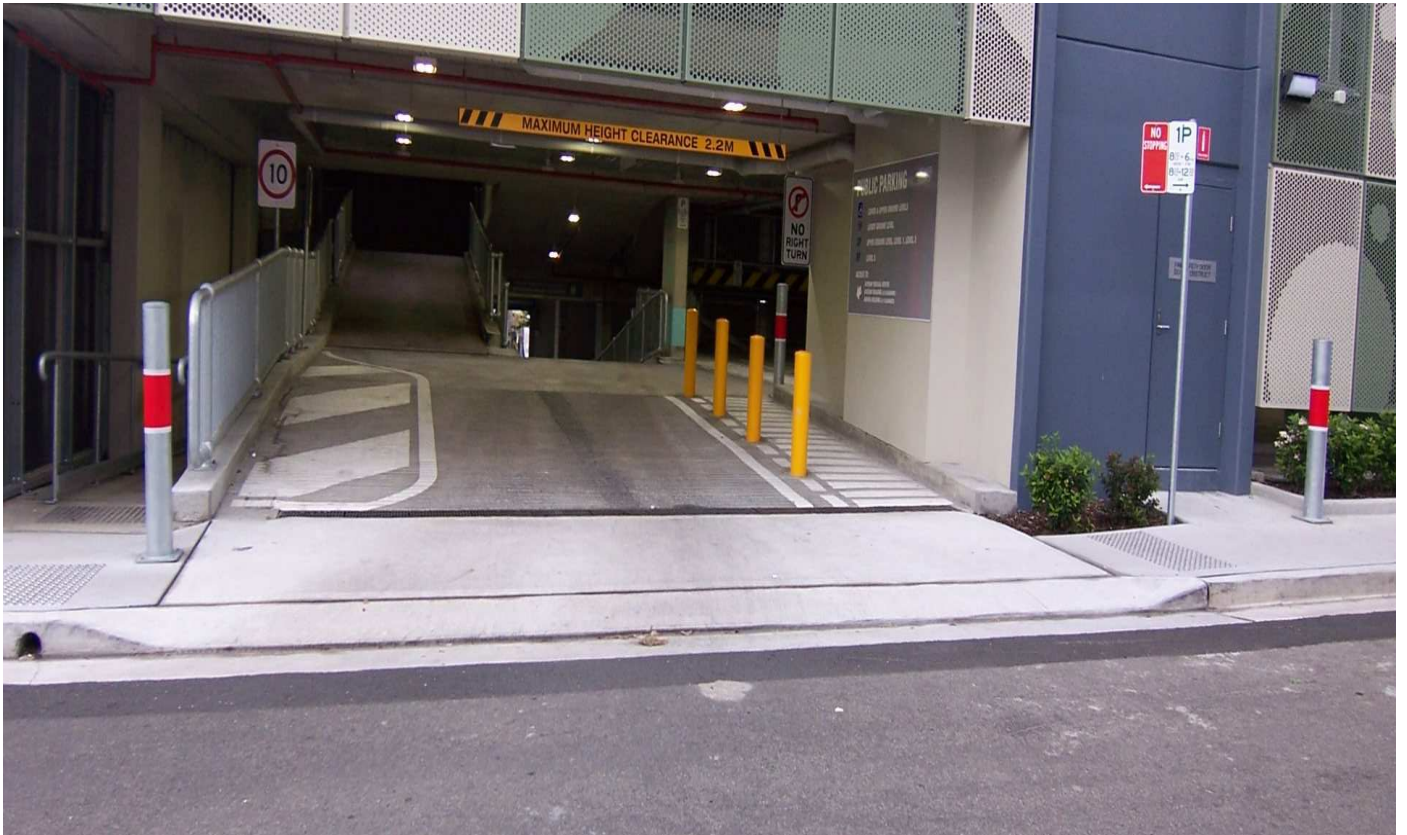
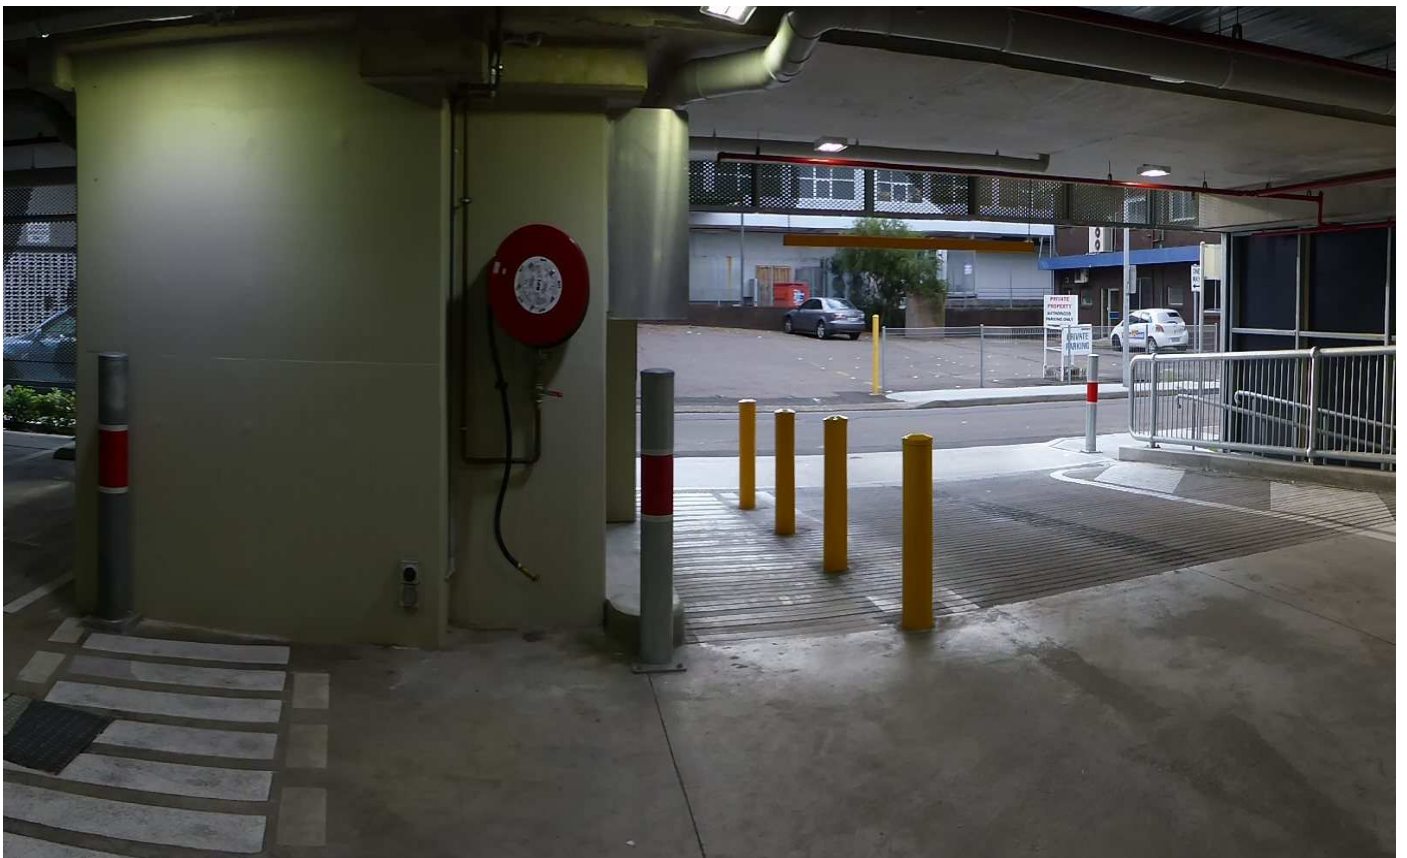
BOLLARDS AT THE ENTRY

As soon as you arrive at the new Pittwater Council Bungan Lane car park you are “Greeted” by the sight of no less than seven (7) Bollards for the start of your “Day of The Bollards” experience.

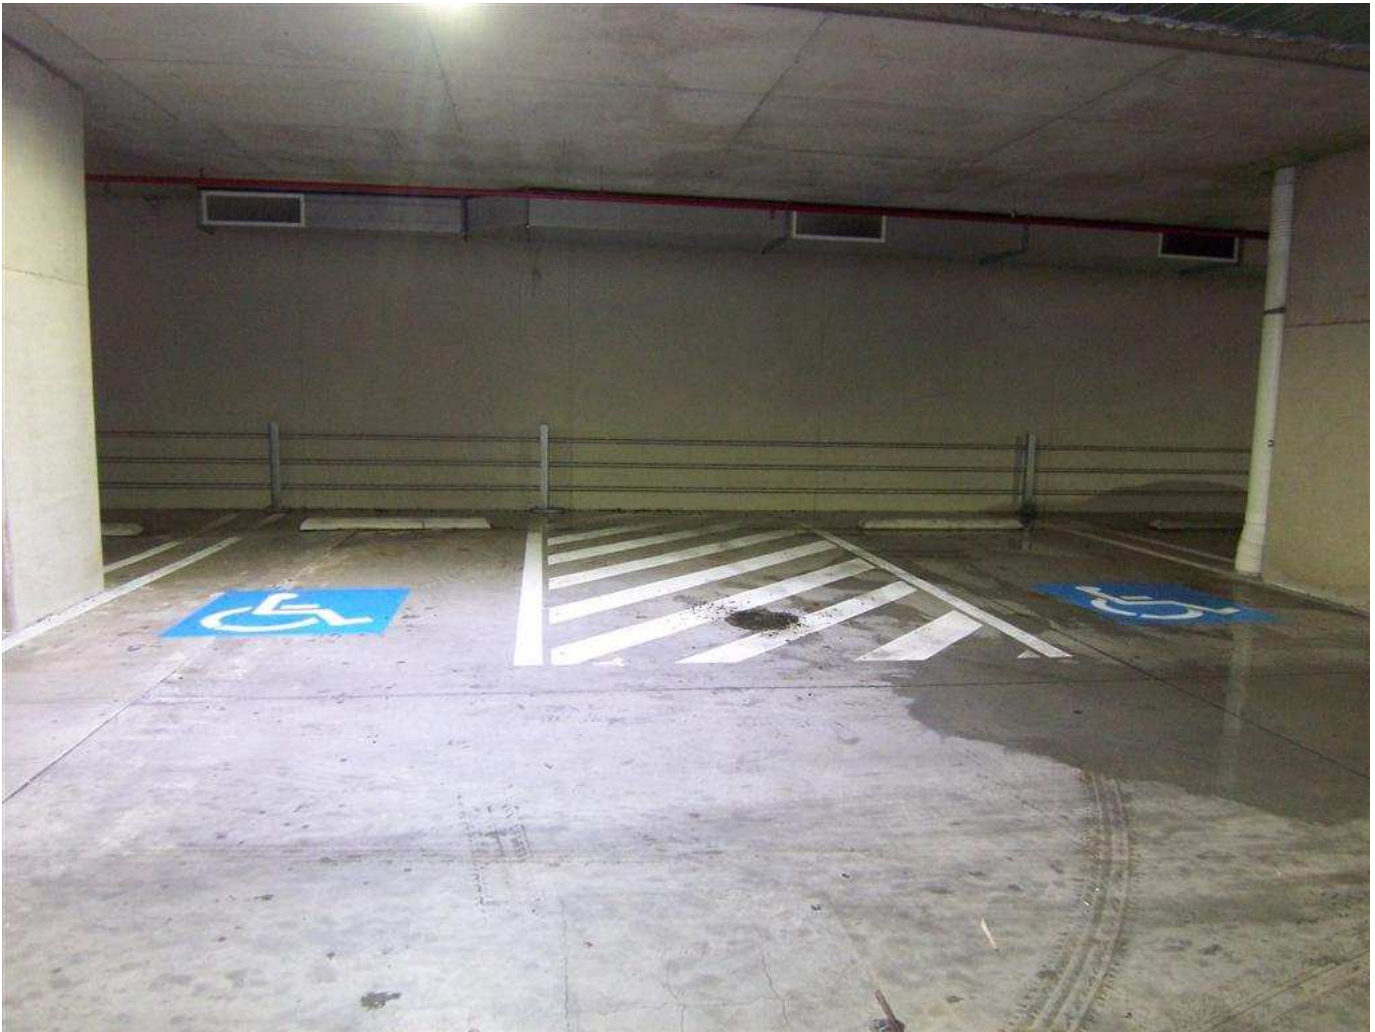
THE FIRST BOLLARD “FINELY TUNED” – LOWER GROUND LEVEL

The photo above was taken 3 January 2015, indicating the bollard was hit by a vehicle prior to this date and removed.

The bollard’s existence therefore lasted less than 2 weeks of operation of the new car park.

As of 17 May 2015 Pittwater Council has done nothing to replace this bollard in the 134 days or 4 months and 14 days (and still counting) since it was first observed “Gone”.

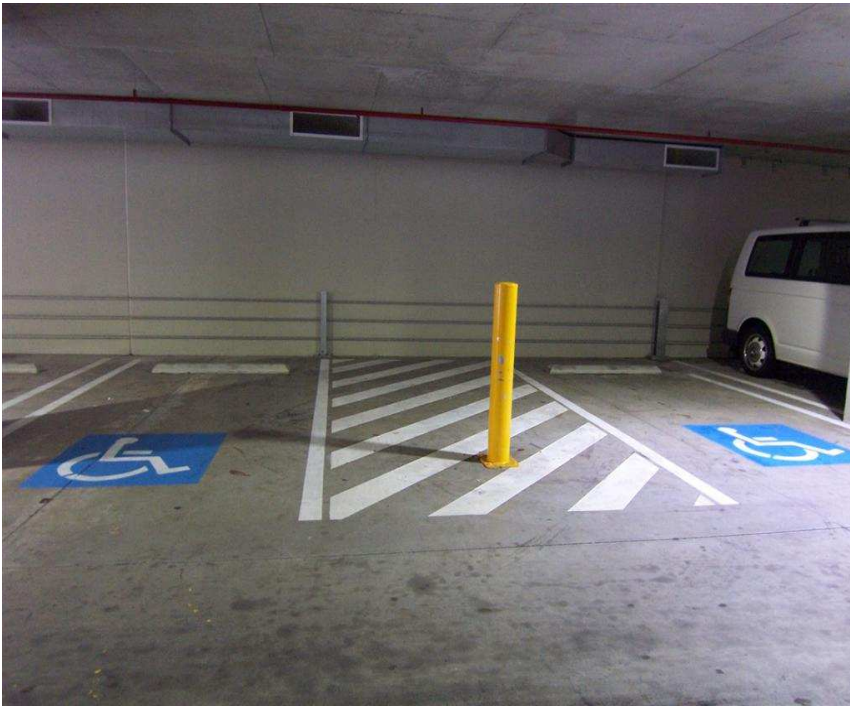
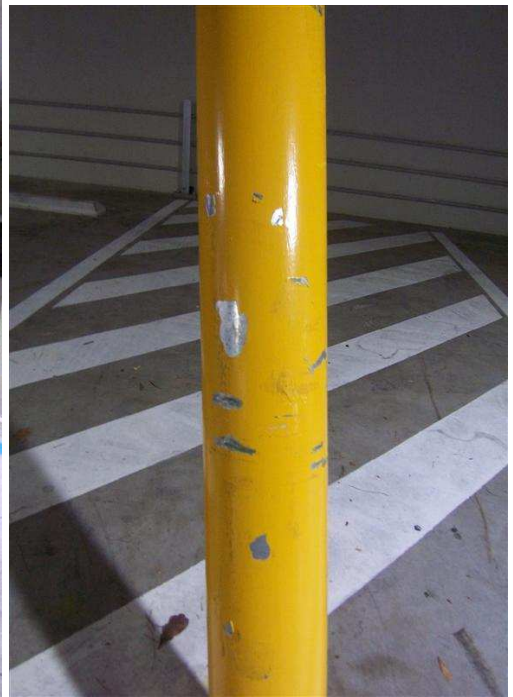
THE SECOND BOLLARD "FINELY TUNED" – LOWER GROUND LEVEL

The 2 photos above were taken 25 February 2015 indicating the "Bollard" is still there despite evidence shown in the close up of paint scrapes resulting from numerous hits by vehicles.

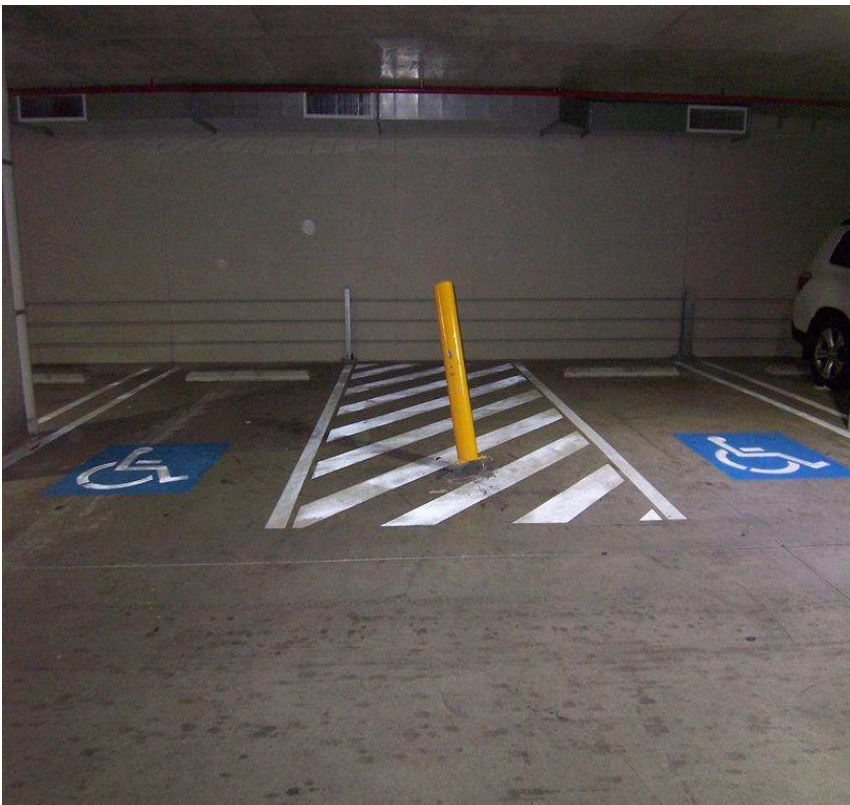
The 2 photos above were taken 1 March 2015 indicating that sometime within the next 3 days since 25 February the "Bollard" was "Finely Tuned" by a user of the car park and their vehicle.

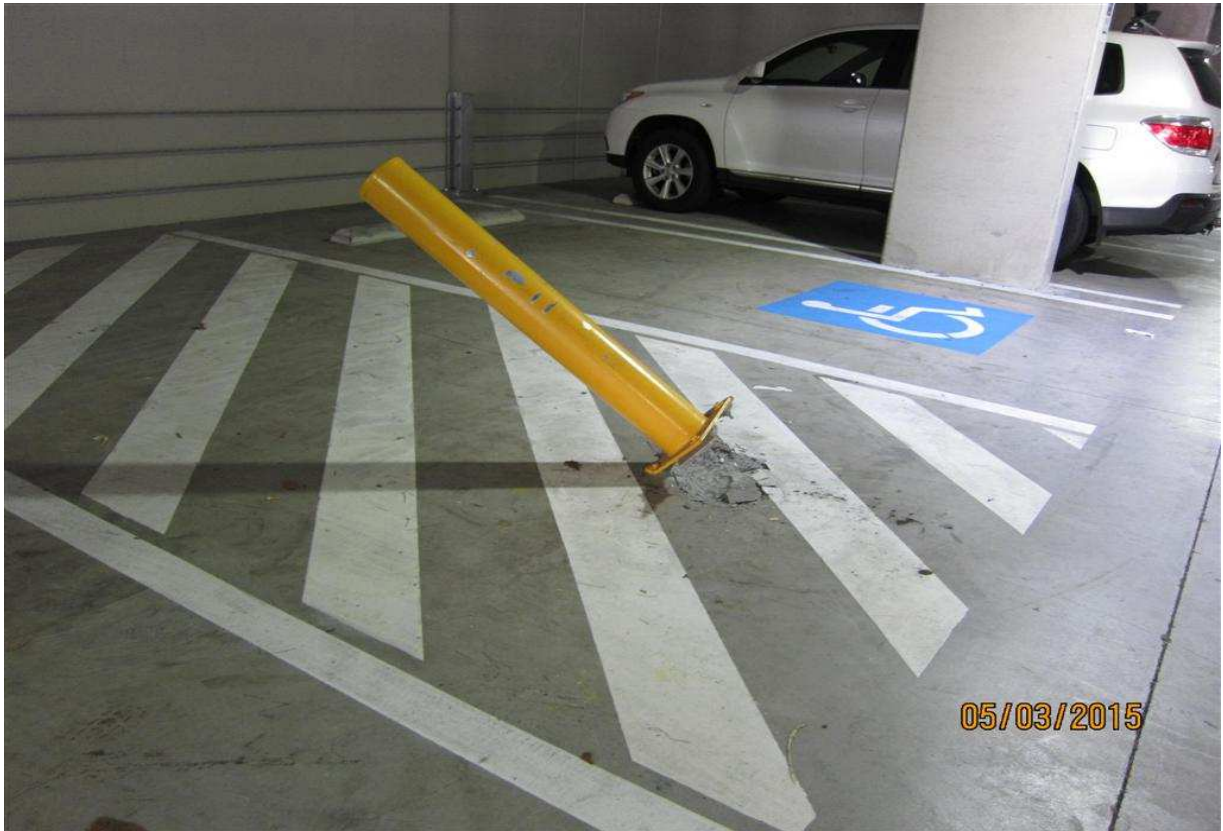
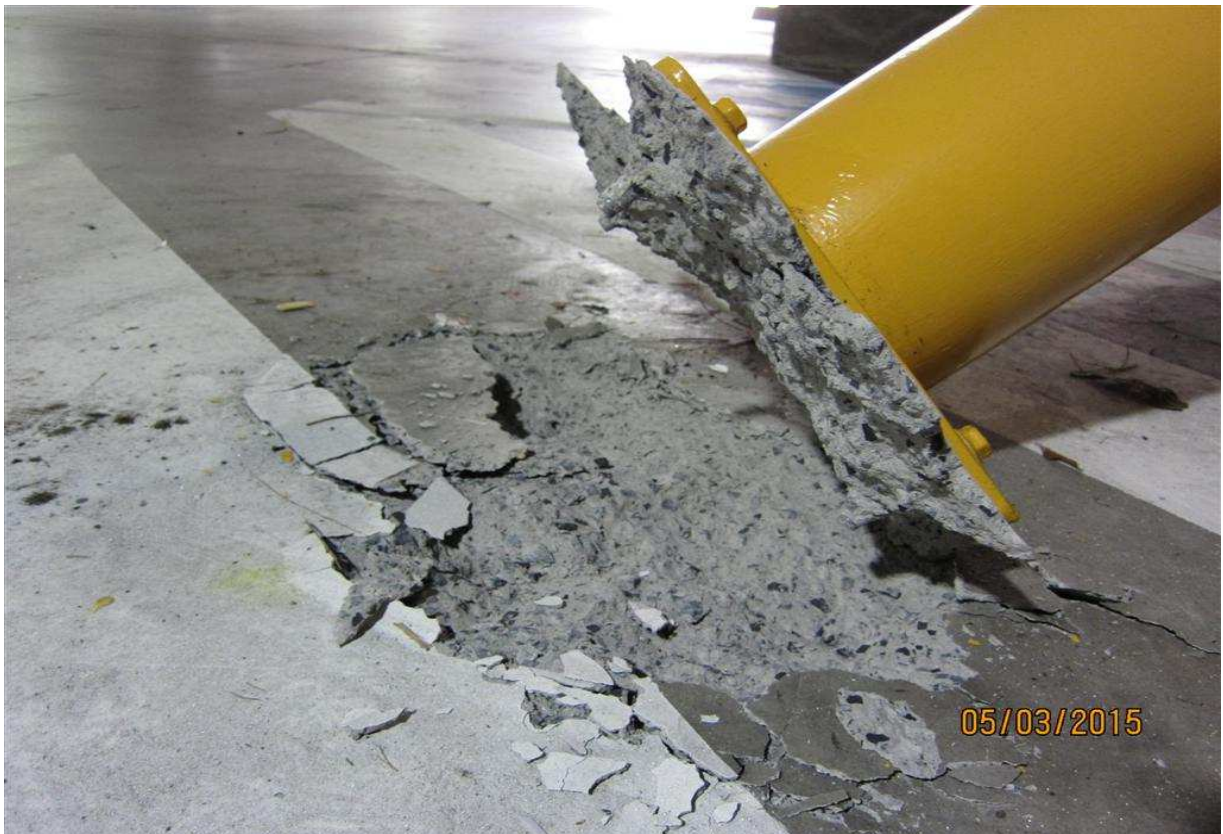
The 2 photos below were taken 5 March 2015 indicating that more "Fine Tuning" has been done in the last 4 days with the bollard leaning over even more after being hit yet again by another user of the car park and their vehicle.

As at 17 May 2015 Pittwater Council has done nothing to replace the bollard in the 77 days or 2 months and 16 days since it was first observed “*Finely Tuned*” and “*Gone*” not long after.

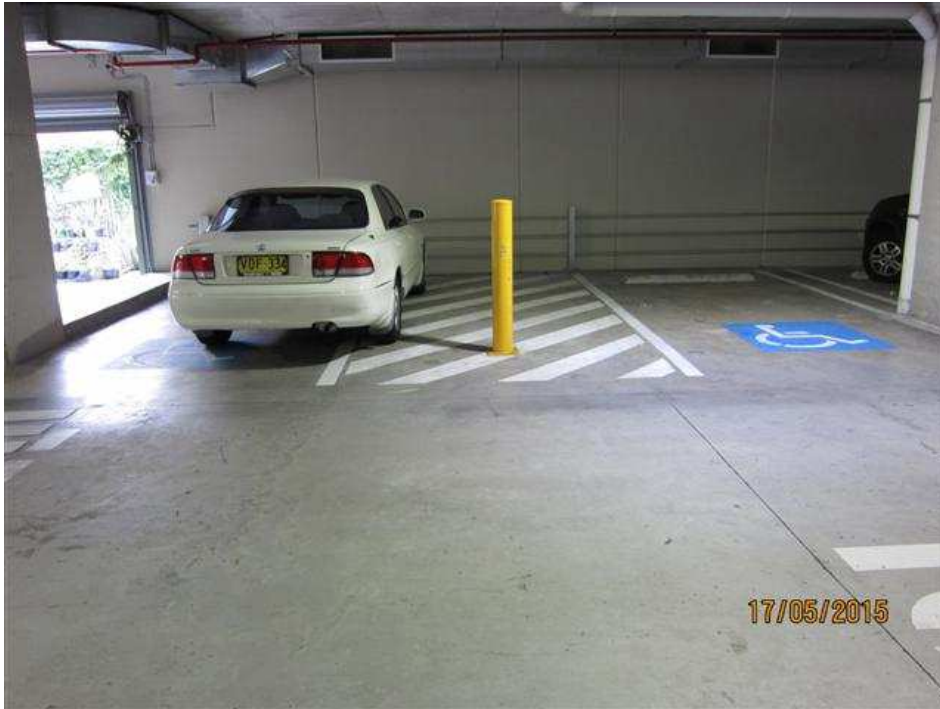
THE LAST DISABLED BOLLARD STANDING – LOWER GROUND LEVEL

This is the last bollard remaining on the lower ground level as part of the disabled parking spaces, however maybe not for long with drivers encroaching into the designated circulation area for the disabled parking as shown in the photo below.

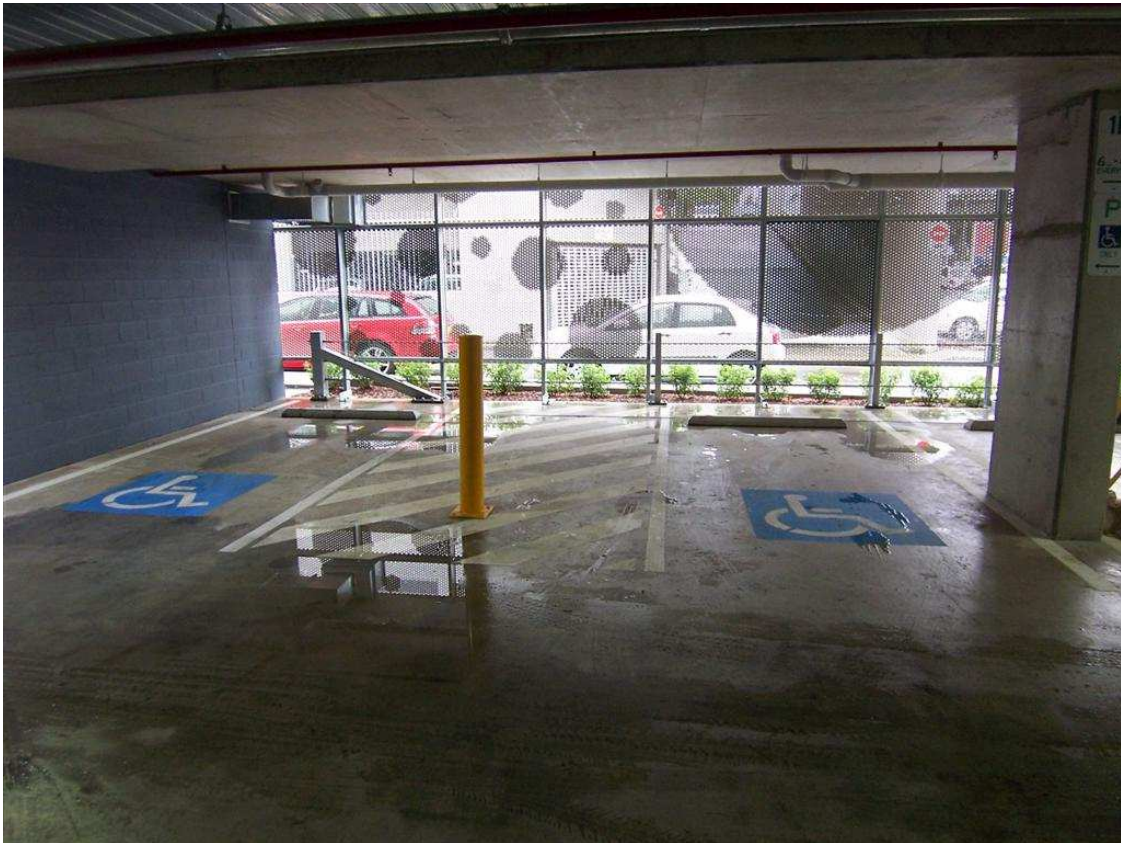
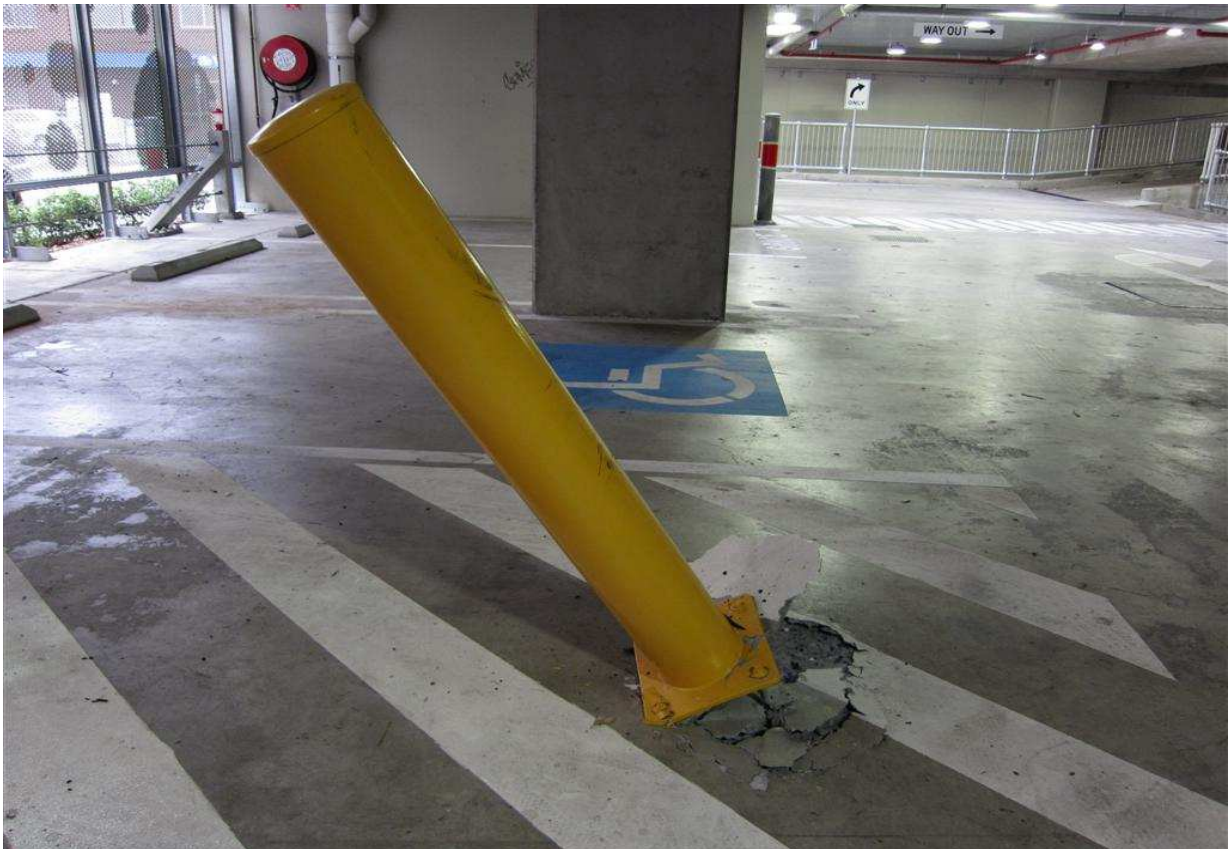
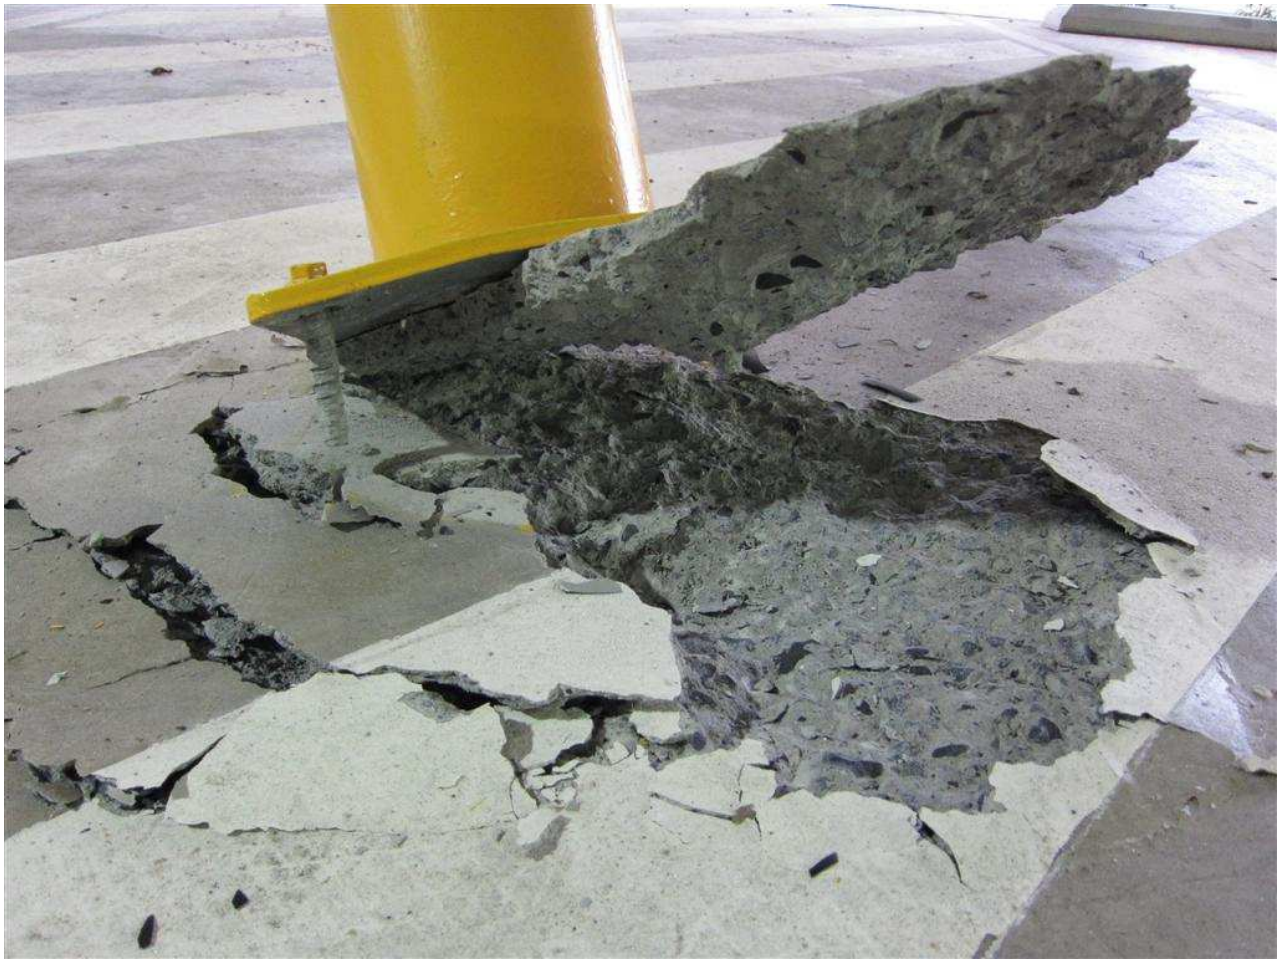
THE THIRD BOLLARD “FINELY TUNED” – UPPER GROUND LEVEL

The photo above was taken 28 February 2015 indicating the “*Bollard*” for the disabled parking provision on the Upper Ground Level was in place at that date. The next 3 photos were taken 22 March 2015 indicating the “*Bollard*” had received some “*Fine Tuning*” prior to this date.
GOING.....

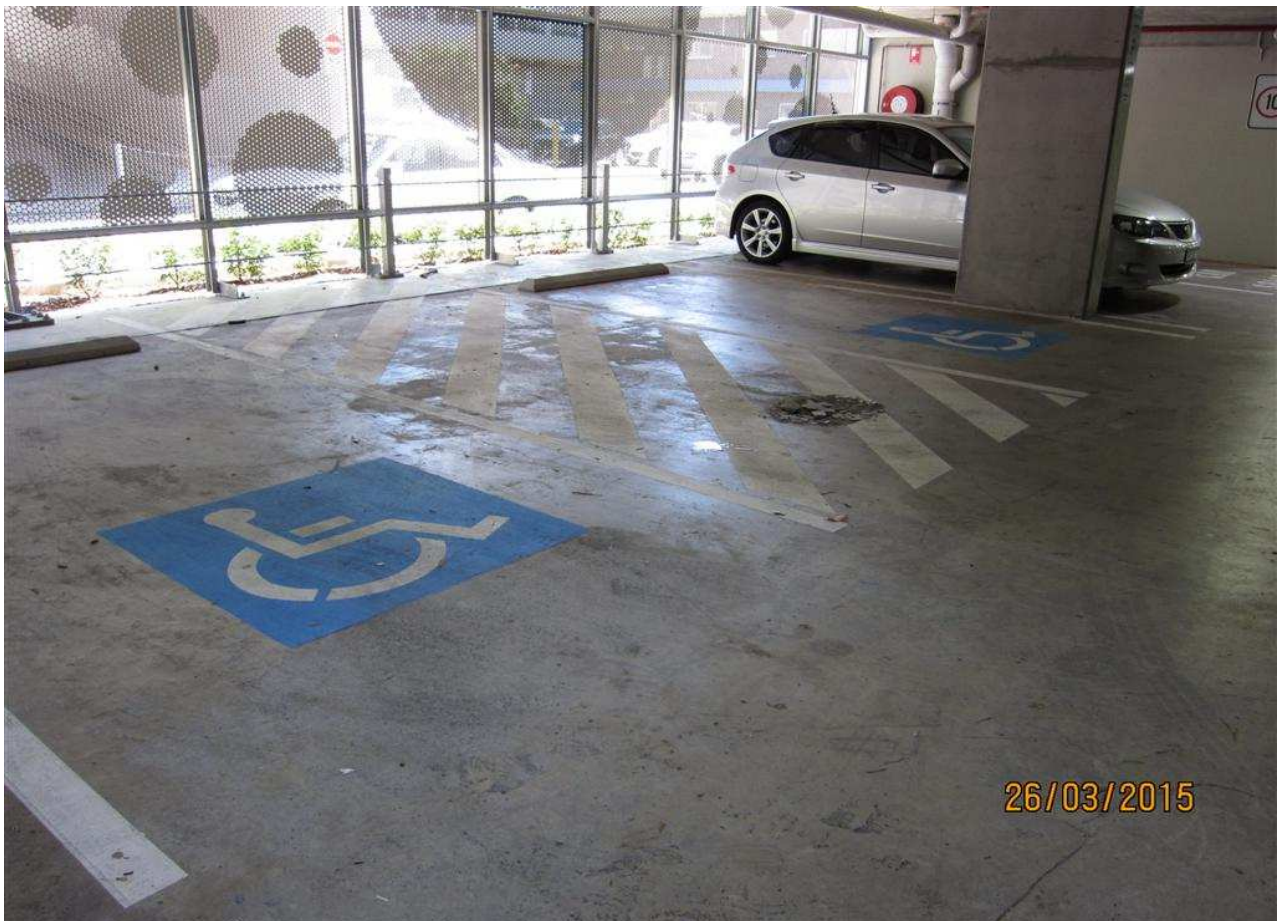
The next photo shows the “Bollard” was“GONE” by 26 March 2015.

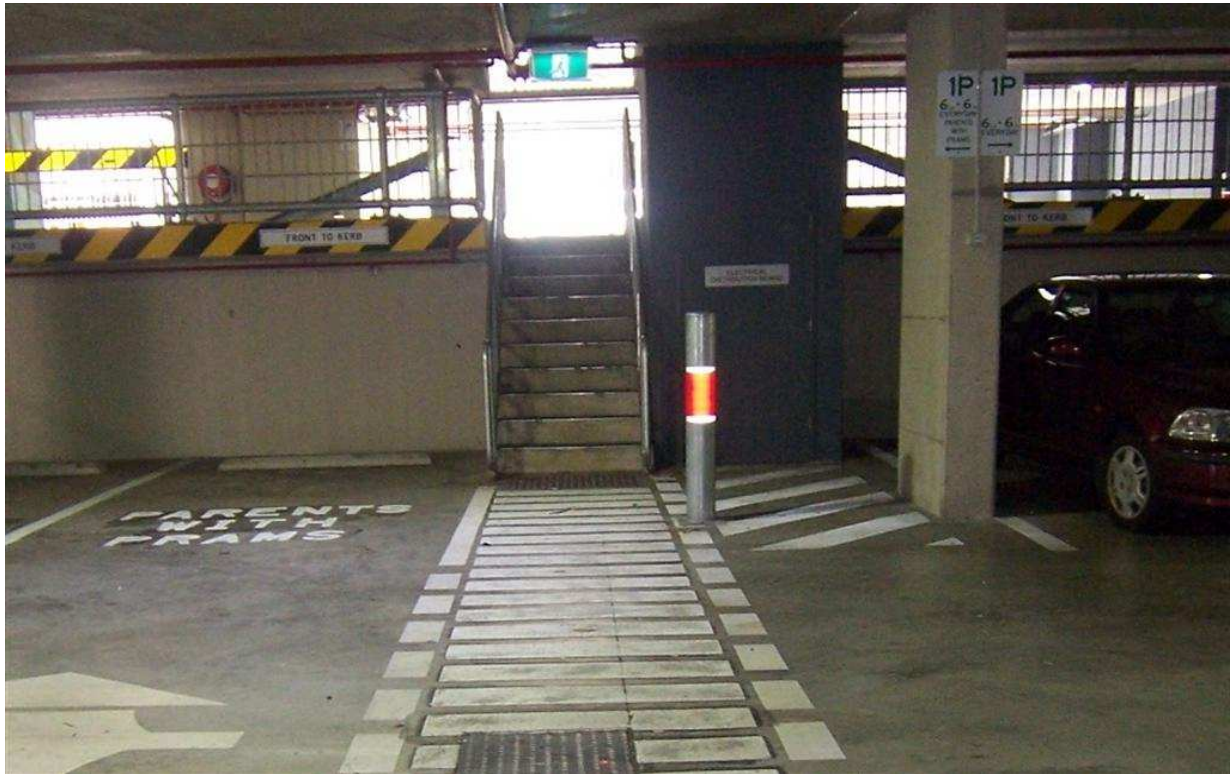
THE FOURTH BOLLARD “FINELY TUNED” – LOWER GROUND LEVEL

The photo above was taken 23 March 2015 indicating the “*Bollard*” for the “No Parking” area on the Lower Ground Level was in place at that date.

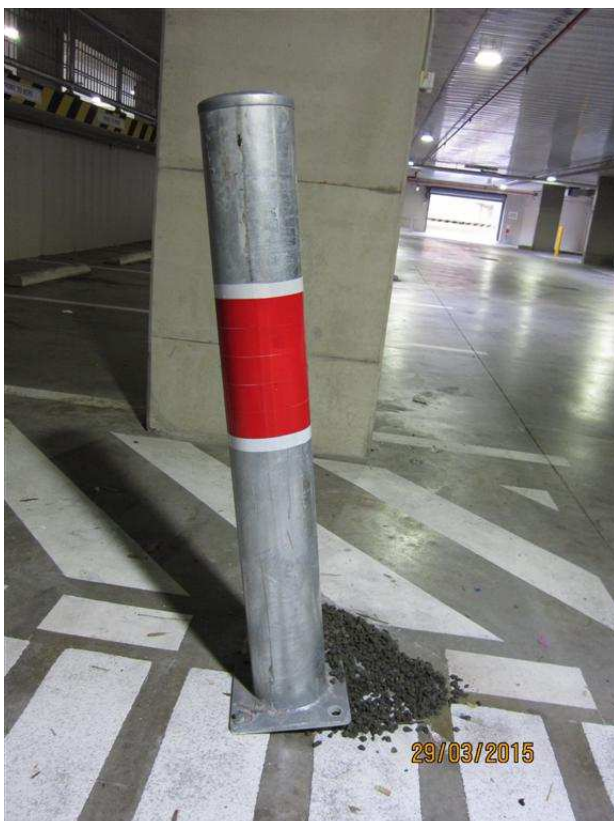
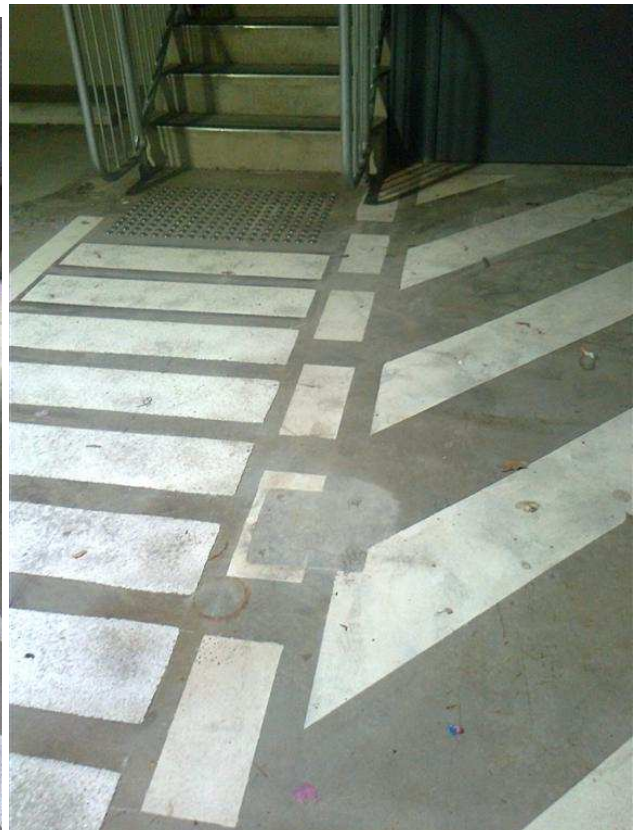
The photo below on the left was taken 6 days later on 29 March 2015 indicating the “*Bollard*” had received some “*Fine Tuning*” and the photo on the right taken 31 March 2015 showing it was “*Gone*”.

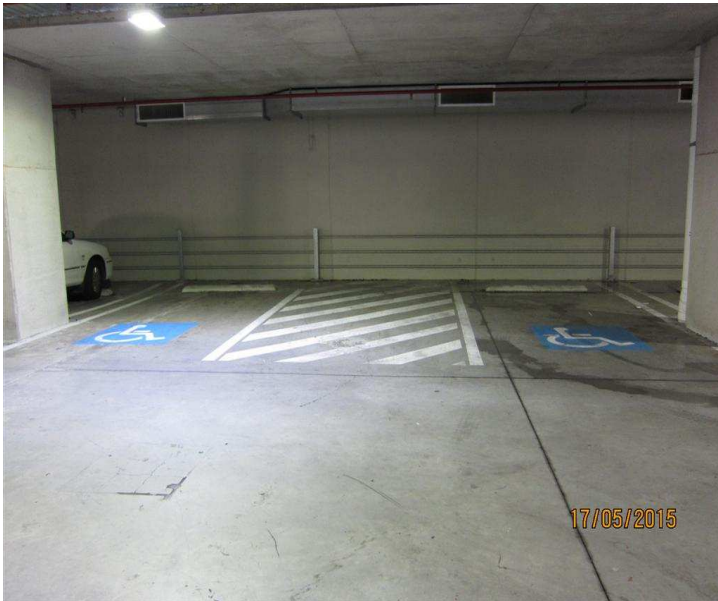
Southern most Parking Spots for Disabled Drivers Lower Ground Level.

Bollard Damaged prior to 3 January 2015.

It lasted less than 2 weeks of car park in operation
Pittwater Council has not replaced it as at 17 May 2015 being **134 days or 4 months and 14 days**, and still counting.

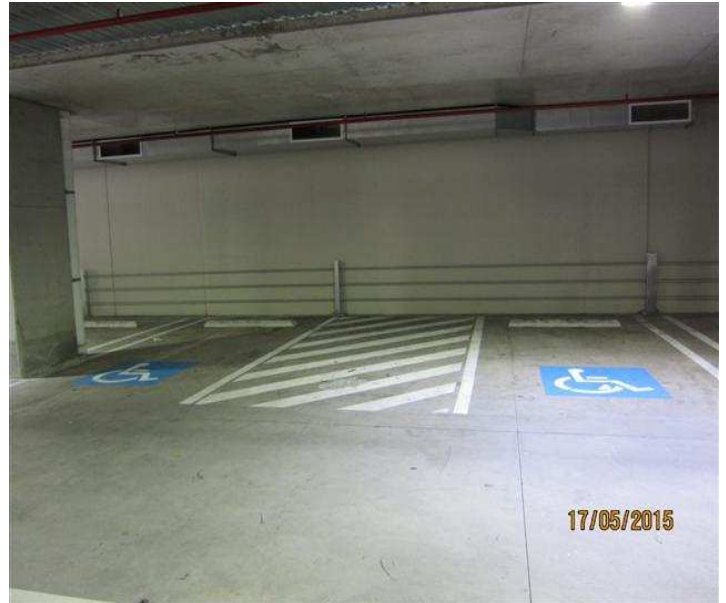
Central Parking Spots for Disabled Drivers Lower Ground Level.

Bollard Damaged prior to 1 March 2015.

Pittwater Council has not replaced it as at 17 May 2015 being **77 days or 2 months and 16 days**, and still counting.

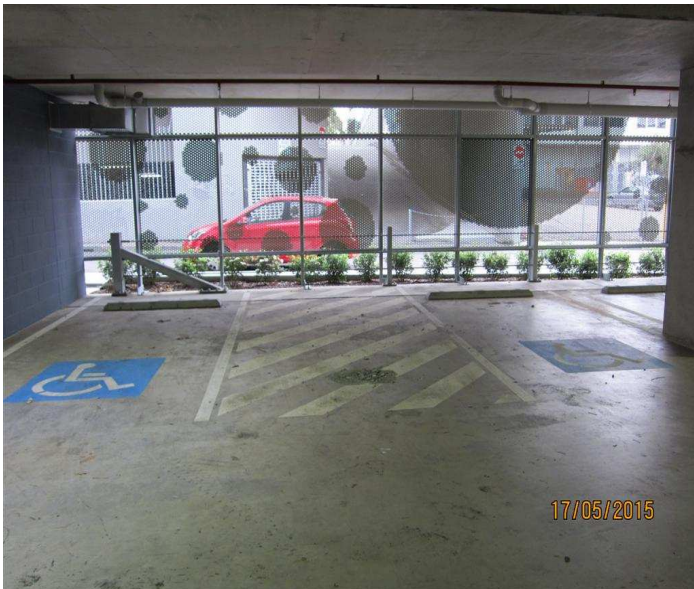
Upper Ground Level Parking Spots for Disabled Drivers.

Bollard Damaged prior to 22 March 2015.

Pittwater Council has not replaced it as at 17 May being **56 days or 1 months and 25 days**, and still counting.

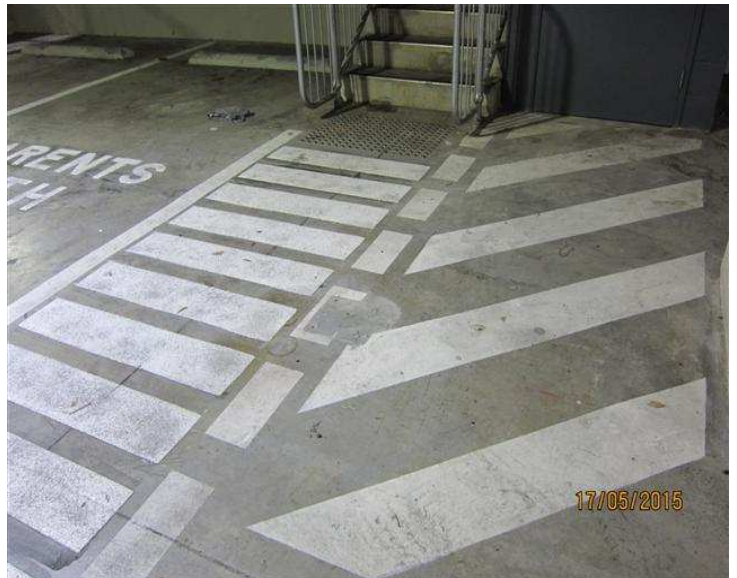
Southern most Walkway, Lower Ground Level.

Bollard Damaged prior to 29 March 2015.

Pittwater Council has not replaced it as at 17 May being **49 days or 1 months and 18 days**, and still counting.
