- MONA VALE BOLLARD CENTRAL -

**THE GENERAL MANAGER – MARK FERGUSON –
CONTINUES HIS “FINE TUNING”
OF THE MONA VALE POST OFFICE CAR PARK
(with no access to the Post Office)
WITH A CLEVER COST SHIFTING TO THE PUBLIC**

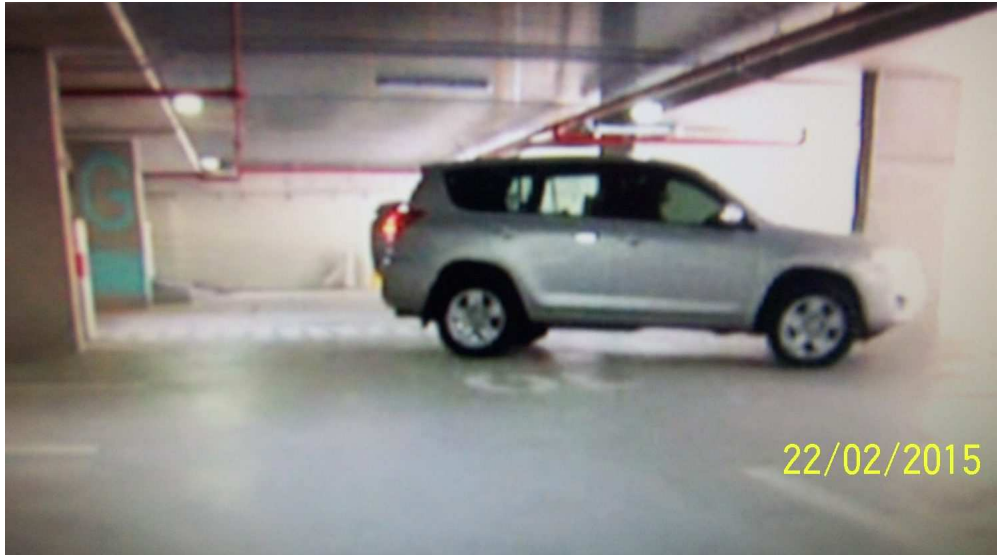
The driver of this was 4WD was observed reversing from the car space and backed right into the bollard shown at the L/H end of the photo. Upon arriving at the scene a large dent was observed in the rear bumper bar.

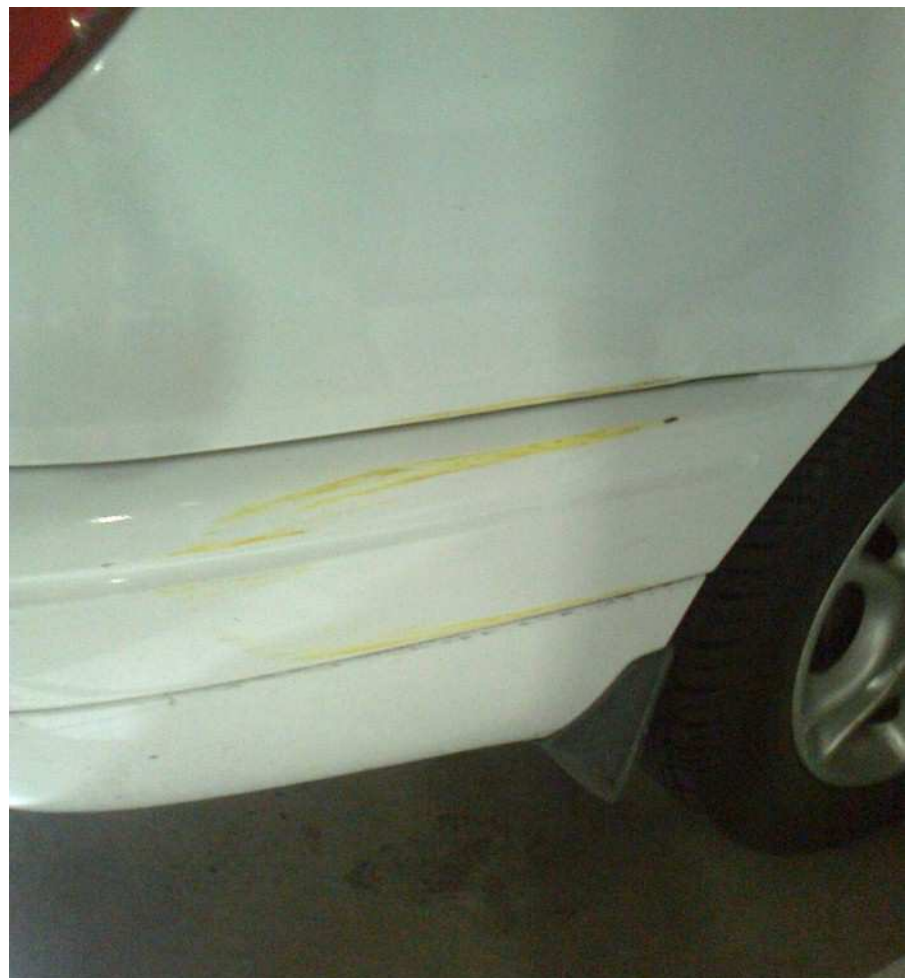
The driver of this vehicle fought and lost *"The Battle with The Bollards"*.

Battle scars of yellow paint are indicated on the rear quarter panel and bumper bar.

The driver complained and said it could have been major damage.

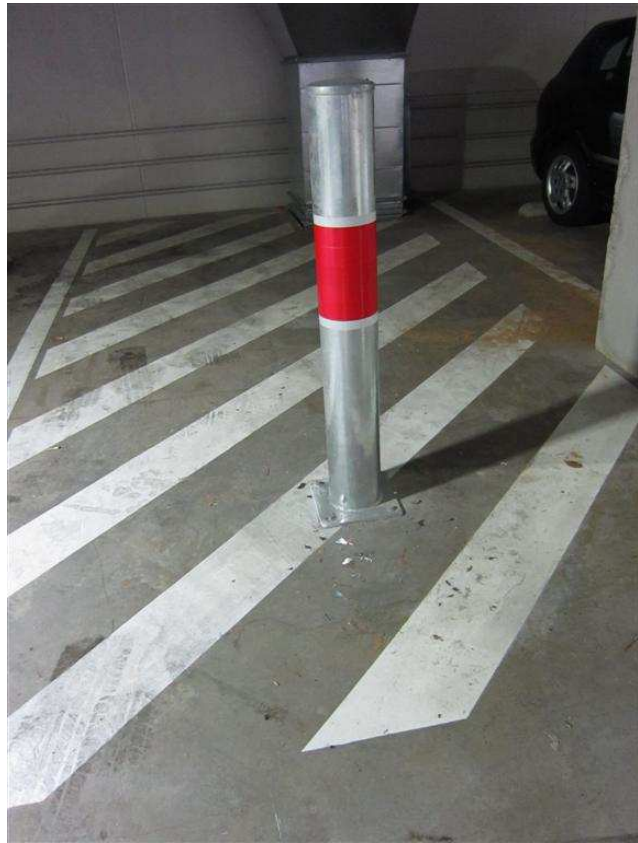
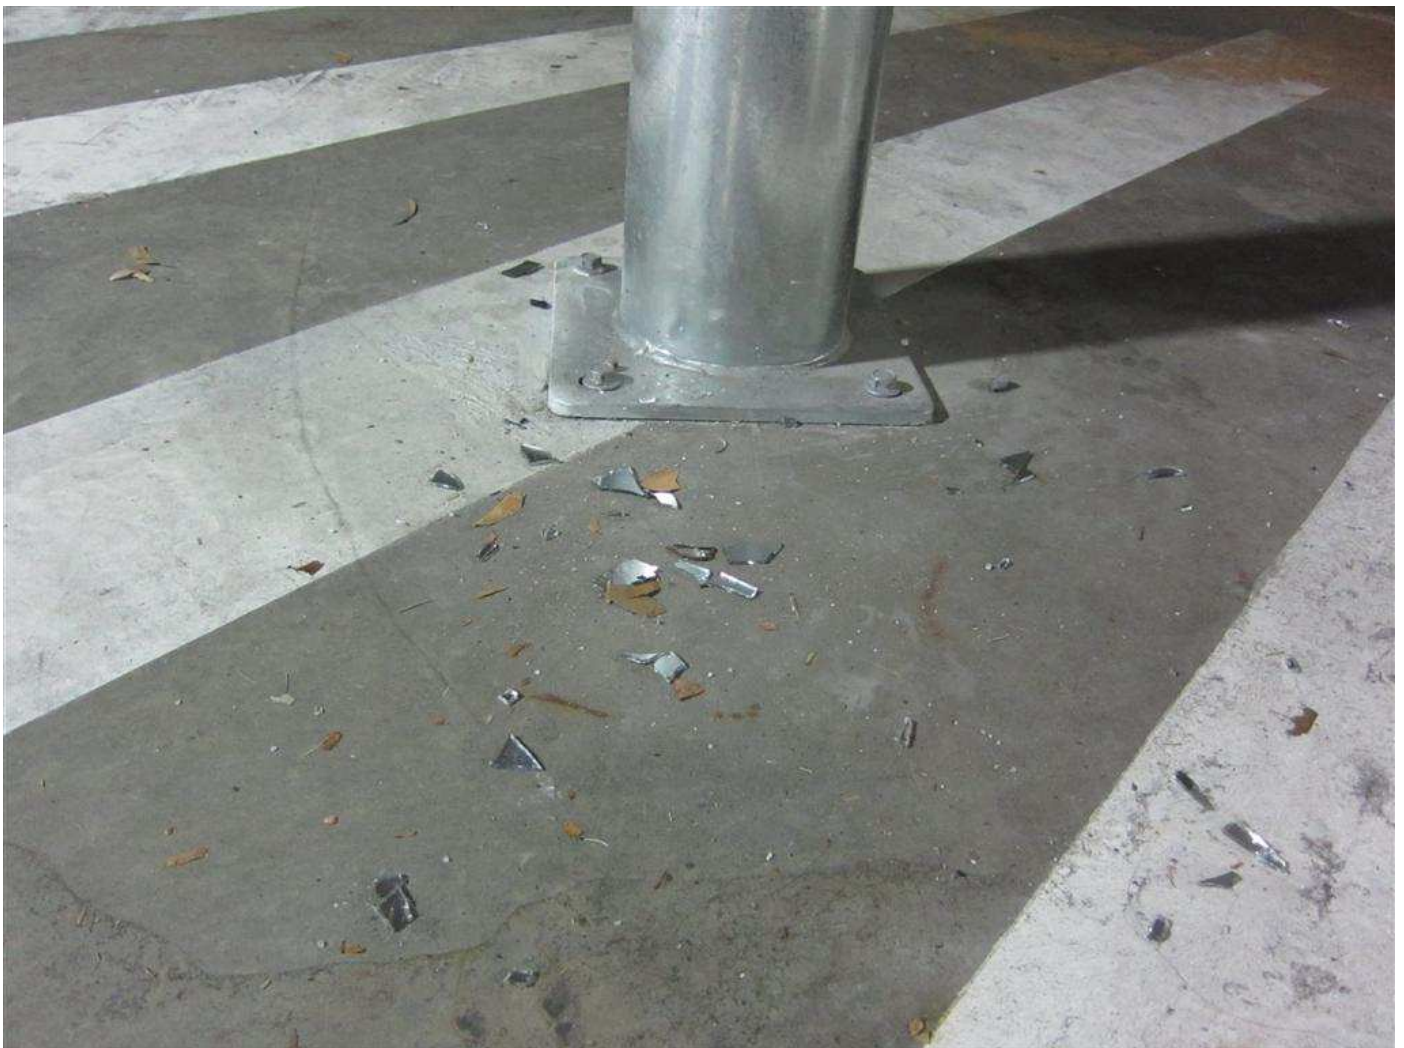
The aftermath of a battle lost was observed with evidence of broken glass from a door mirror shown these photos.

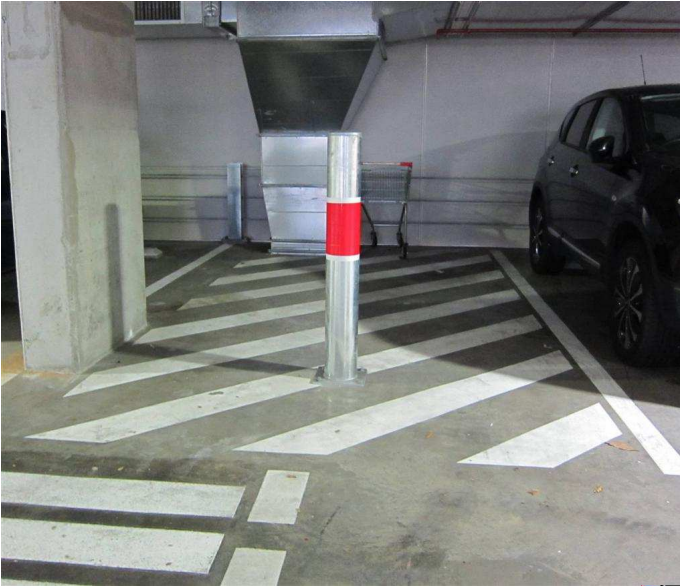
MECHANICAL VENTILATION BOLLARDS

These Bollards on each level are now waiting to do battle on the “*Eastern Front*”, after their comrade took out the vehicle door mirror identified on the previous page.

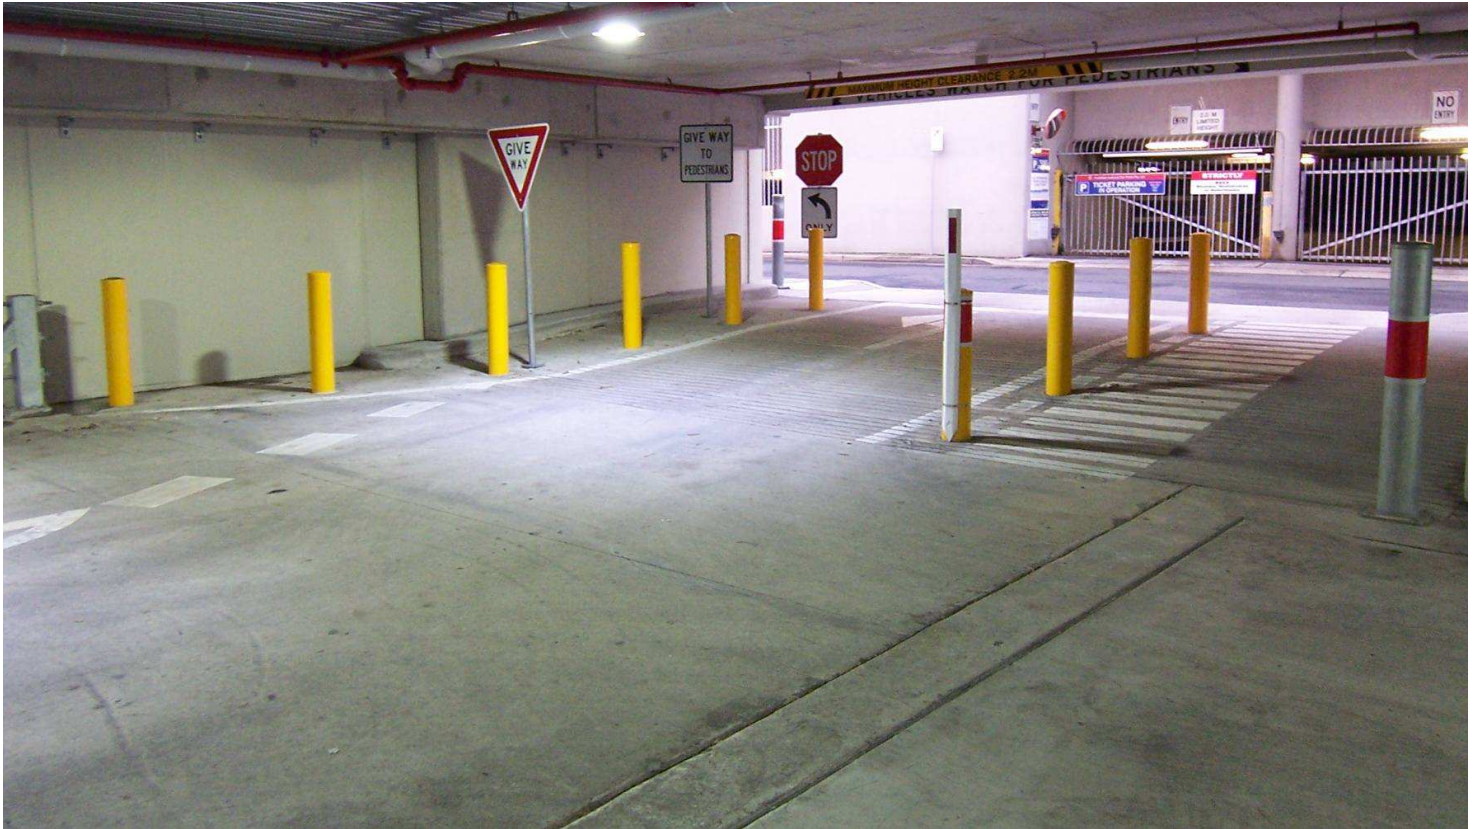
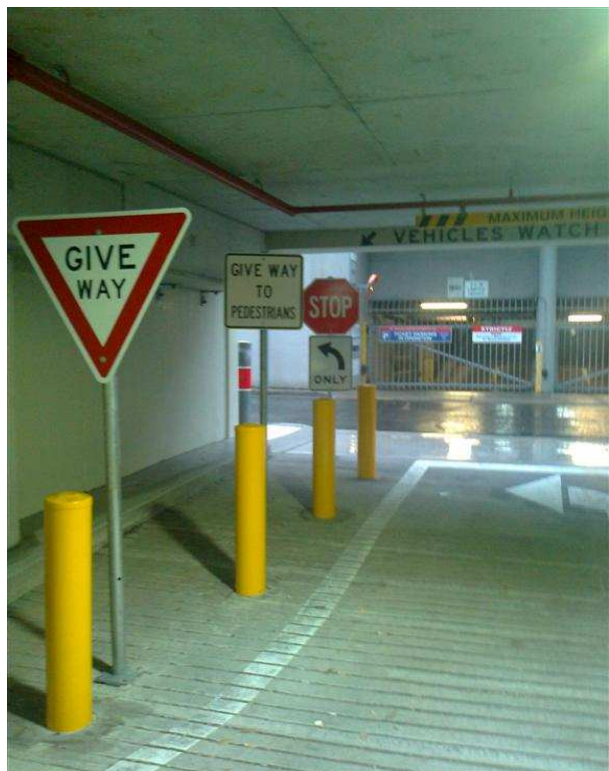
BOLLARDS AT THE EXIT

And now the Finale - The Bollard Feature of the Car Park – “*The Exit*”. Just in case drivers and visitors haven’t yet achieved “*Bollarditis*” they are finally “*Greeted*” by the sight of no less than fourteen (14) Bollards as a “*Farewell*” at the exit, consisting of two galvanised Bollards to the right, a yellow parade “*Right and Left*” of 10 Bollards and two more “*Right and Left*” on the footpath.

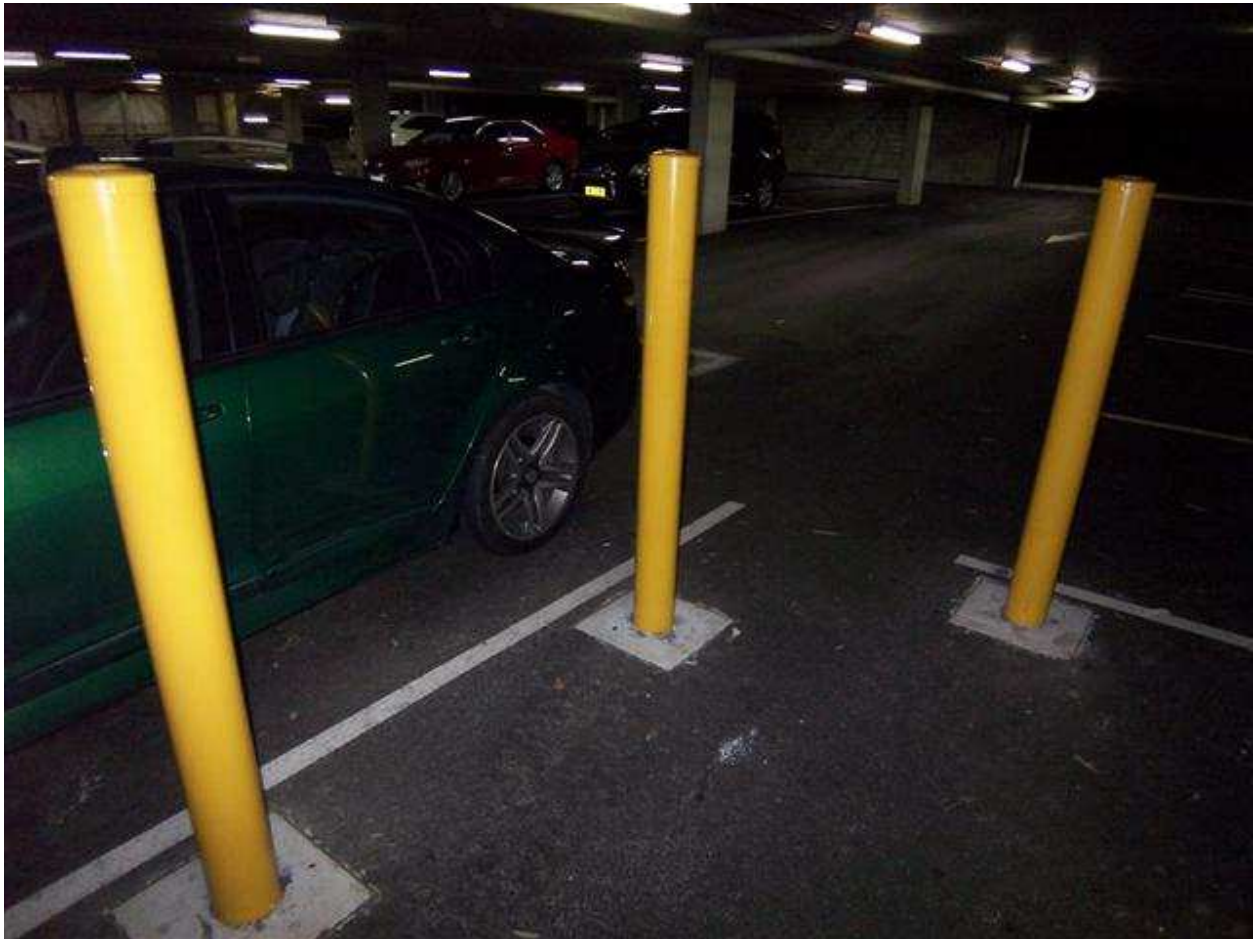
The problem with bollards being hit is because they are not clearly visible to drivers when in their normal driving position and reversing from car parking spaces.

Is it as simple as the bollards are not tall enough? This is likely so with a recent visit to Pittwater RSL, which showed, the bollards in their multi storey car park are much taller as shown in the photo below.

The Pittwater RSL bollards as shown above measure 1485mm in High.

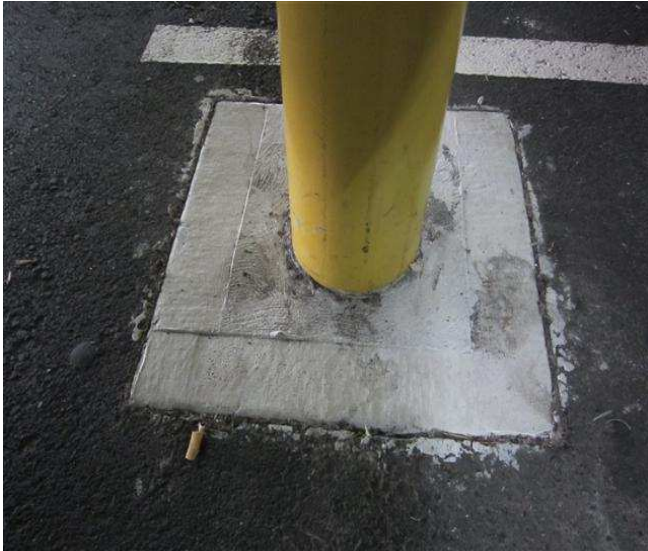
It would seem the method of installation of the Bollards could also be a problem. The surface mounting of the bottom flange to the concrete slab and securing with self threading bolts is not the best method. Noted from the Pittwater RSL car park and the entry and exit of the Bungan Lane car park the Bollards have been cored drilled and secured in the floor.

← Pittwater RSL Bollards are mounted into the floor

It would seem the General Manager needs to do more *“Fine Tuning”* by reinstalling all the bollards which have bottom plate surface mounting, with the *“In Slab”* method. All bollards need to be taller to be more visible.

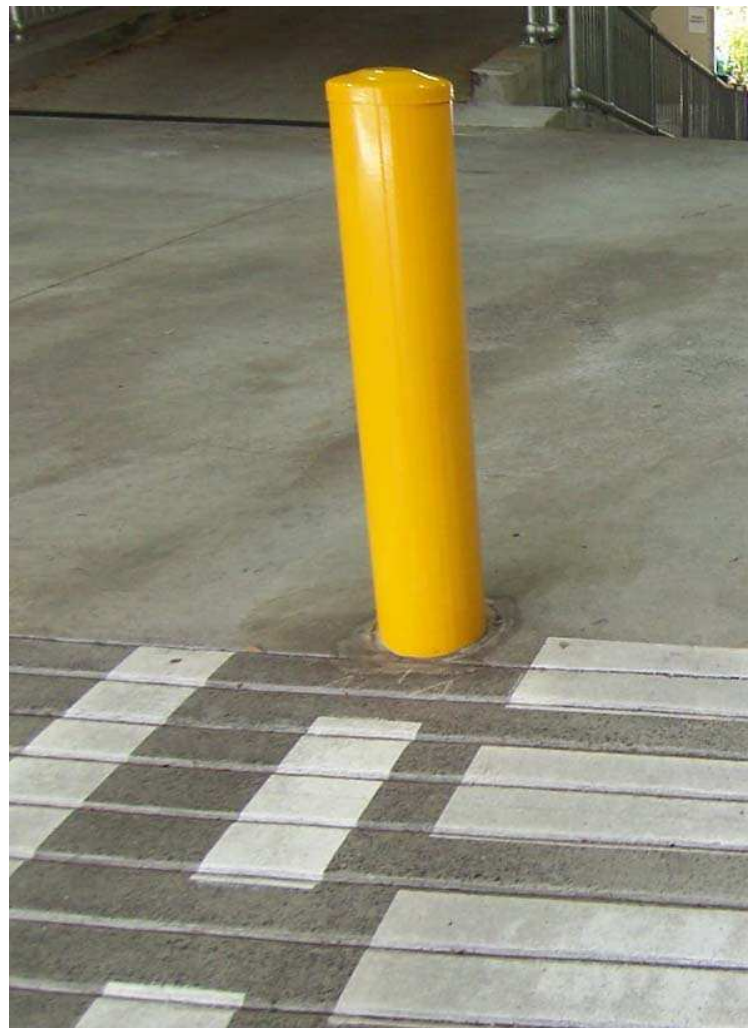
Bungan Lane Car Park – Photo shows the concrete slab entry / exit driveways was core drilled.

Bungan Lane Car Park – Photo shows the bollards mounted in the core holes
