Appendix B

Photographs

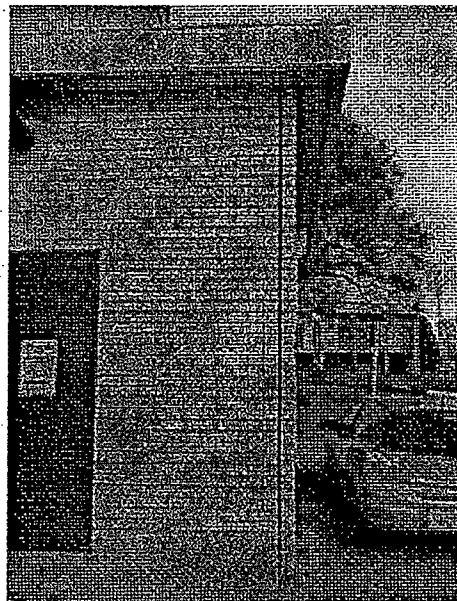
Figure B1-15: Brickwork – Gradual leaning and peeling of brickwork panel. Ground level, northwest corner of west wing.

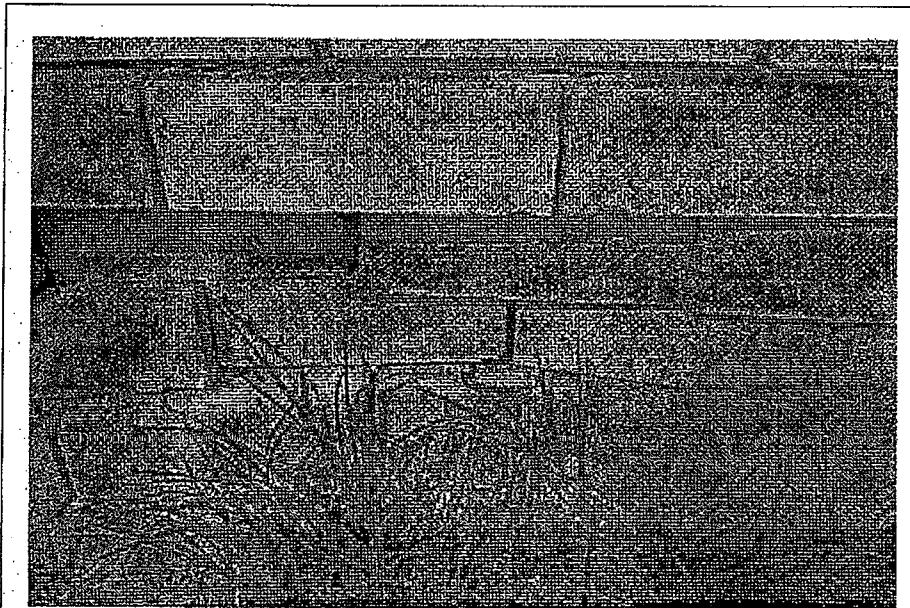
Figure B1-20: Brickwork – Displacement of brickworks due to loss of mortar and impact loads on the northern wing.

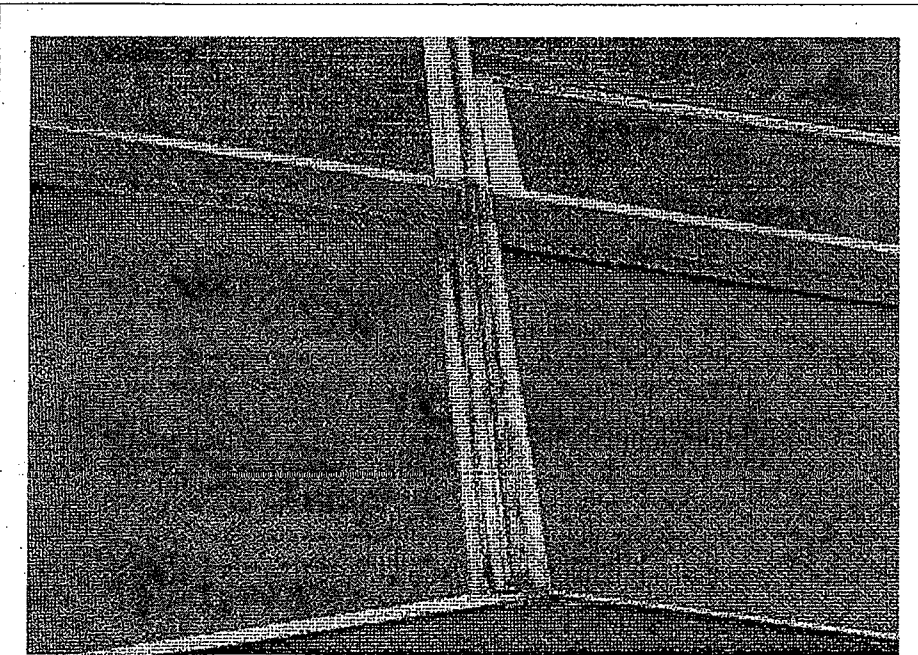
Figure B2-20: Windows and Louvres – Displaced trims on curtain wall stairs windows.
