FLOODING OF THE GENERAL MANAGER'S "FINELY TUNED" MONA VALE POST OFFICE CAR PARK

Extensive flooding occurs in the Mona Vale Post Office Car Park in Bungan Lane, when it rains, which is a regular occurrence in Mona Vale ! This results in not just wet concrete but flowing floodwaters through the car park, creating "unsafe situations" for the public walking through the car park.

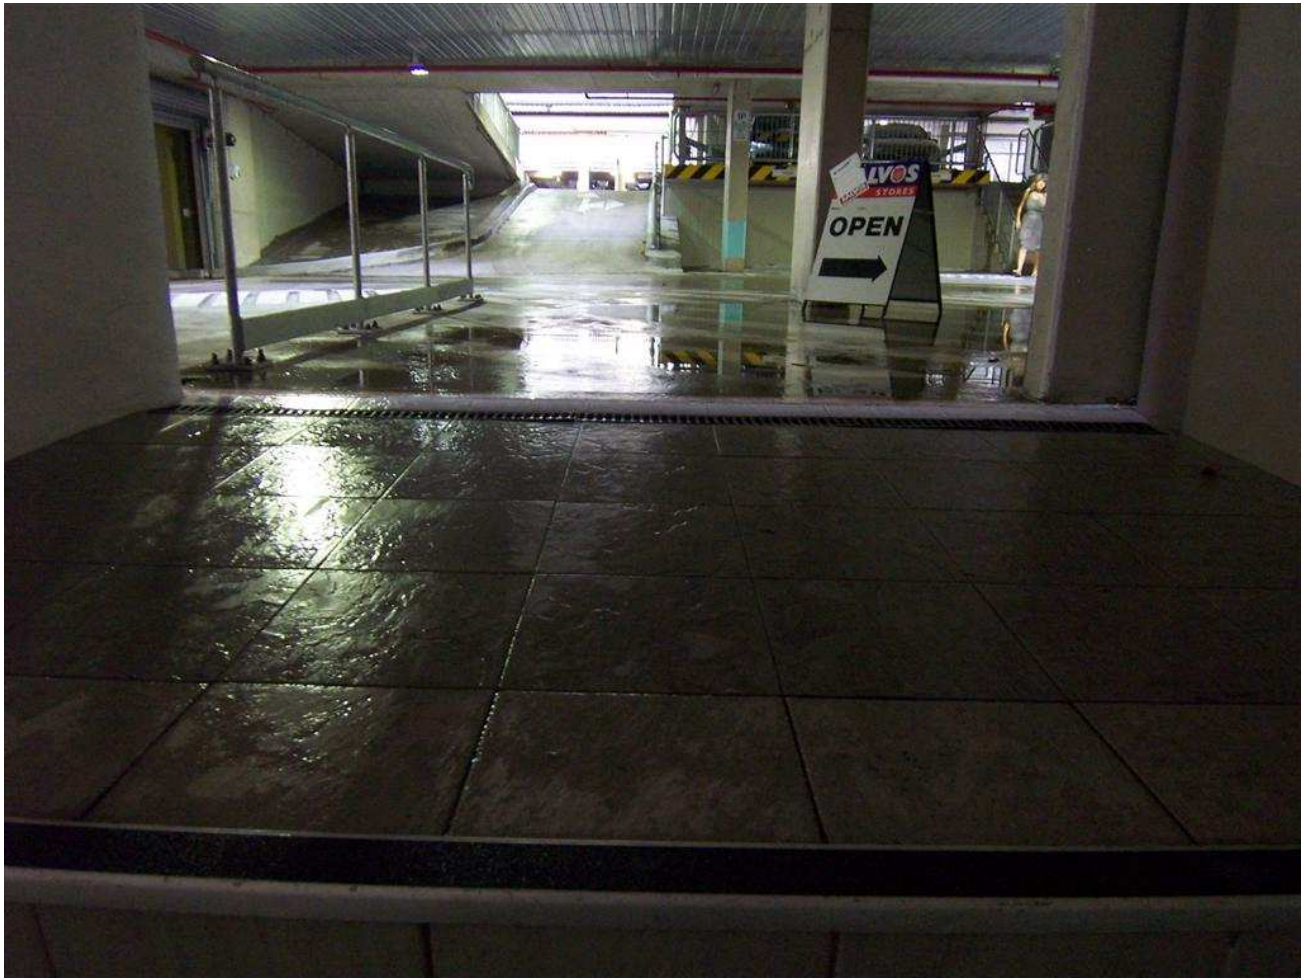
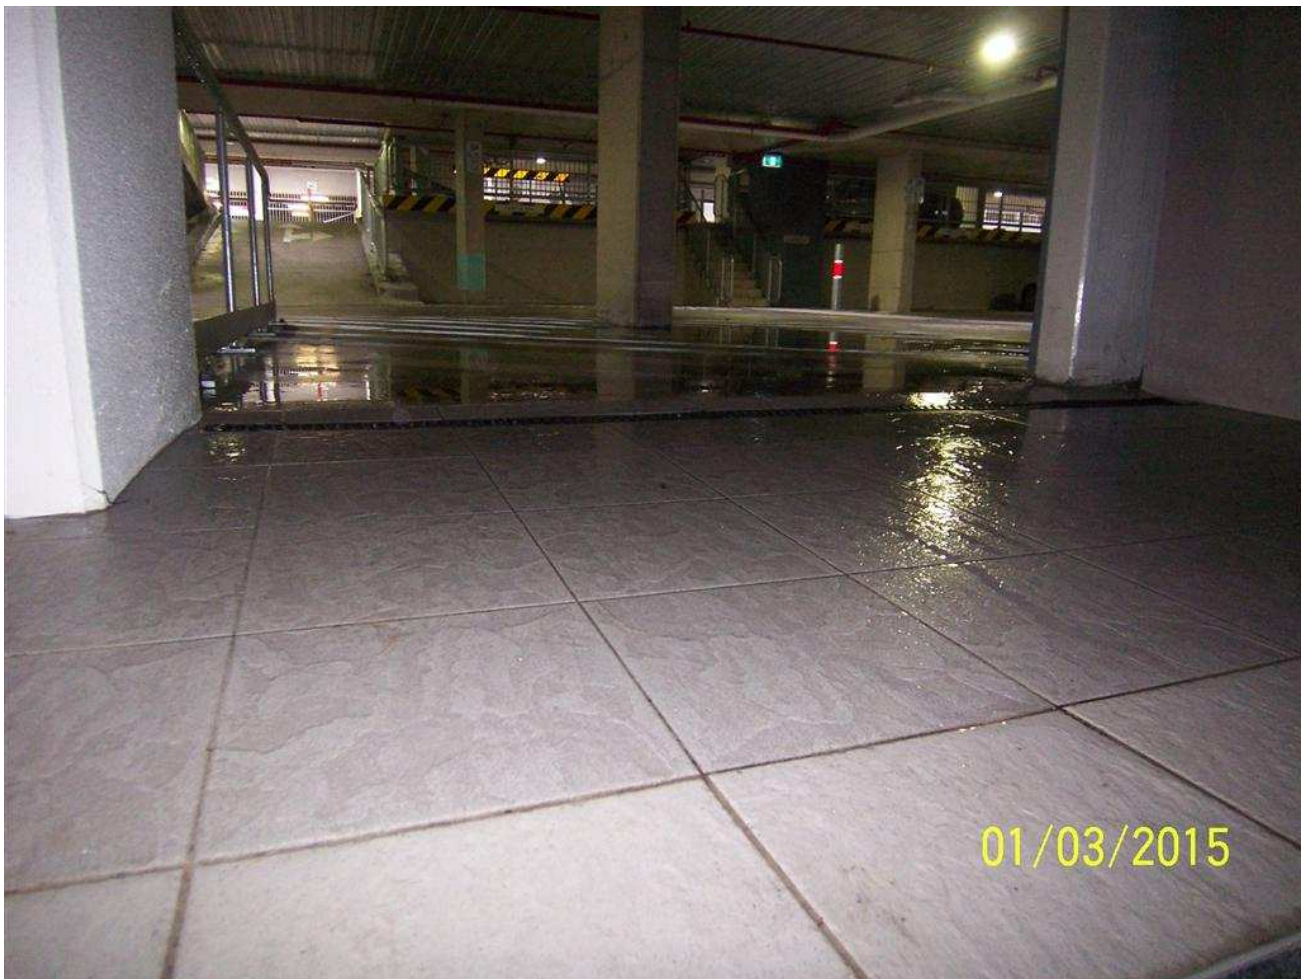
The photos above and below show the regular puddle of water at the top of the stairs and the water on top of the tiled stairs and landing.

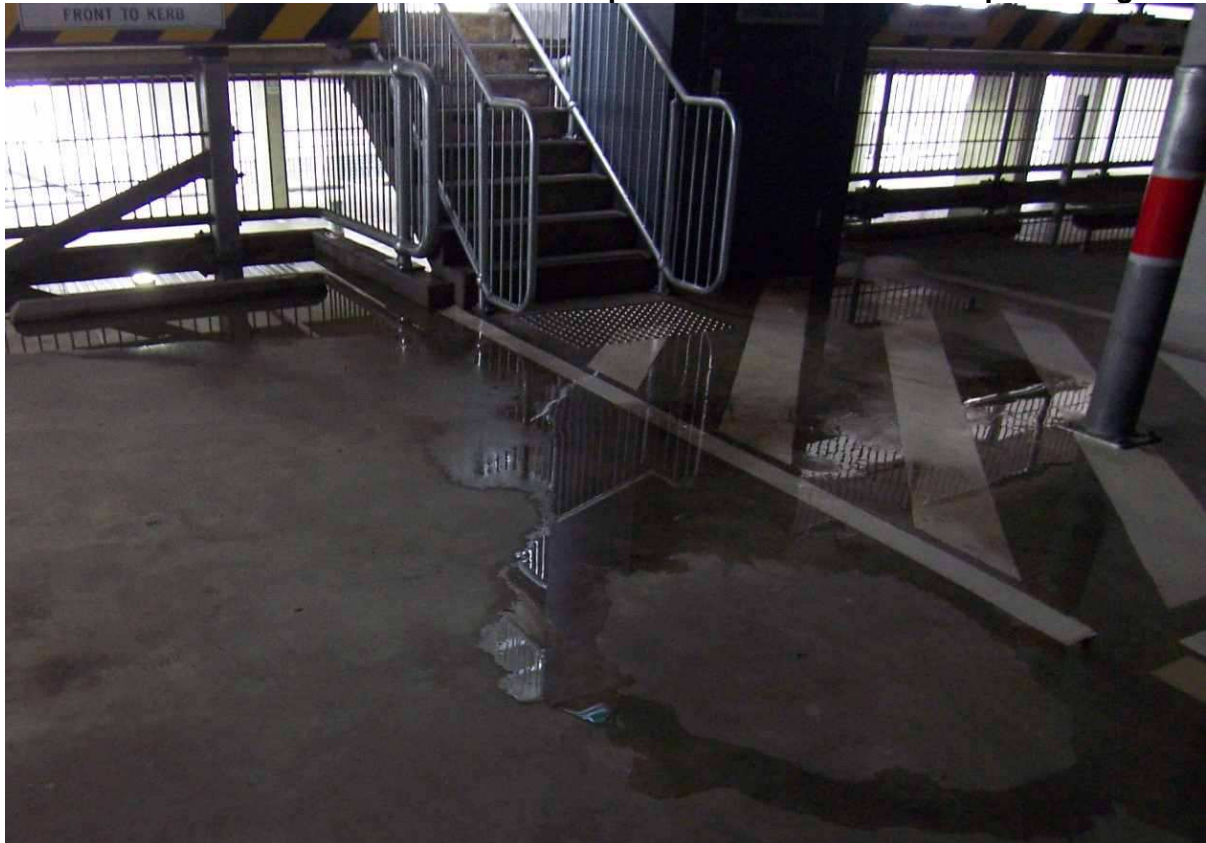
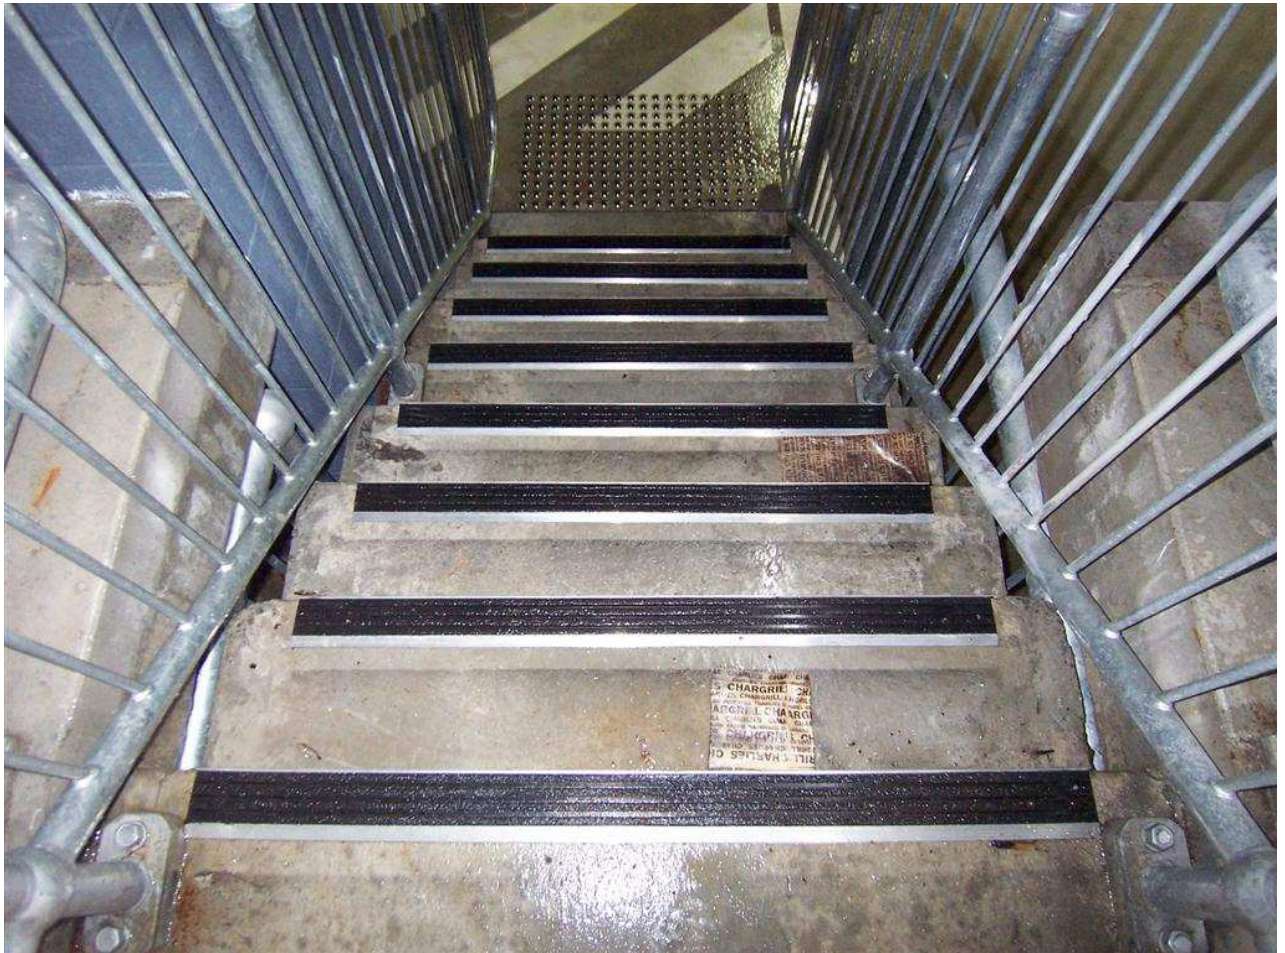
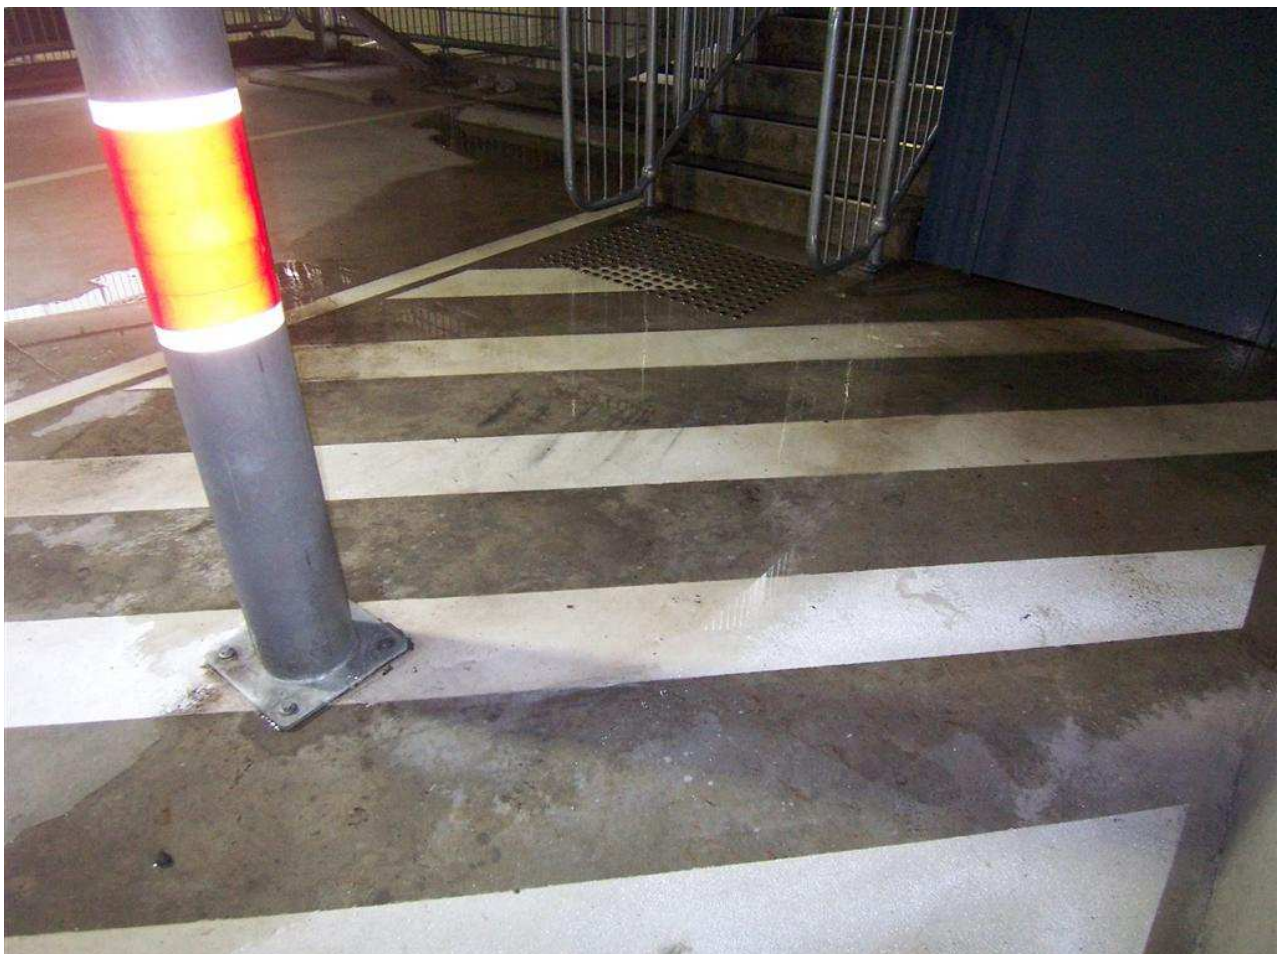
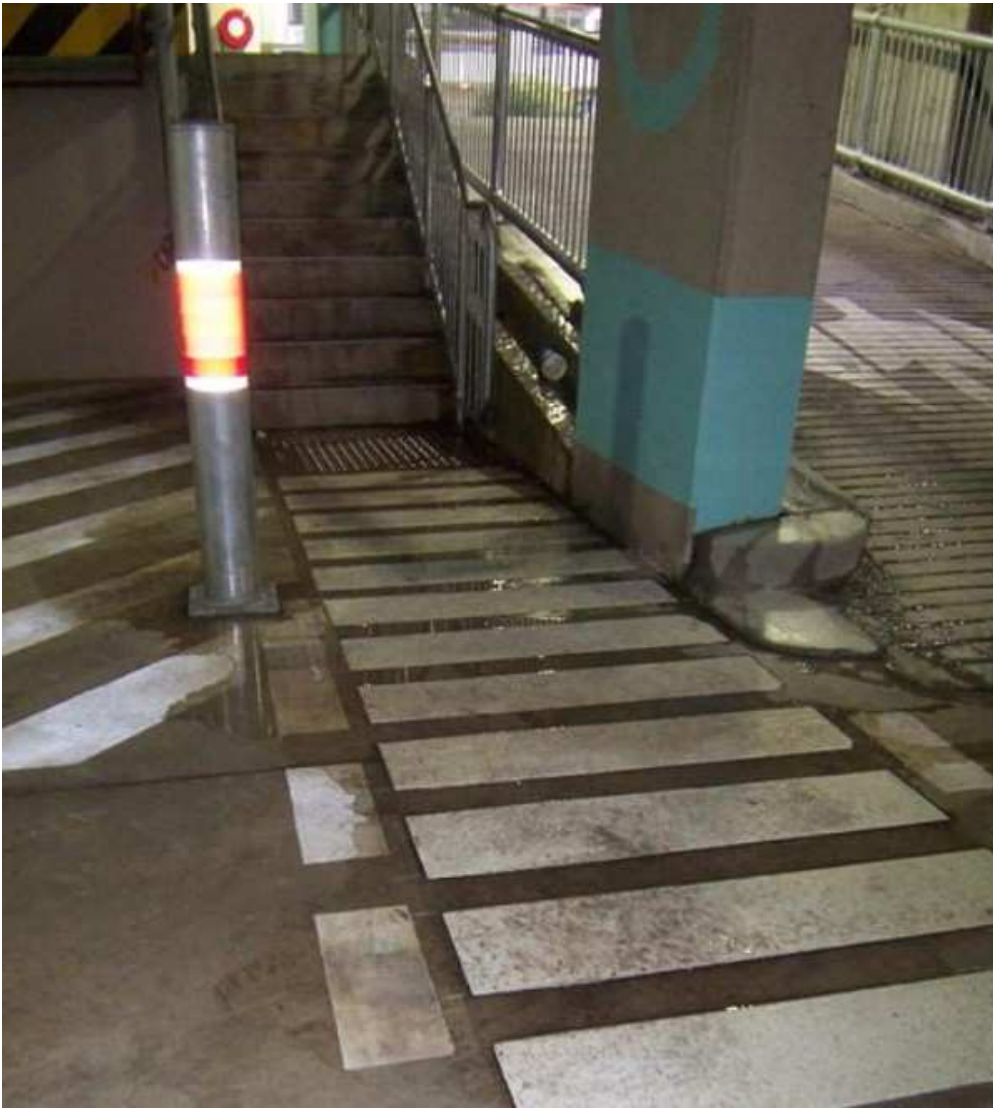
This results in the “*unsafe situation*” of steps on each level of the car park being wet.

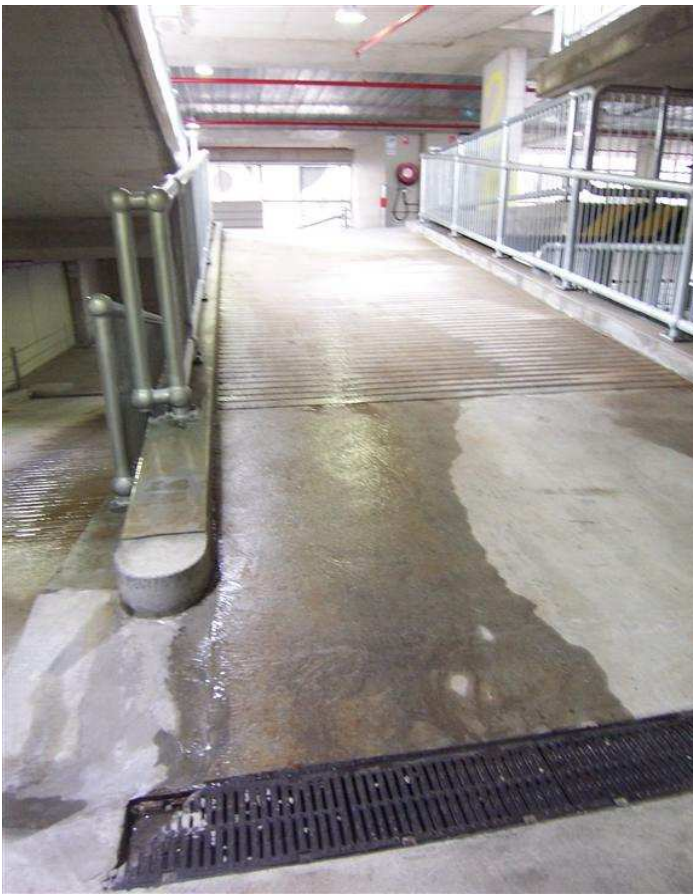
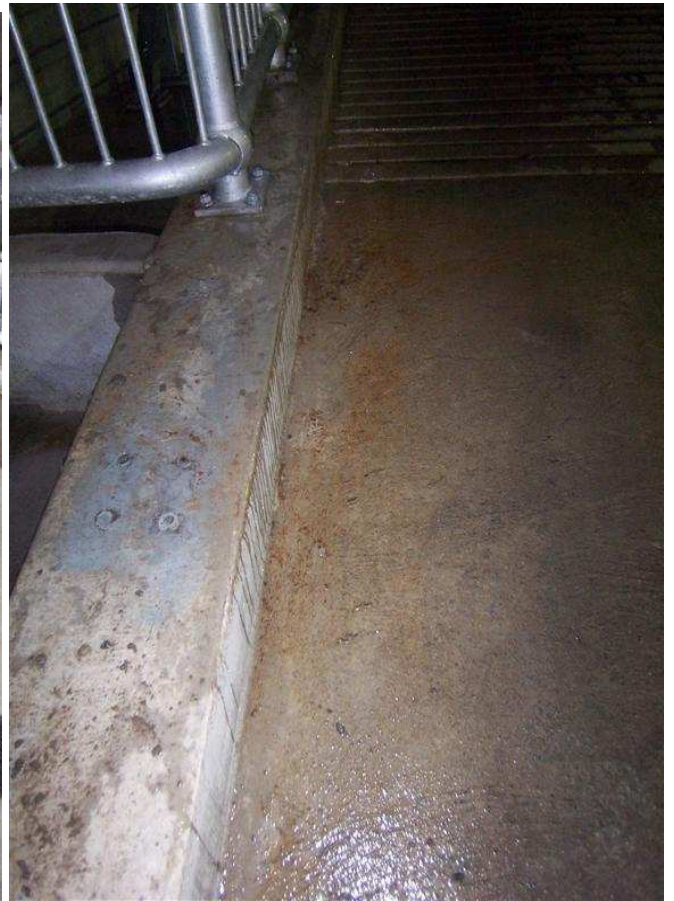
- 5) The internal vehicular ramps, which become flooded are “*unsafe situations*” as they are used extensively by pedestrians.
