Appendix B

Photographs

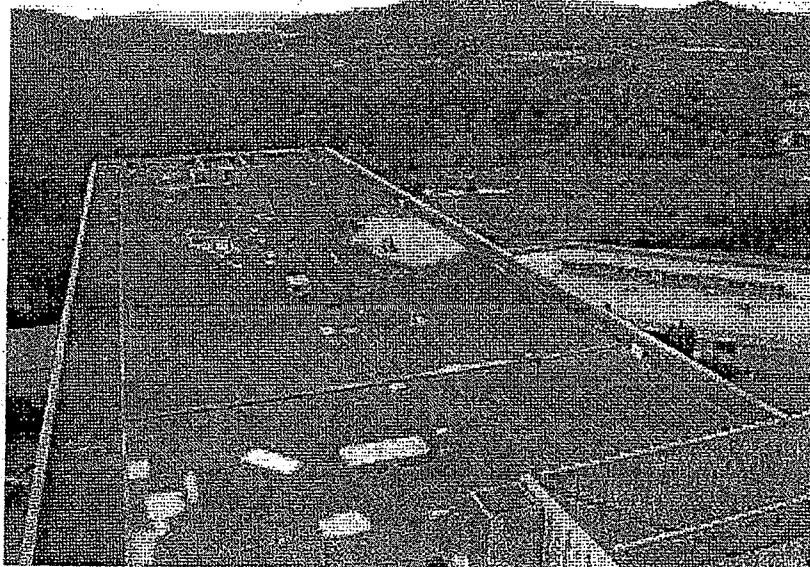
Figure B5-2: Roof areas – Patched areas of nuralite membrane on the northern wing.

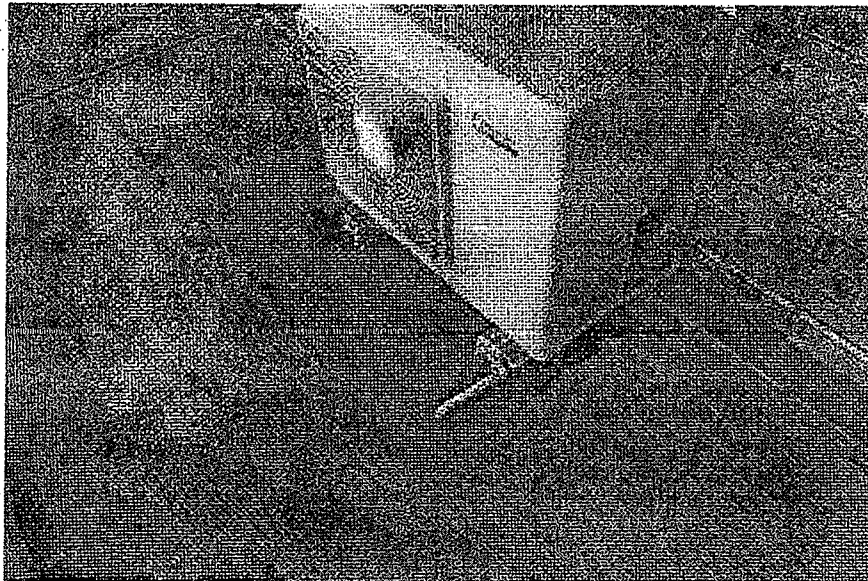
Figure B5-4: Roof areas – Water pooling on the lower roof of the western elevation of the northern wing.
